Macon and Adair County, Route 63, Job J2P0485

Route 63, Howell Co., project J9P0497, HDPE double wall storm sewer, W. Side Rt.63

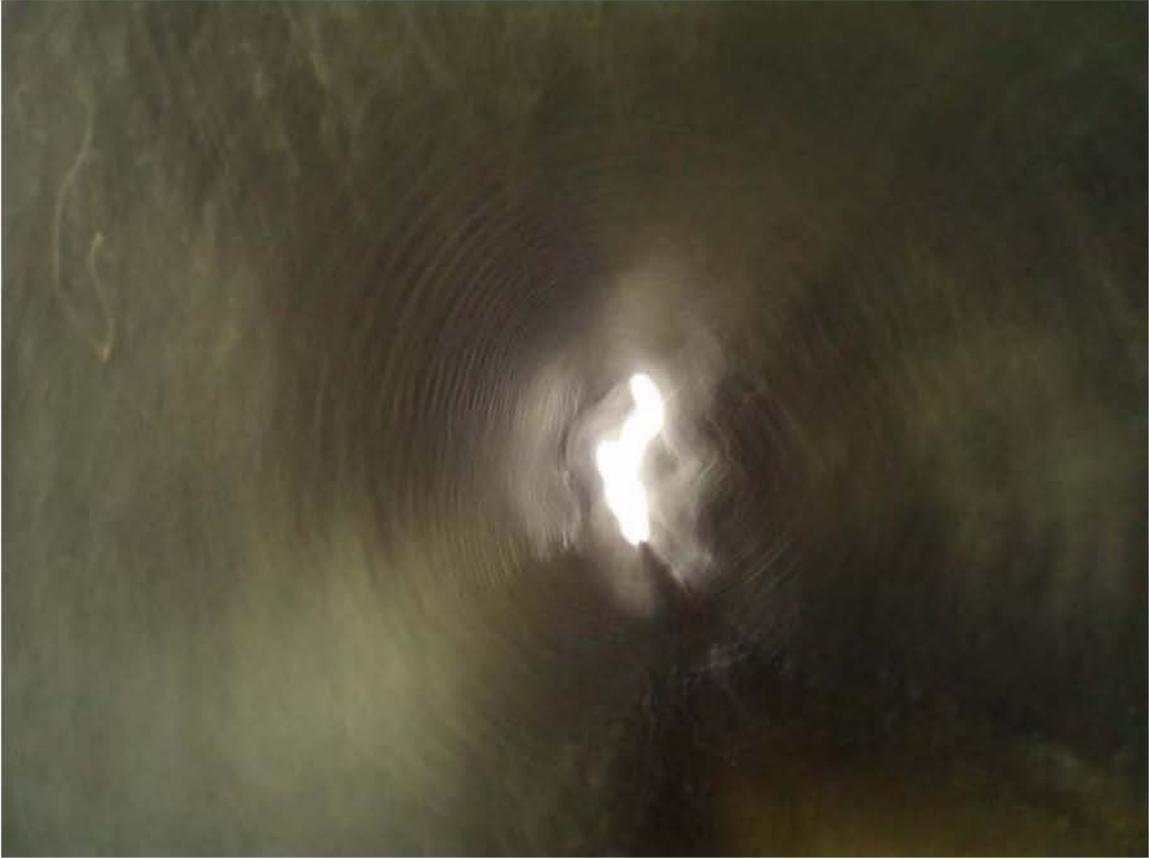
7-31-07, s-172, 18", 1804+00

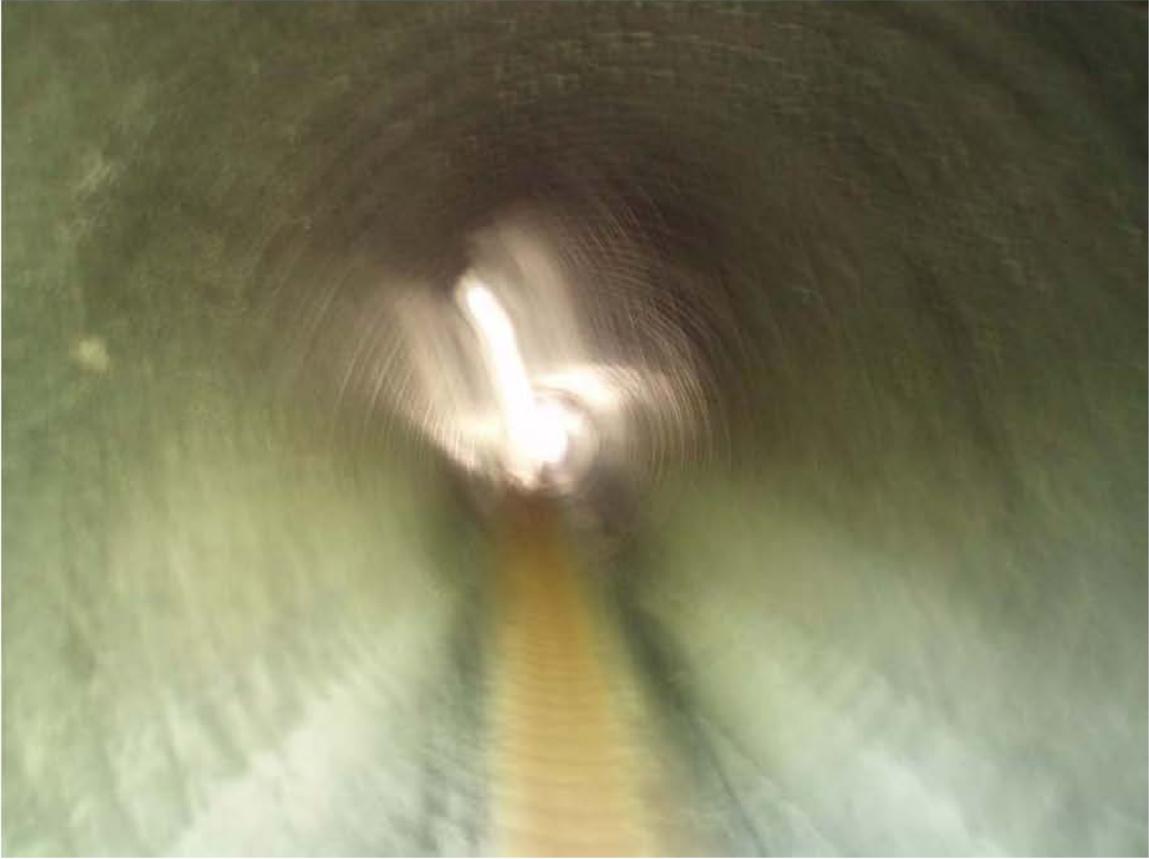
7-31-07, p-168, 42", 1790+92

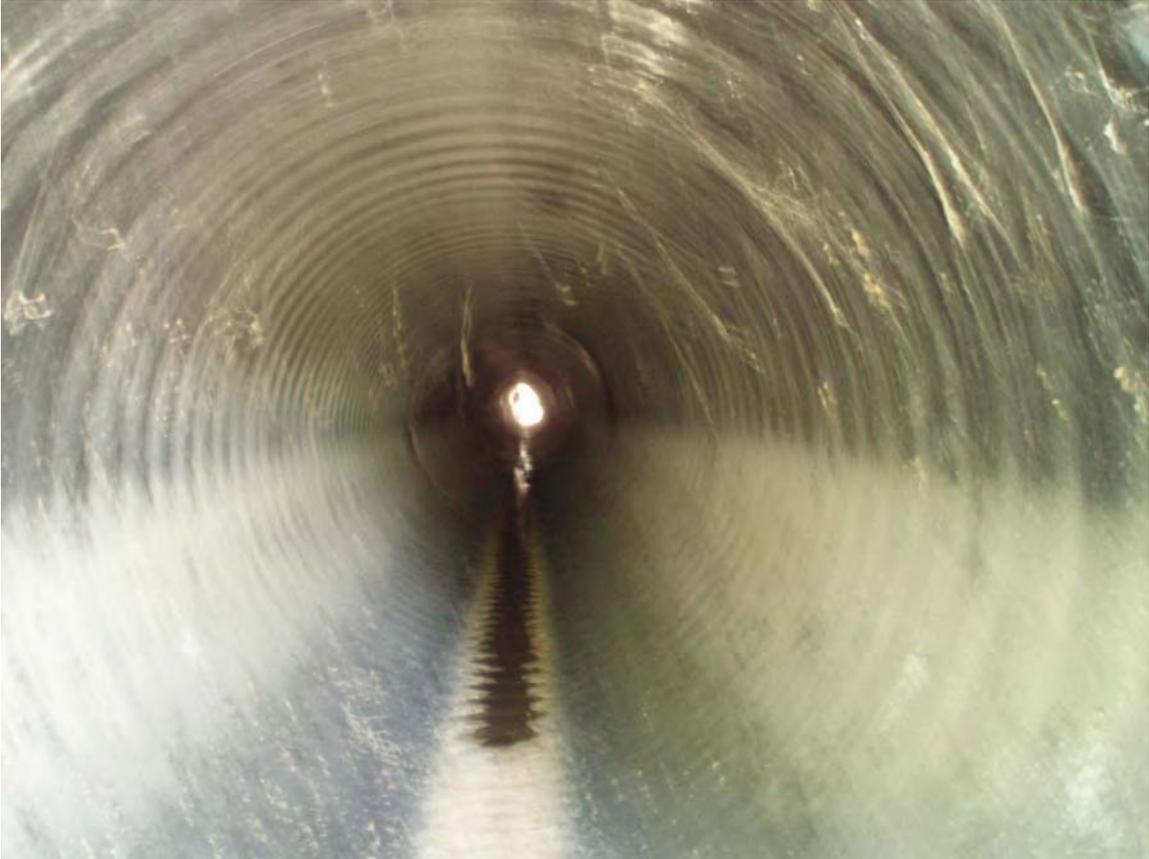
7-31-07, s-166, 18", 1786+00, Type S Grate

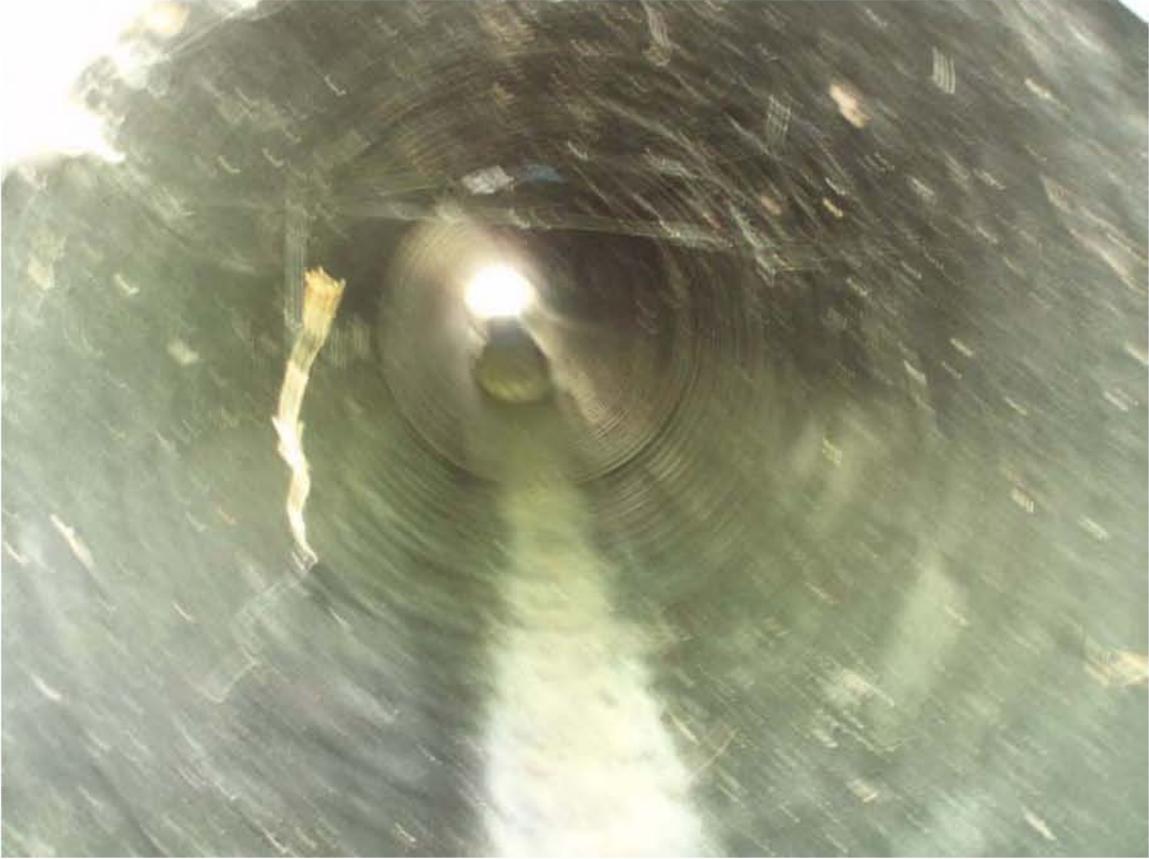
7-31-07, s-165, 18", 1779+00, Type S Grate,

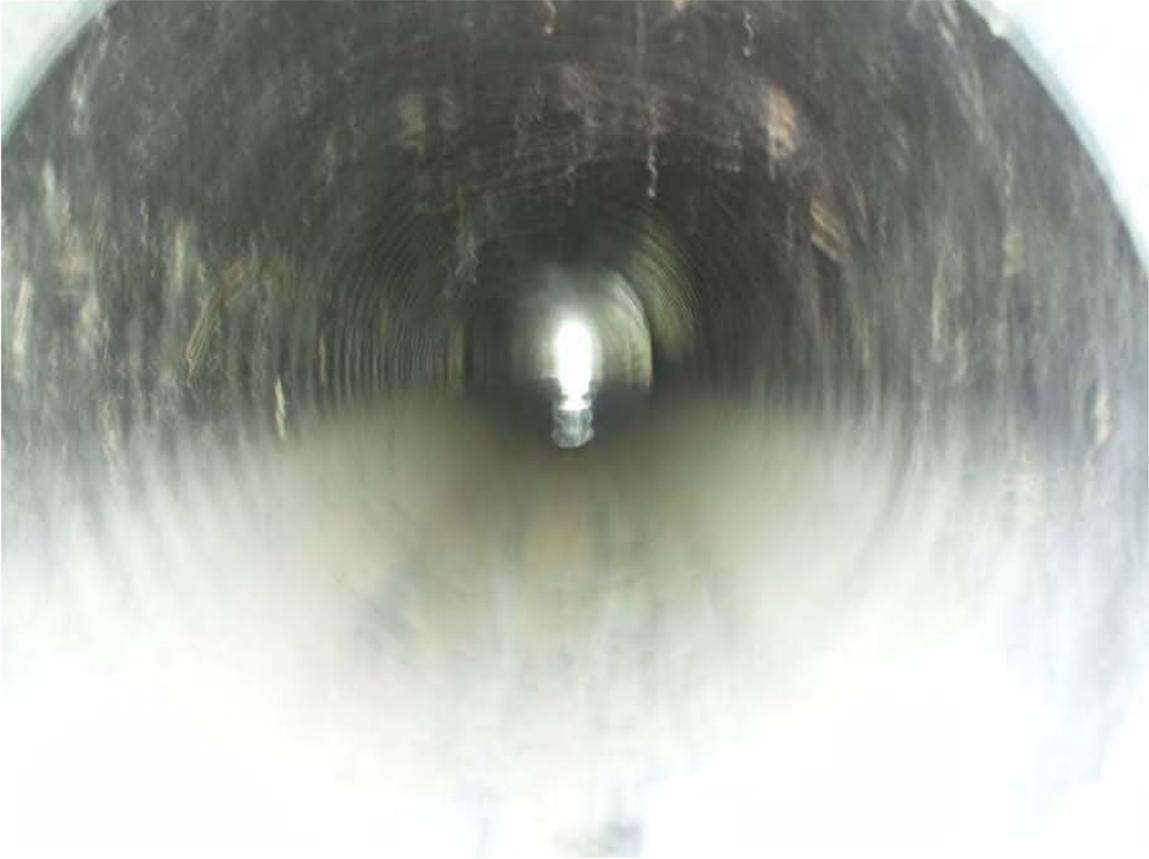
7-31-07, s-163, 18", 1755+00

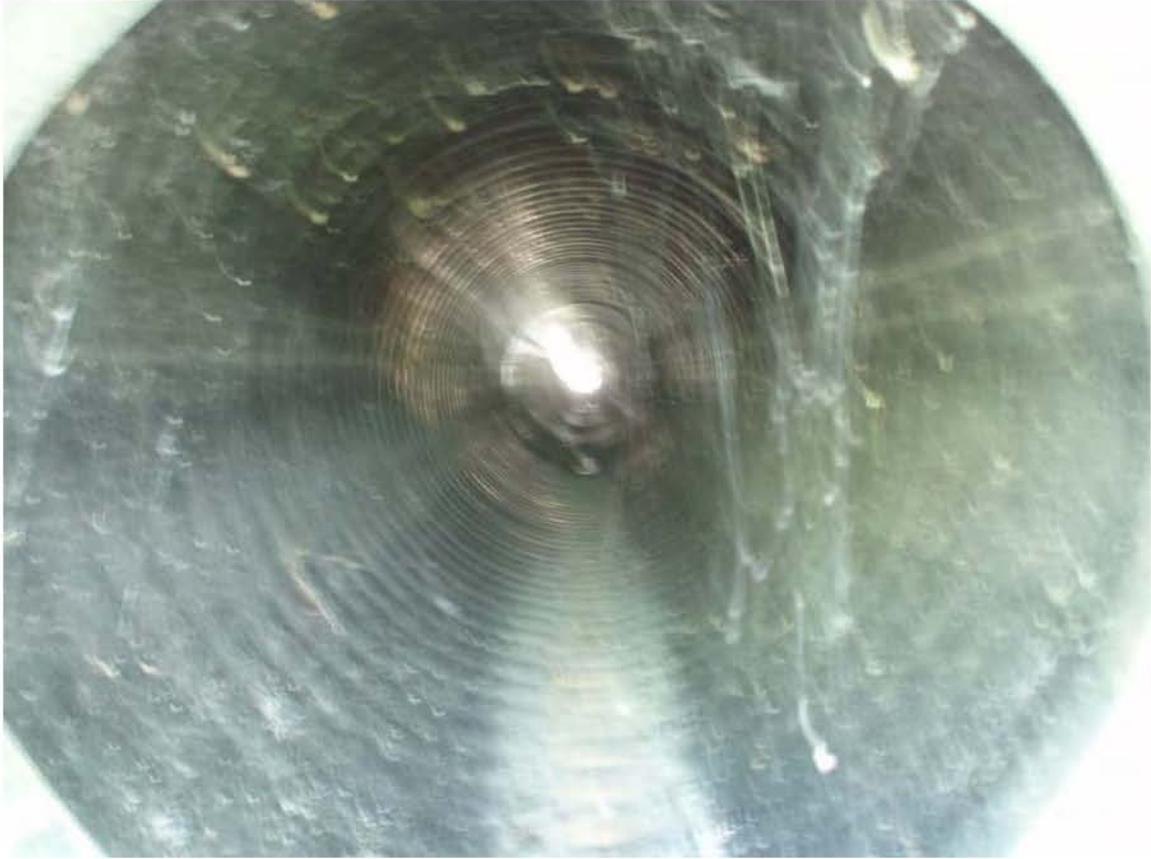
7-31-07, s-159, 18" 1749+00,

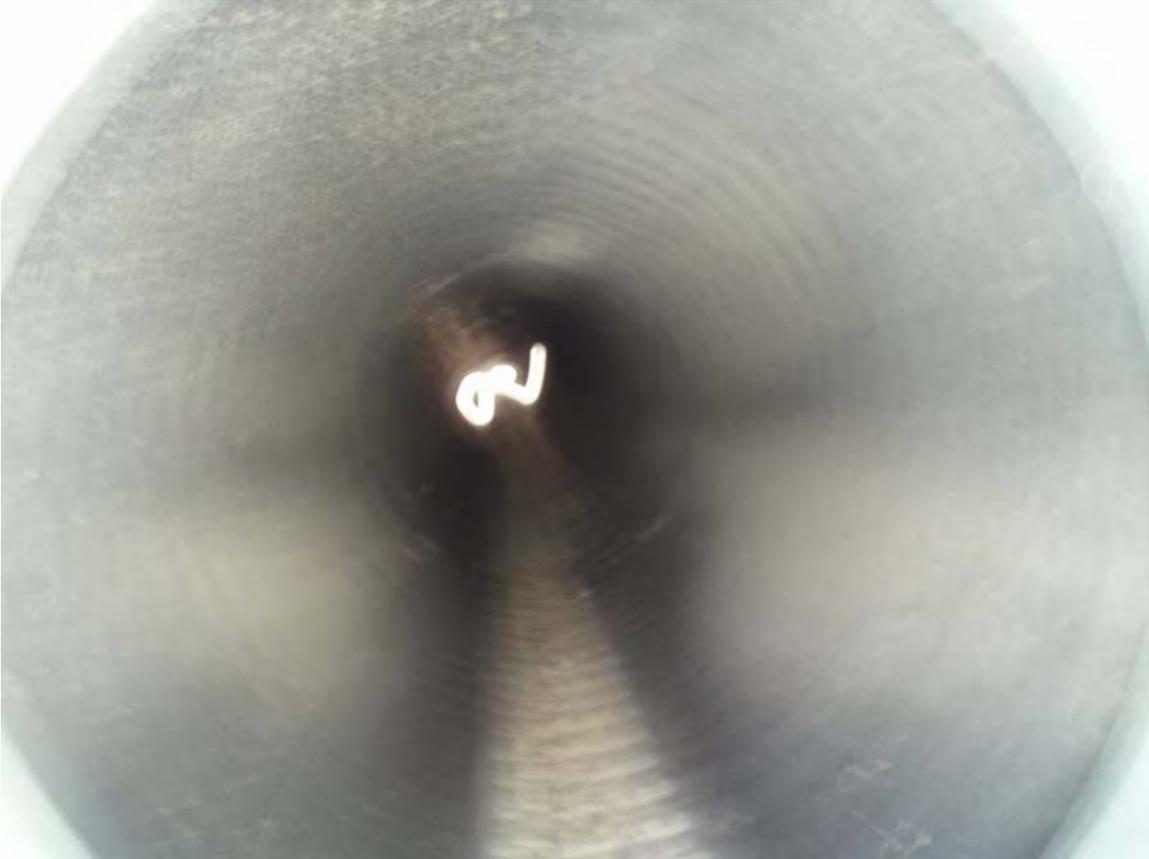
7-31-07, s-158, 30", 1746+00, Inlet 1" Gap at Bottom, joint with FE section.

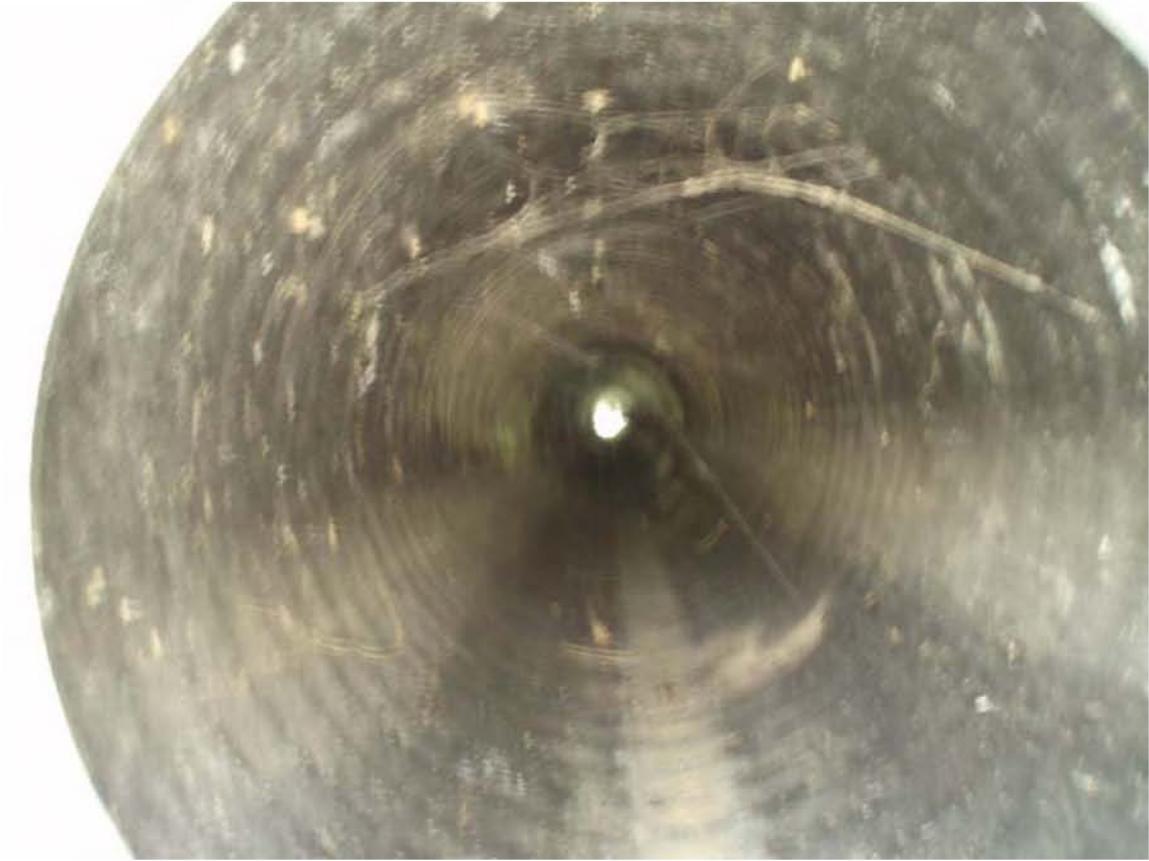
7-31-07, p-155, 36", 1724+67

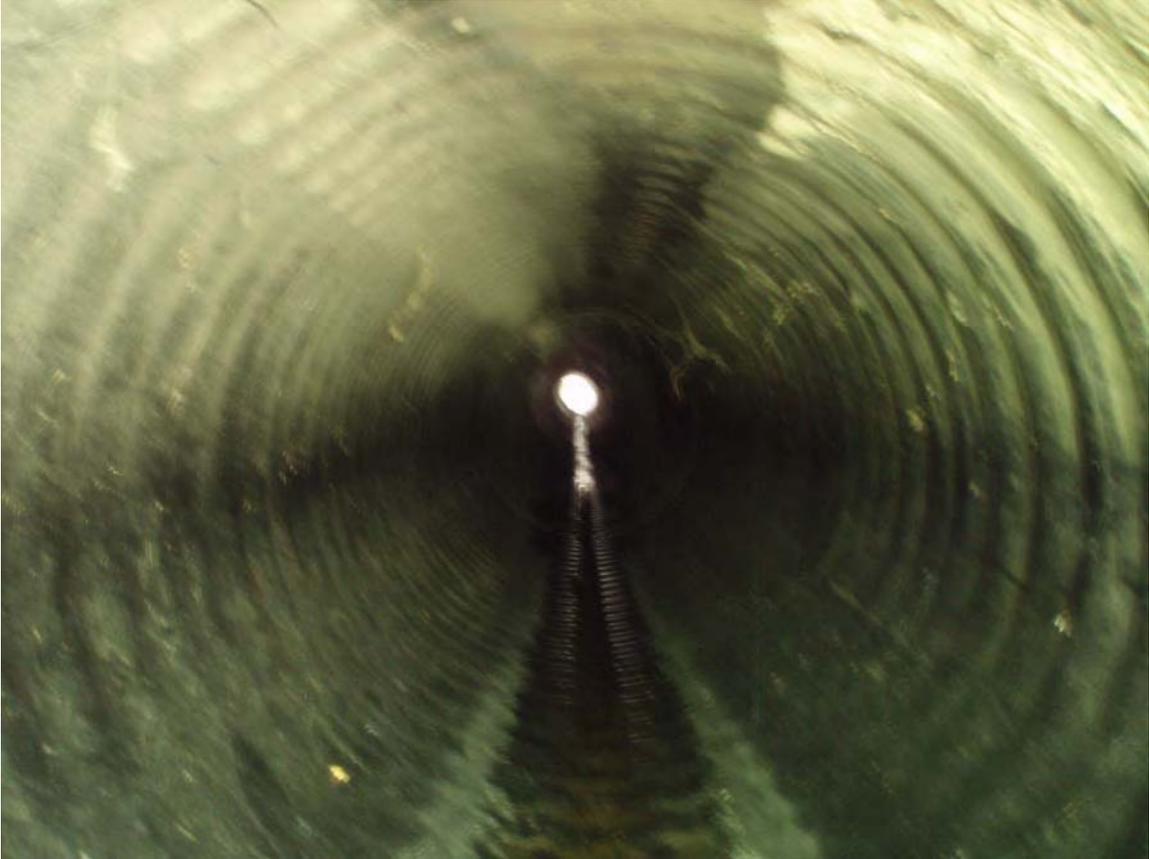
7-31-07, p-154, 18"1720+00

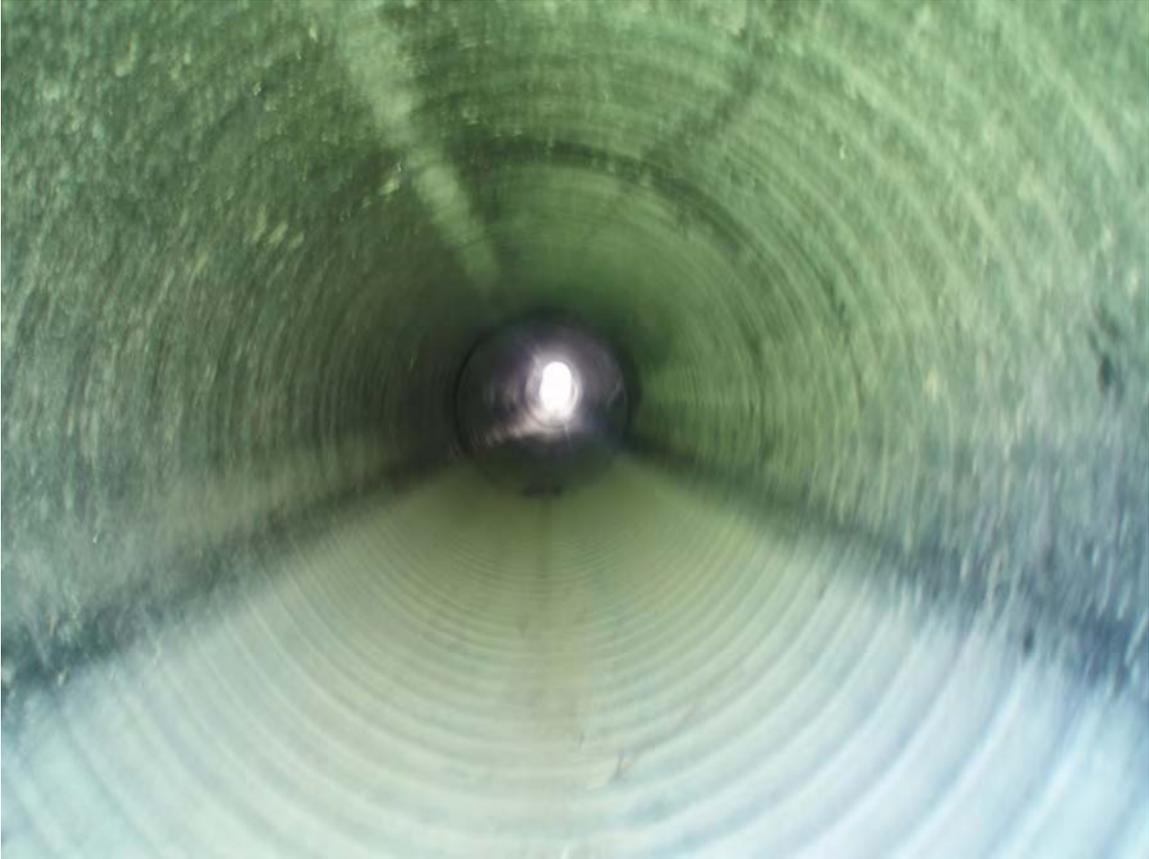
7-31-07, s-151, 24", 1699+00, Mandreled 8-2-07 Good,

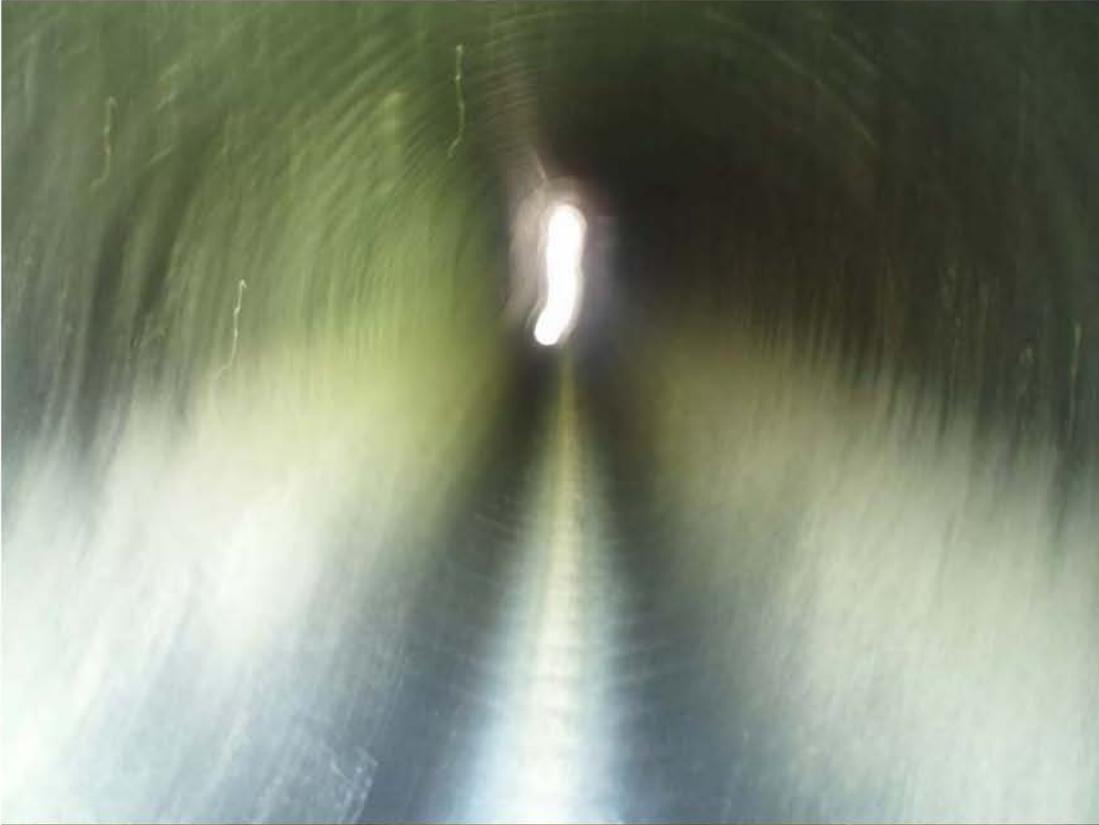
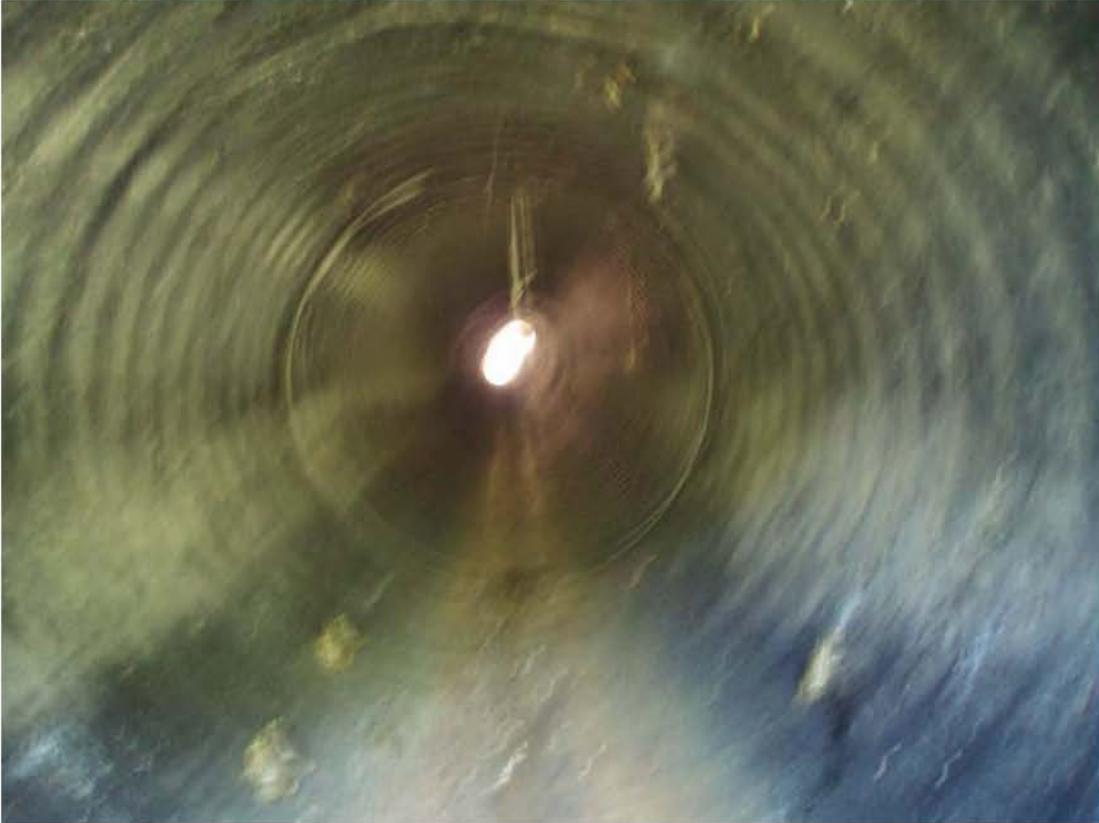
7-31-07, p-150, 30", 1690+04, Top of flared section 1" elevation difference.

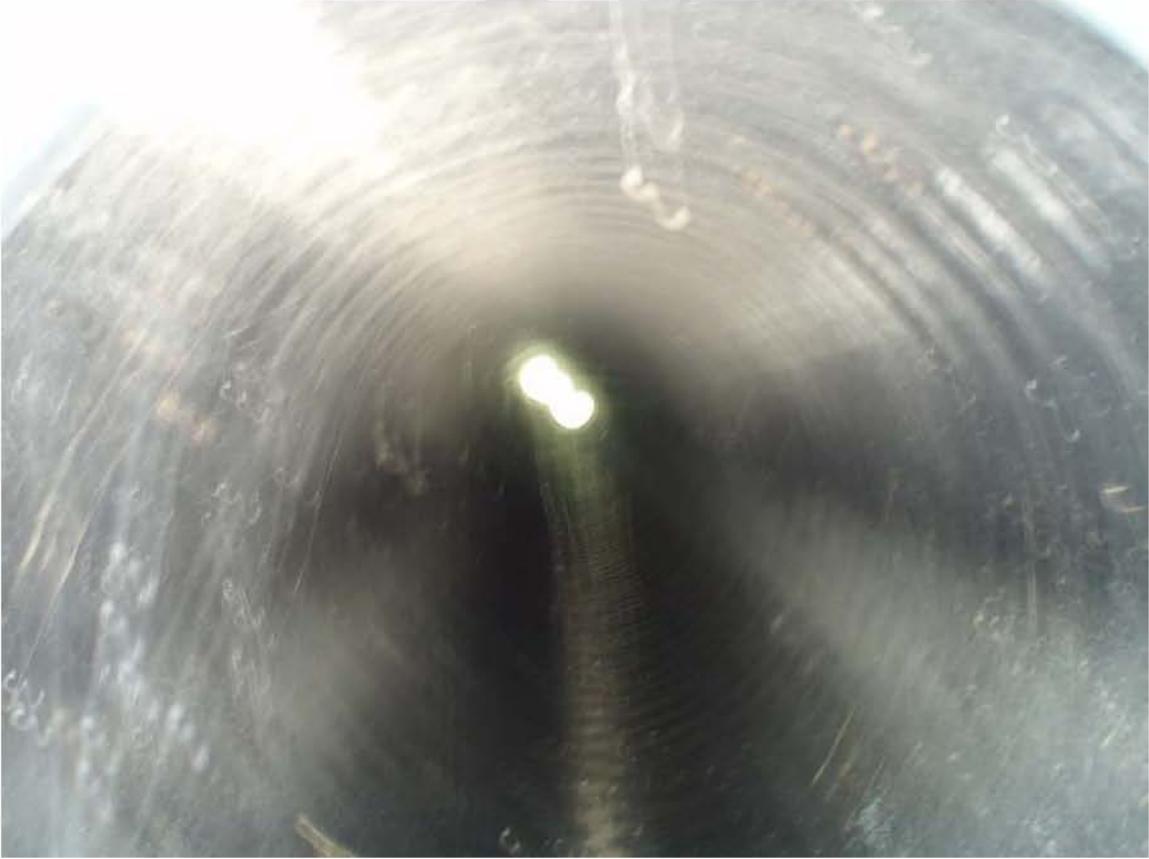
7-31-07, s-145, 15", 1677+00

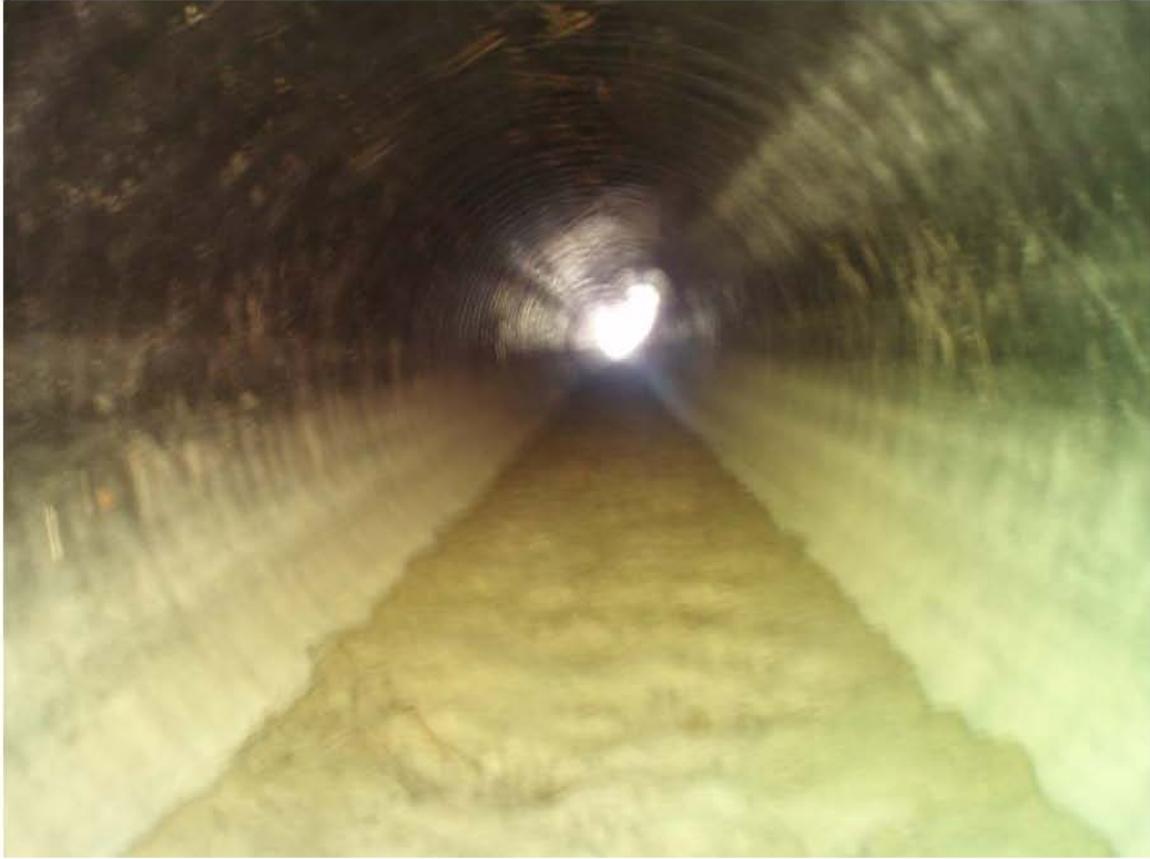
7-31-07, s-144, 15", 1672+00

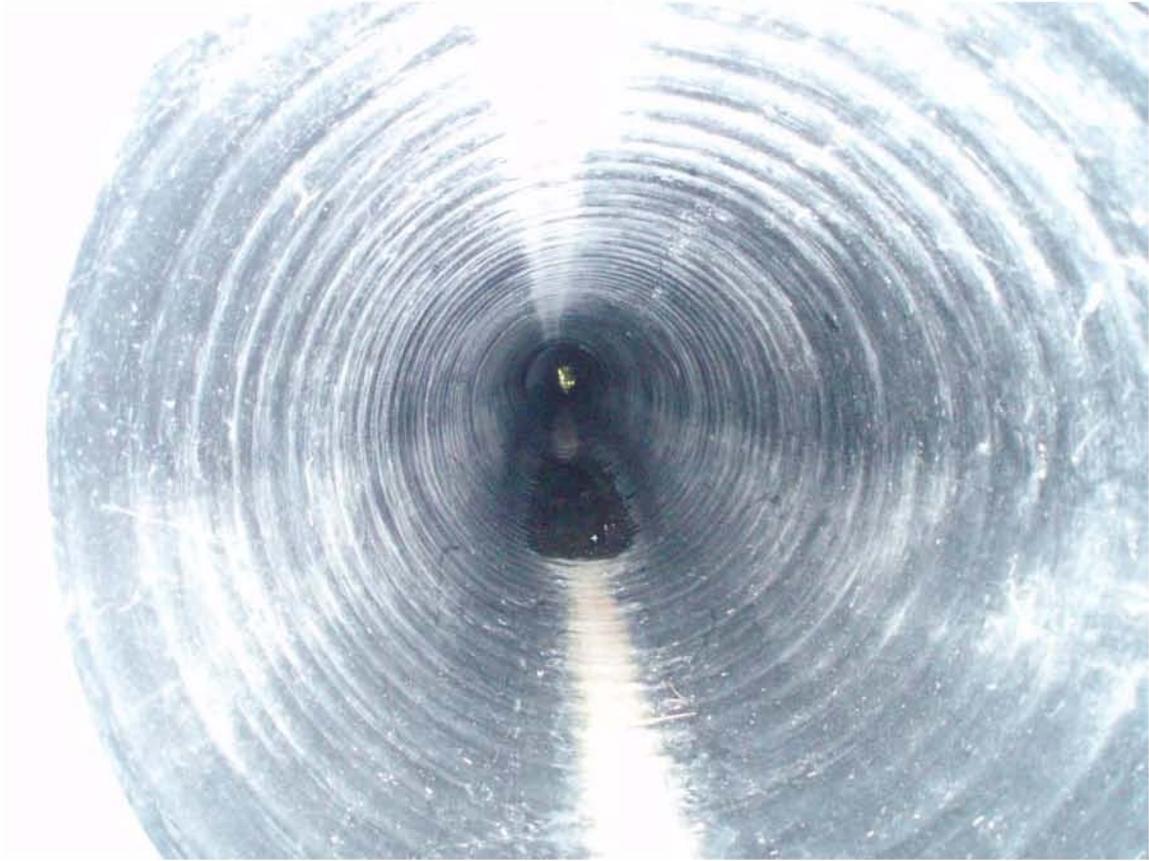
7-31-07, s-143, 15", 1667+00

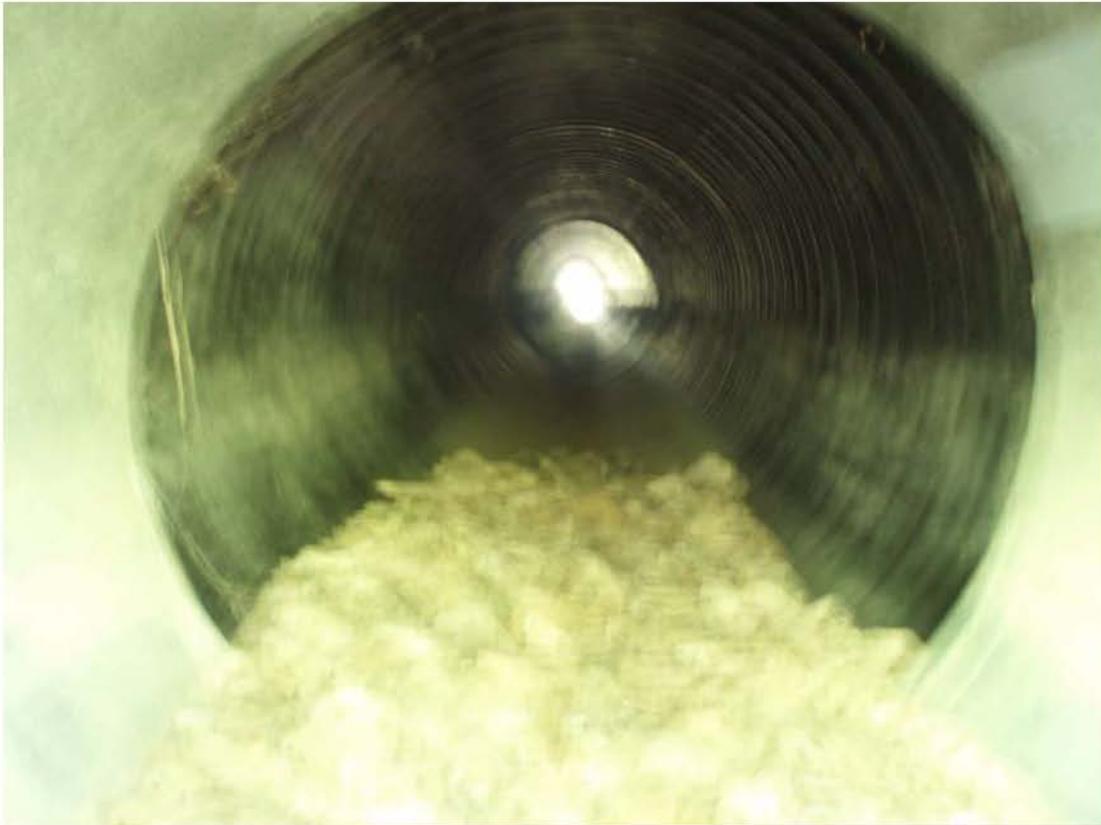
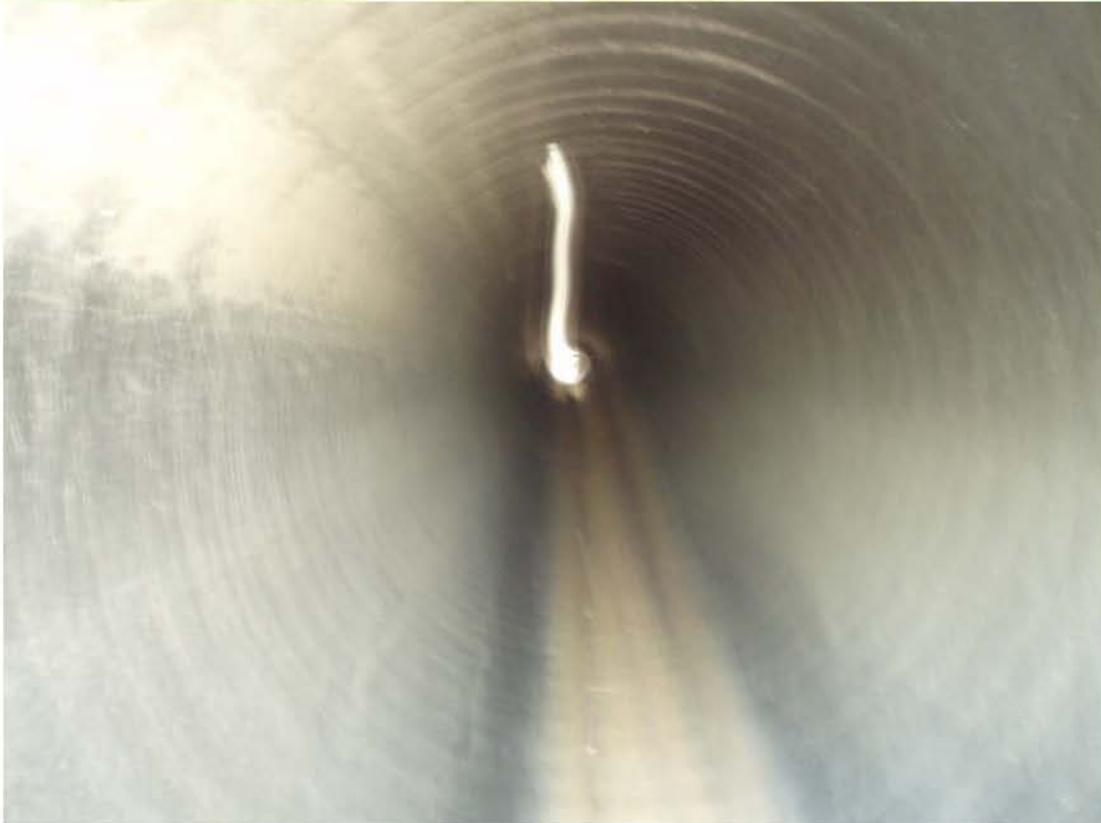
7-31-07, p-141, 24", 1657+00

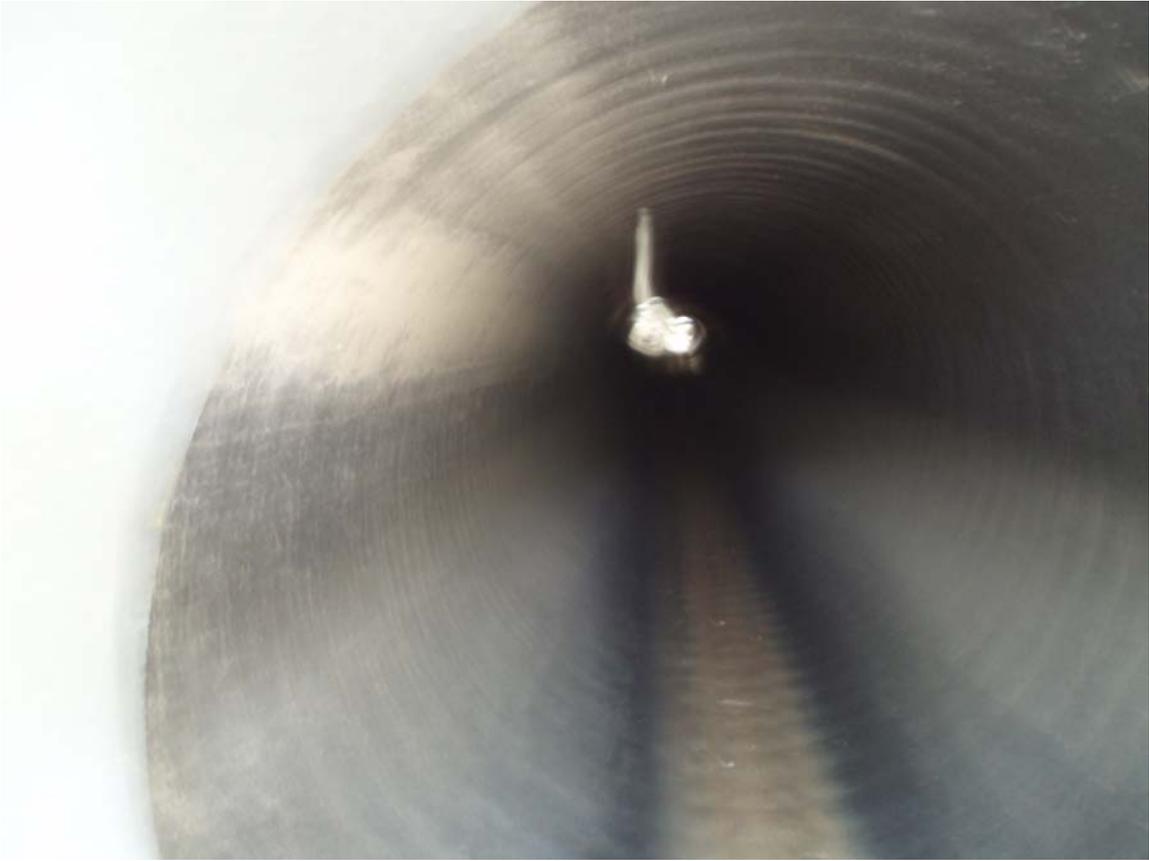
7-31-07, s-139, 18", 1643+00,

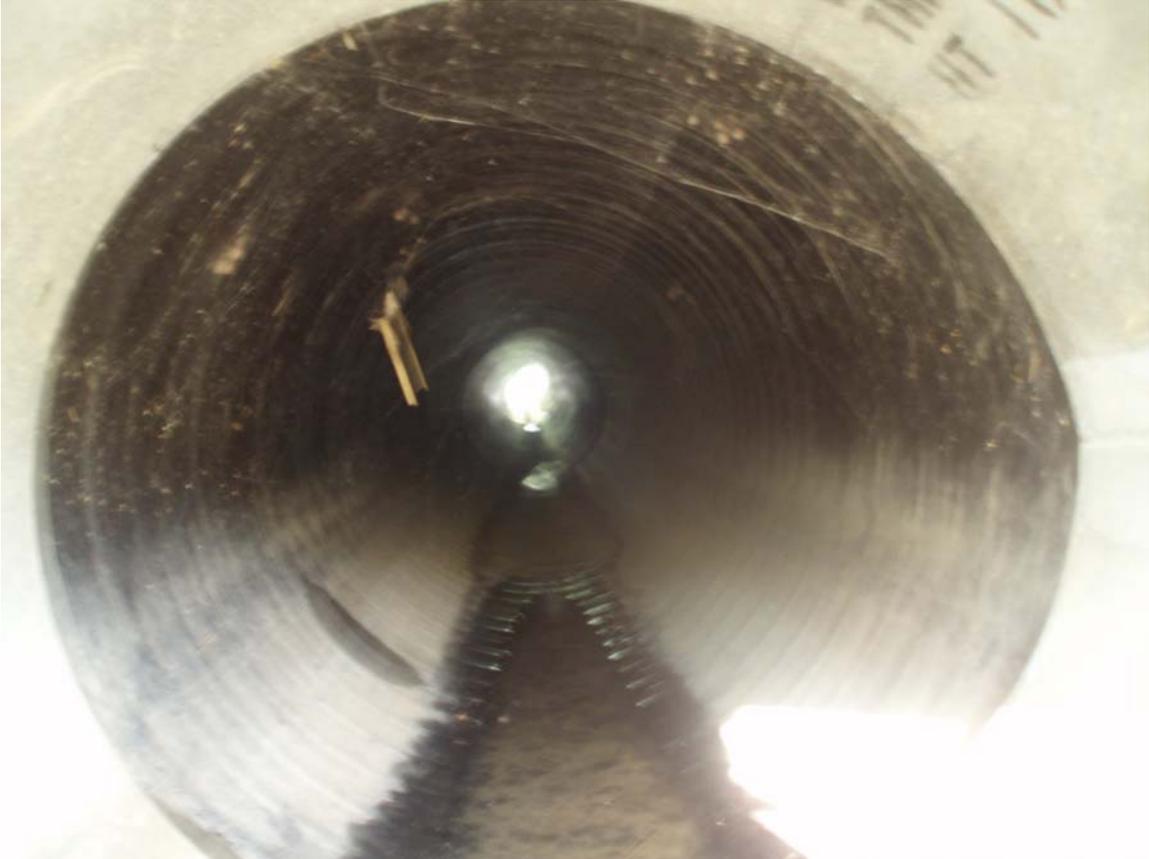
8-1-07, s-138, 18", 1635+00

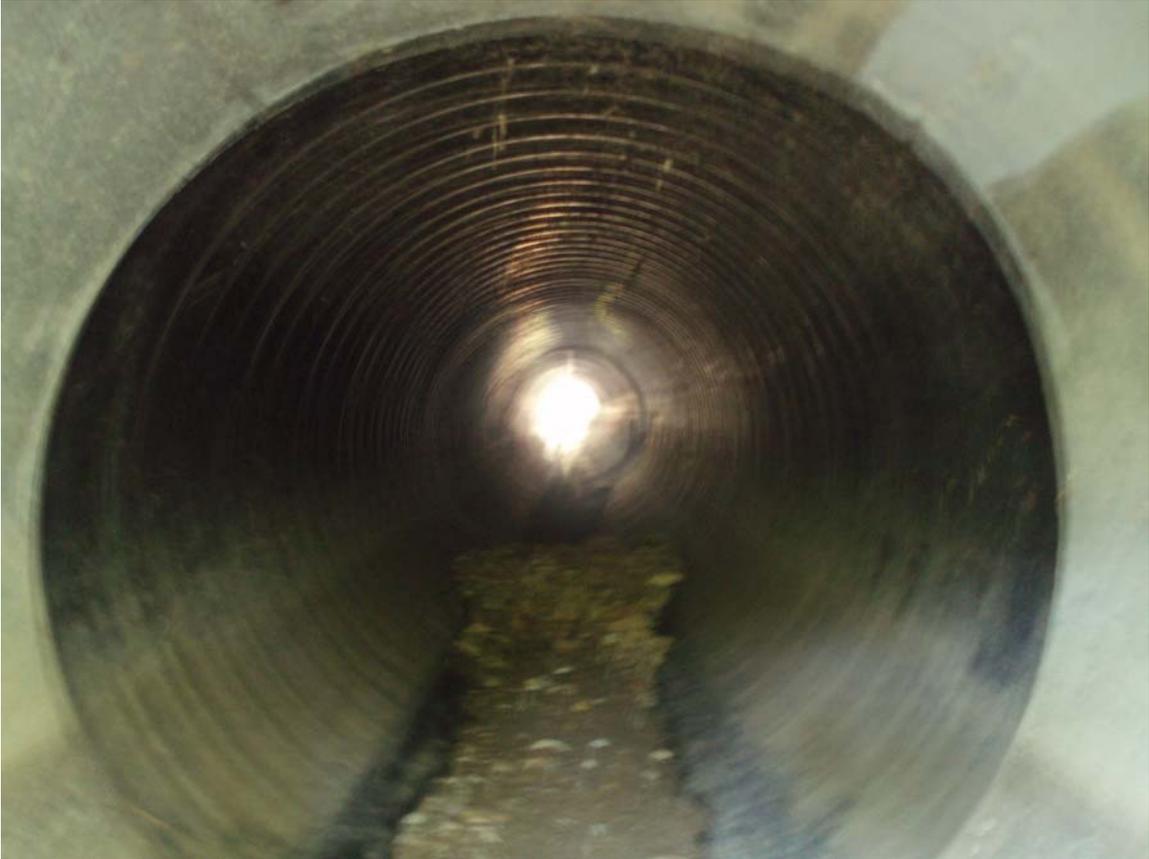
8-1-07, s-137, 18", 1627+00

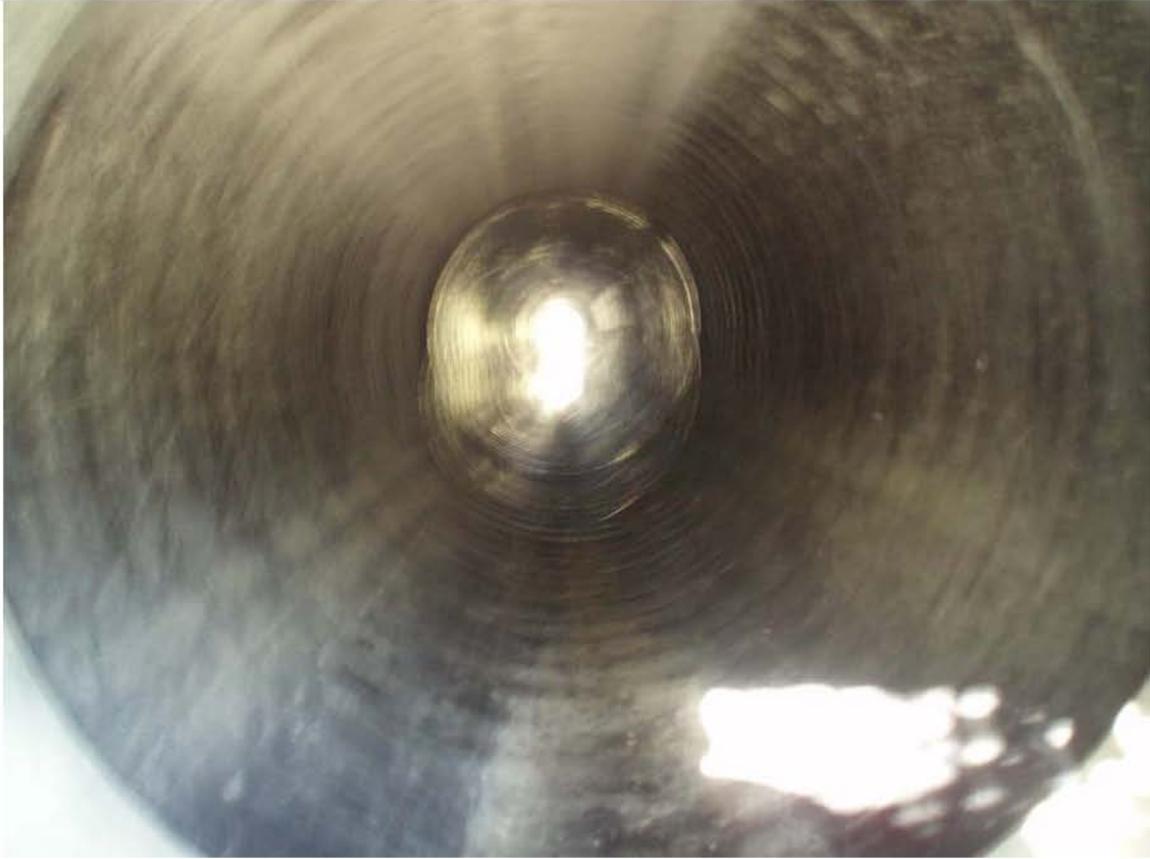
8-1-07, p-136, 24", 1617+78,

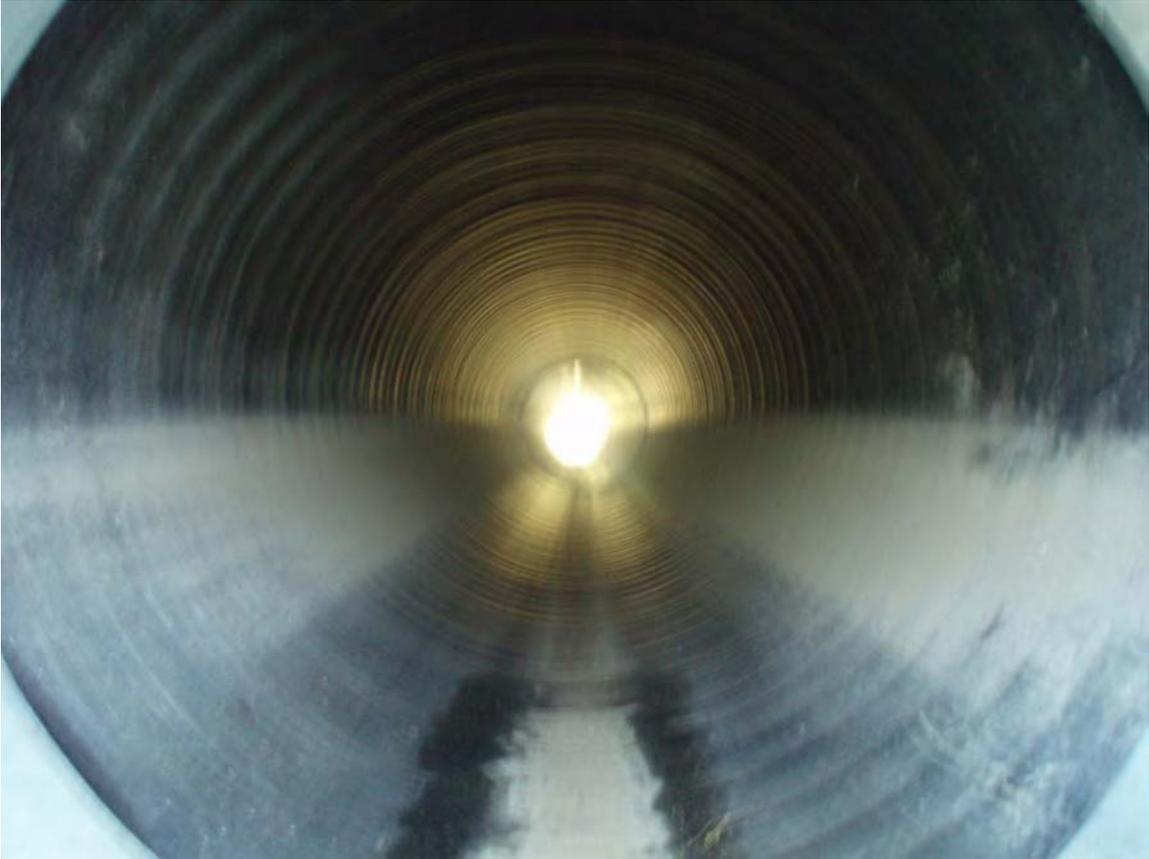
8-1-07, p-135, 30", 1604+18

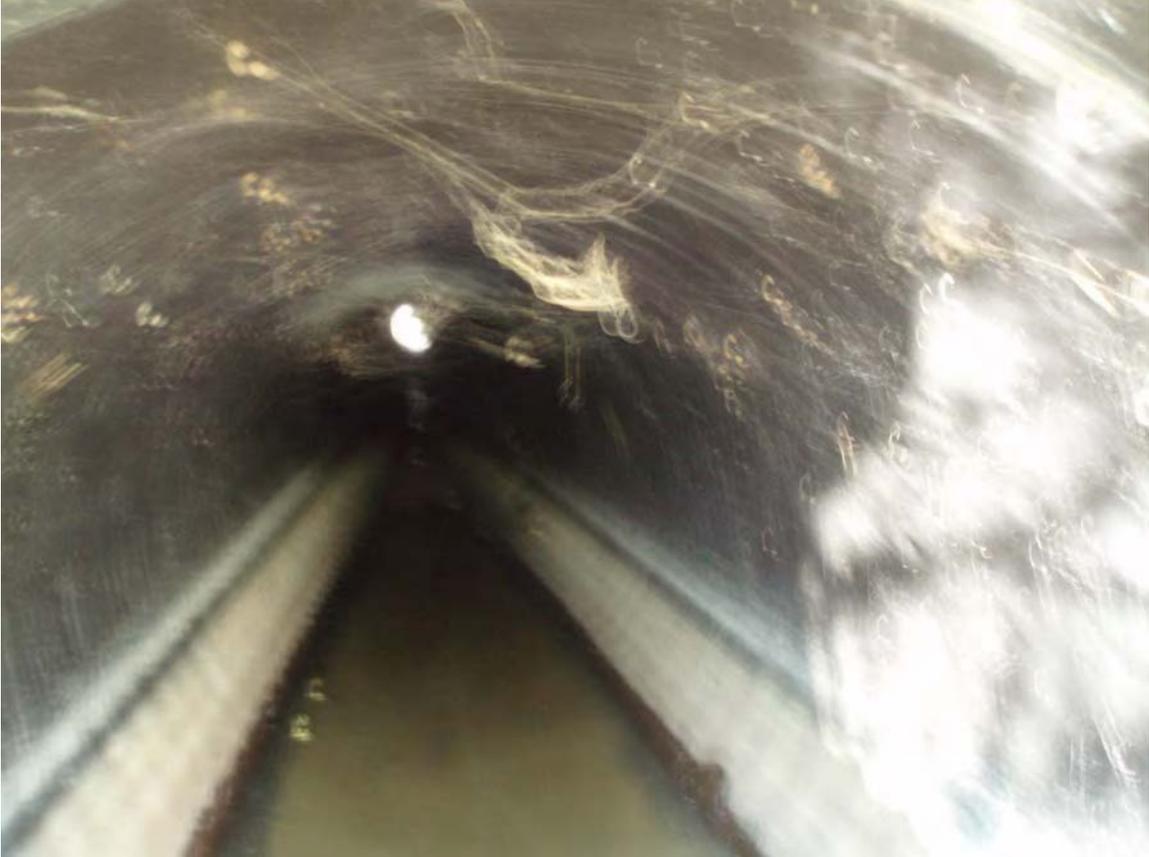
8-1-07, p-132, 24", 1594+79
