Macon and Adair County, Route 63, Job J2P0485

Route 63, Howell Co., project J9P0497, HDPE double wall storm sewer, W. Side Rt.63

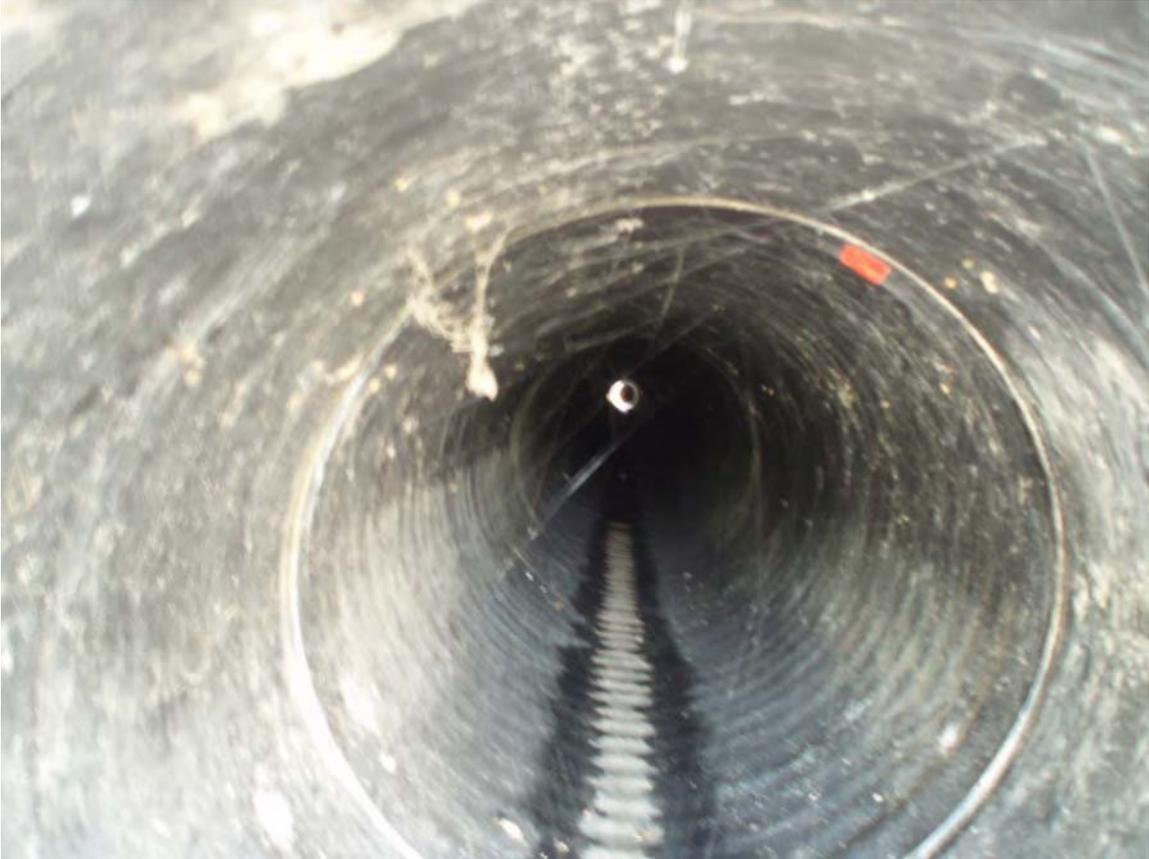
8-1-07, s-131, 18", 1589+00

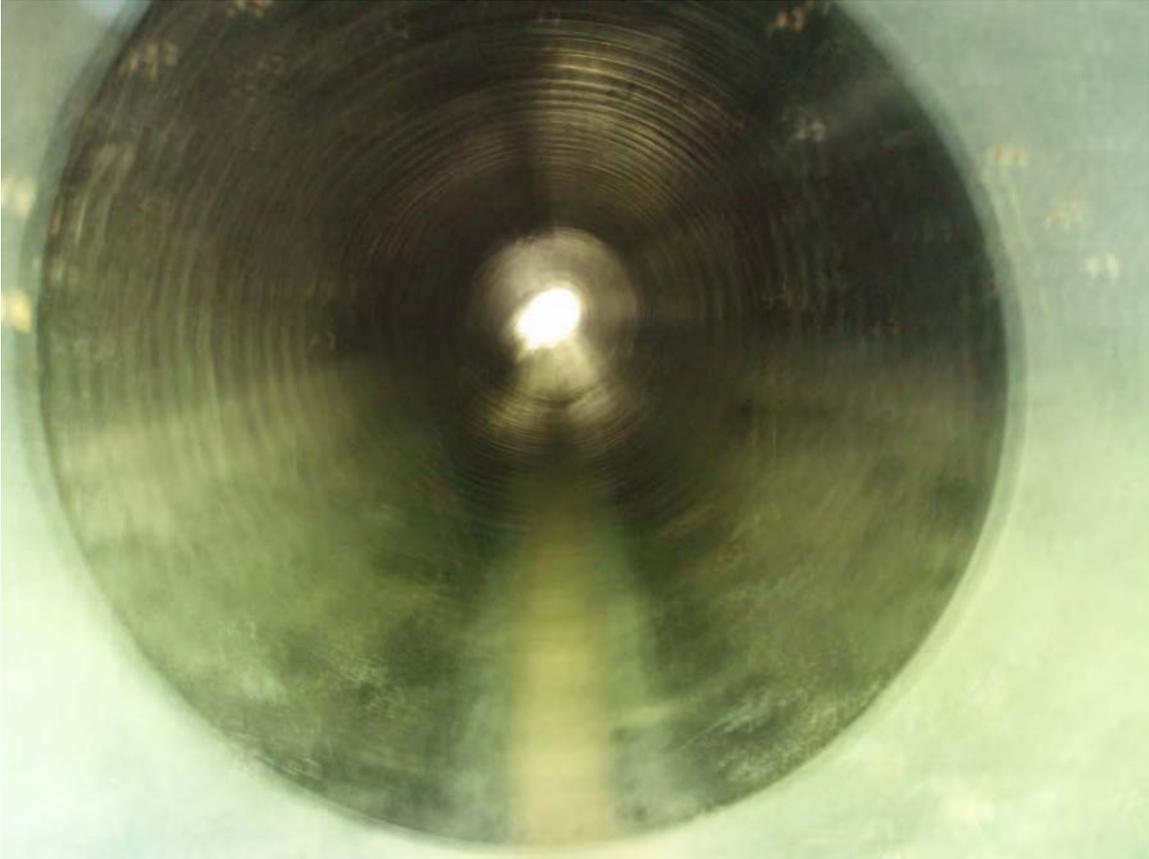
8-1-07, s-130, 24", 1585+00

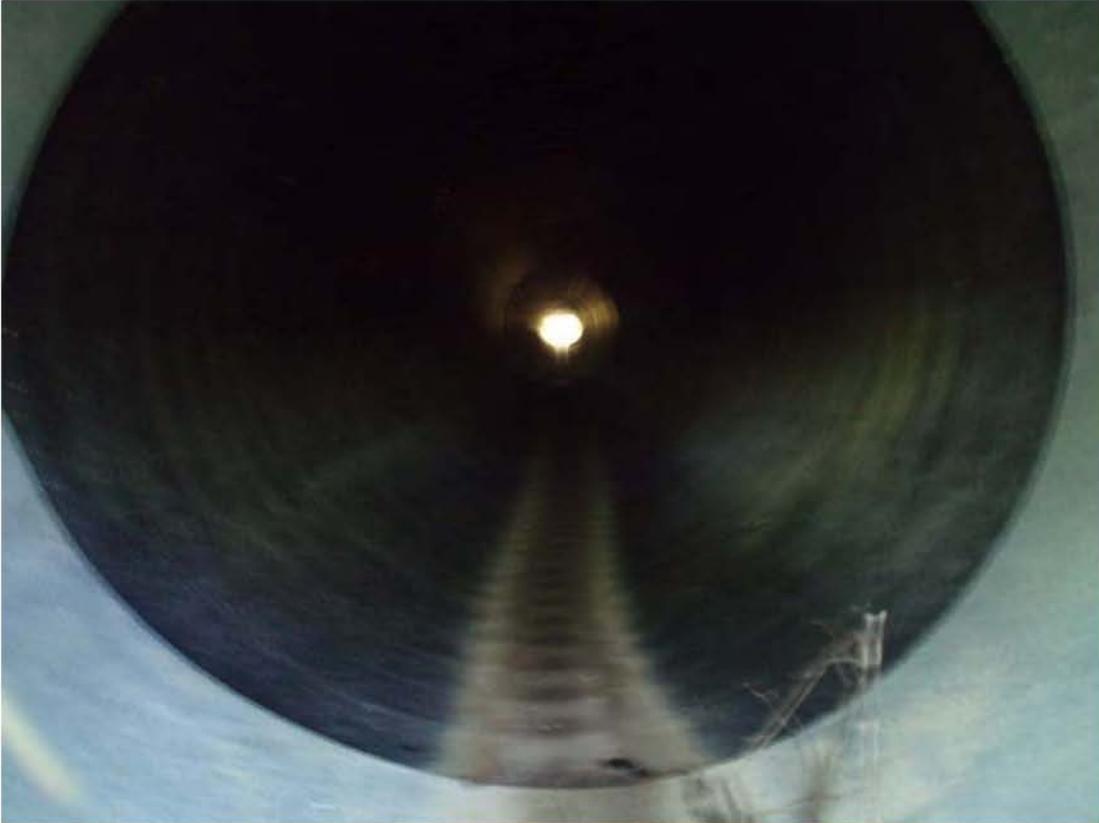
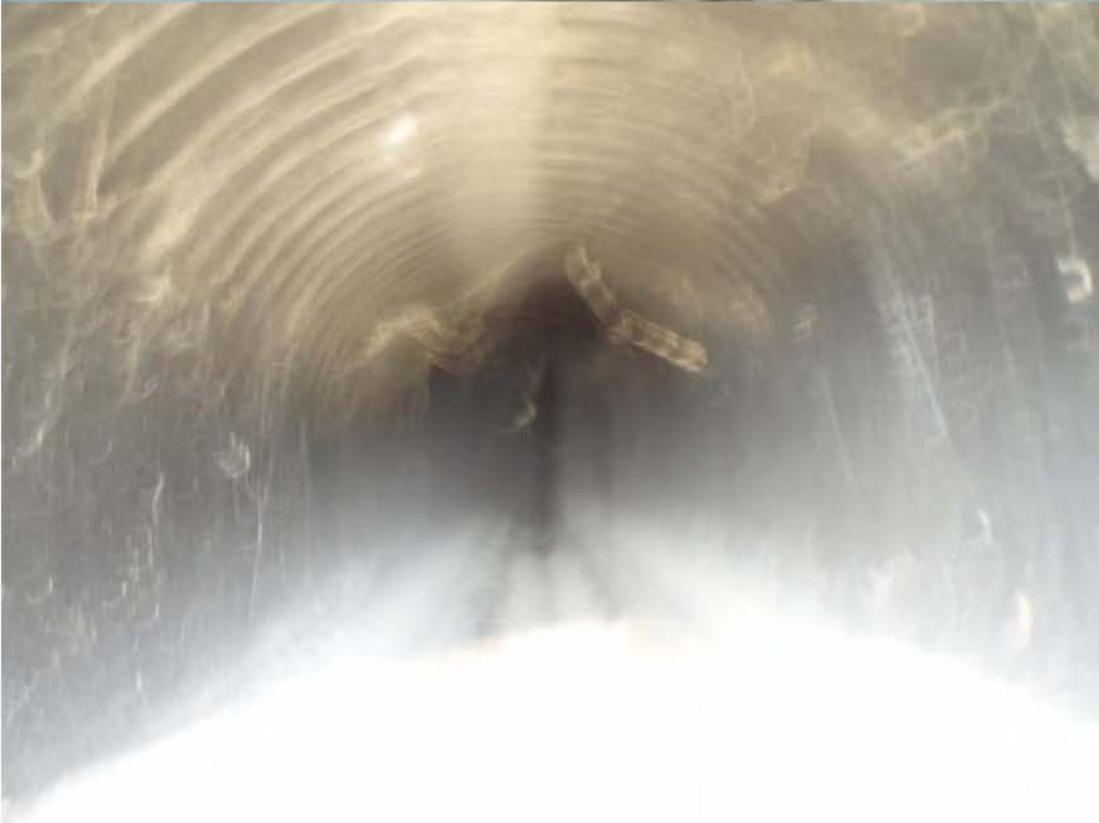
8-1-07, p-129, 30", 1581+29, End flare joint misalignment,

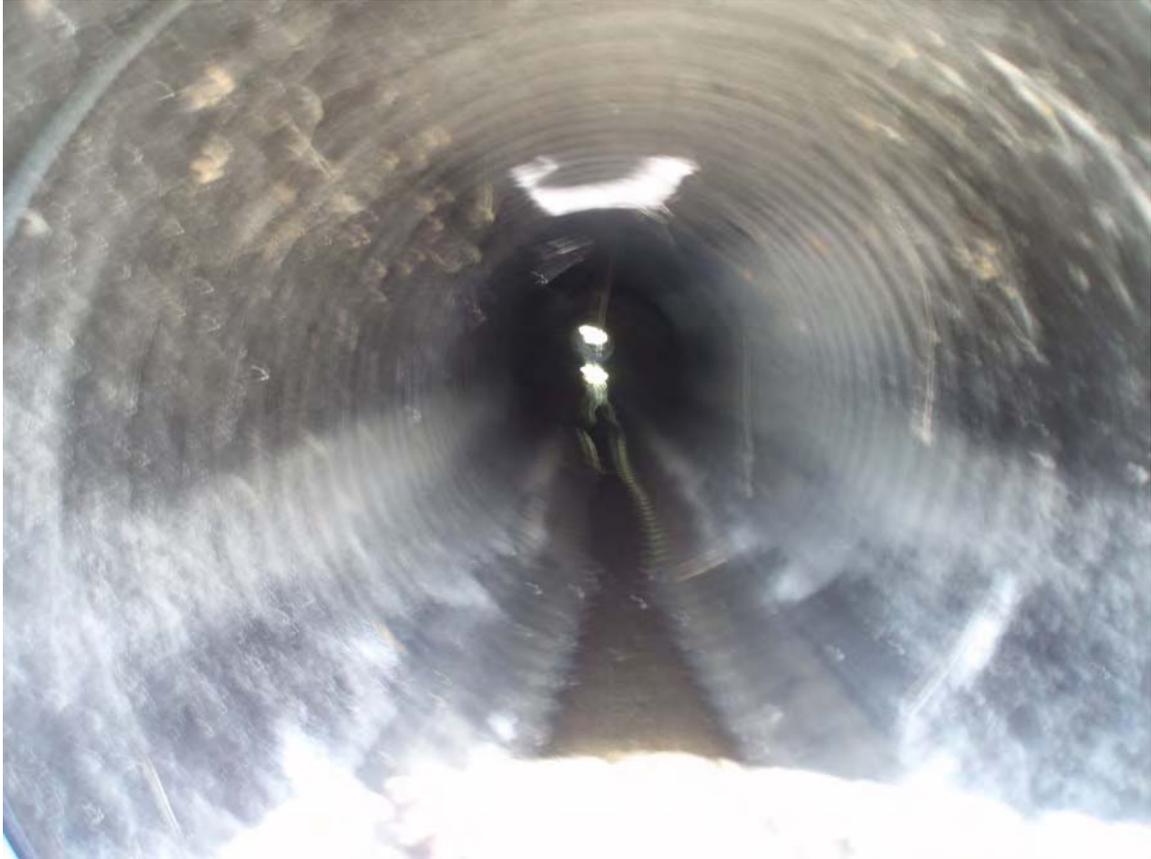
8-1-07, p-125, 18", 1575+00

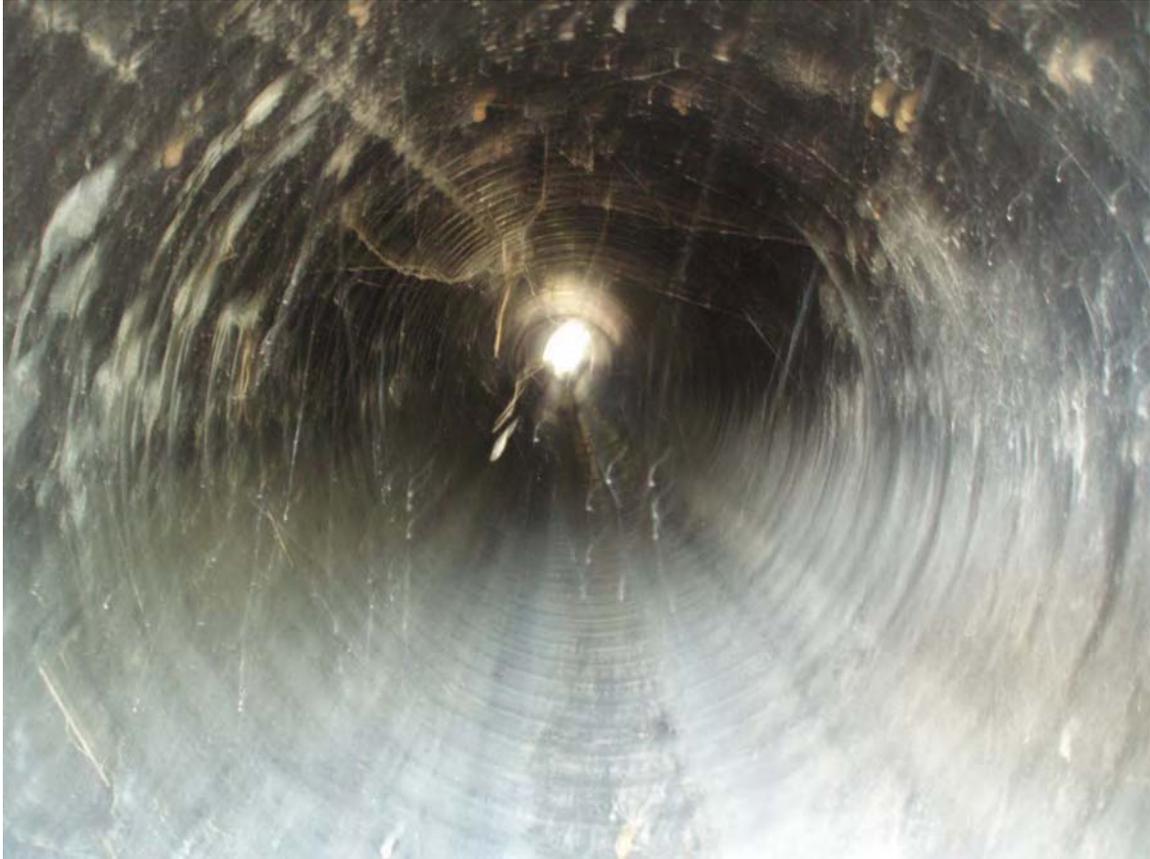
8-1-07, s-124, 24", 1565+00

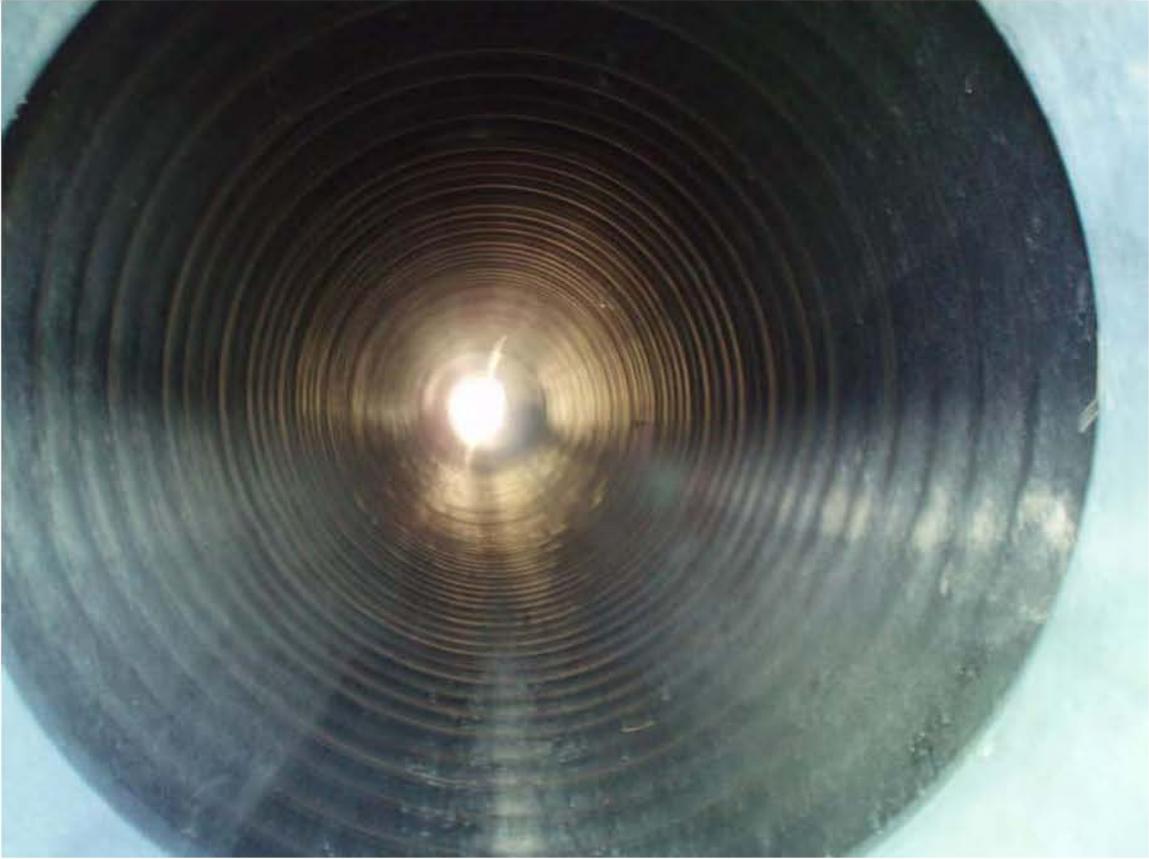
8-1-07, p-123, 24", 1556+00,

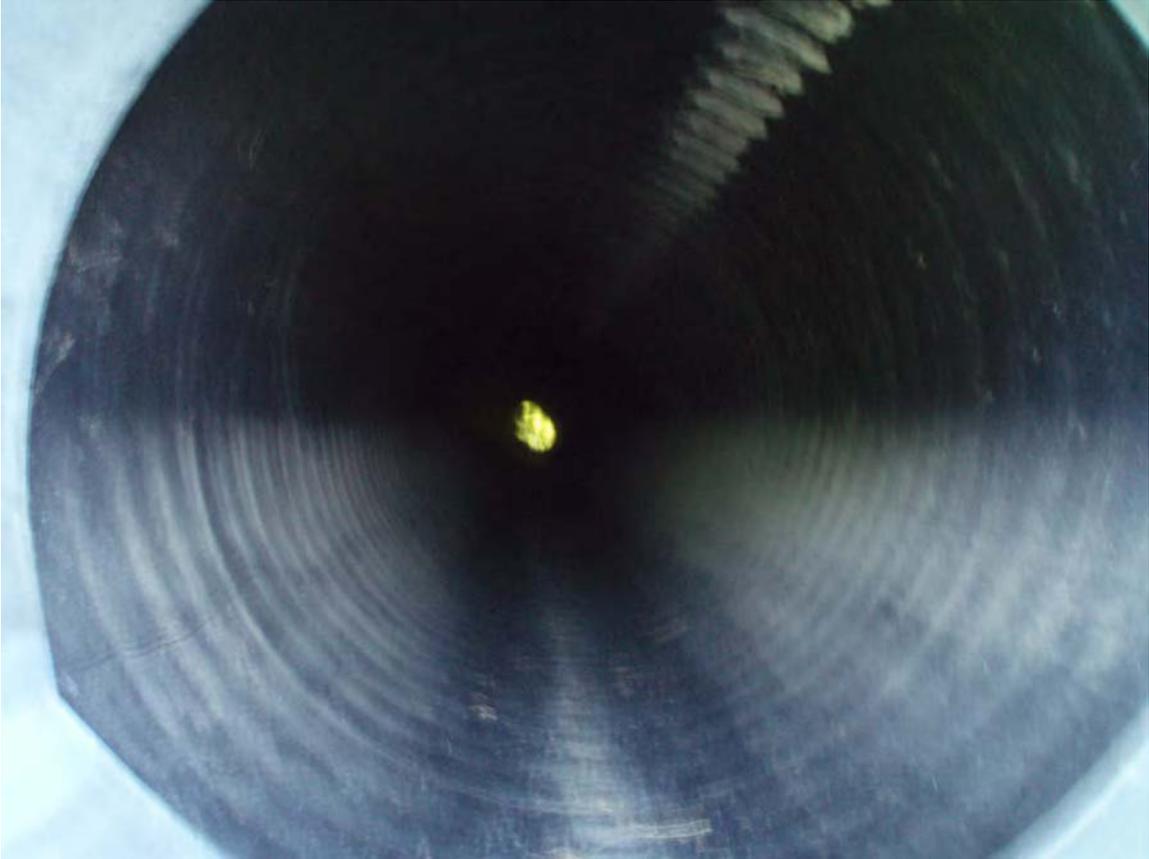
8-1-07, s-122, 24", 1548+00

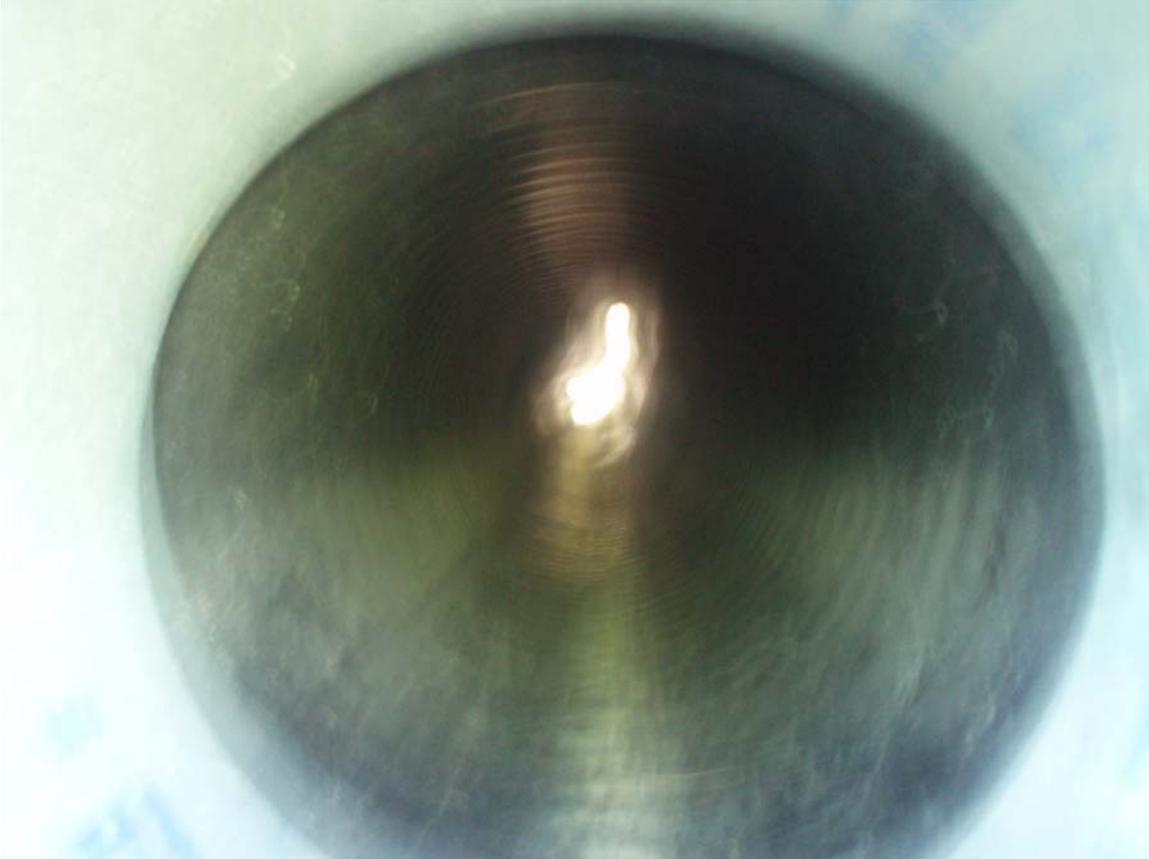
8-1-07, p-121, 24", 1539+00

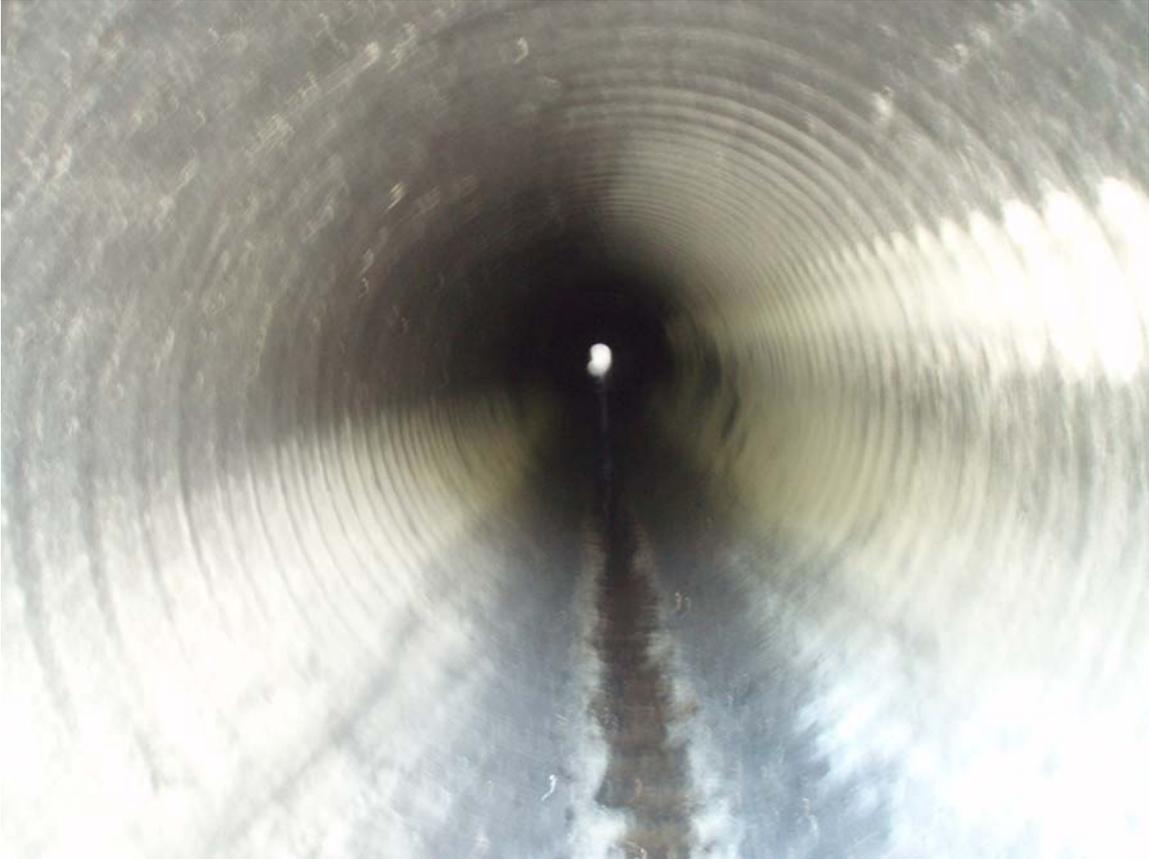
8-1-07, p-119, 24", 1530+00

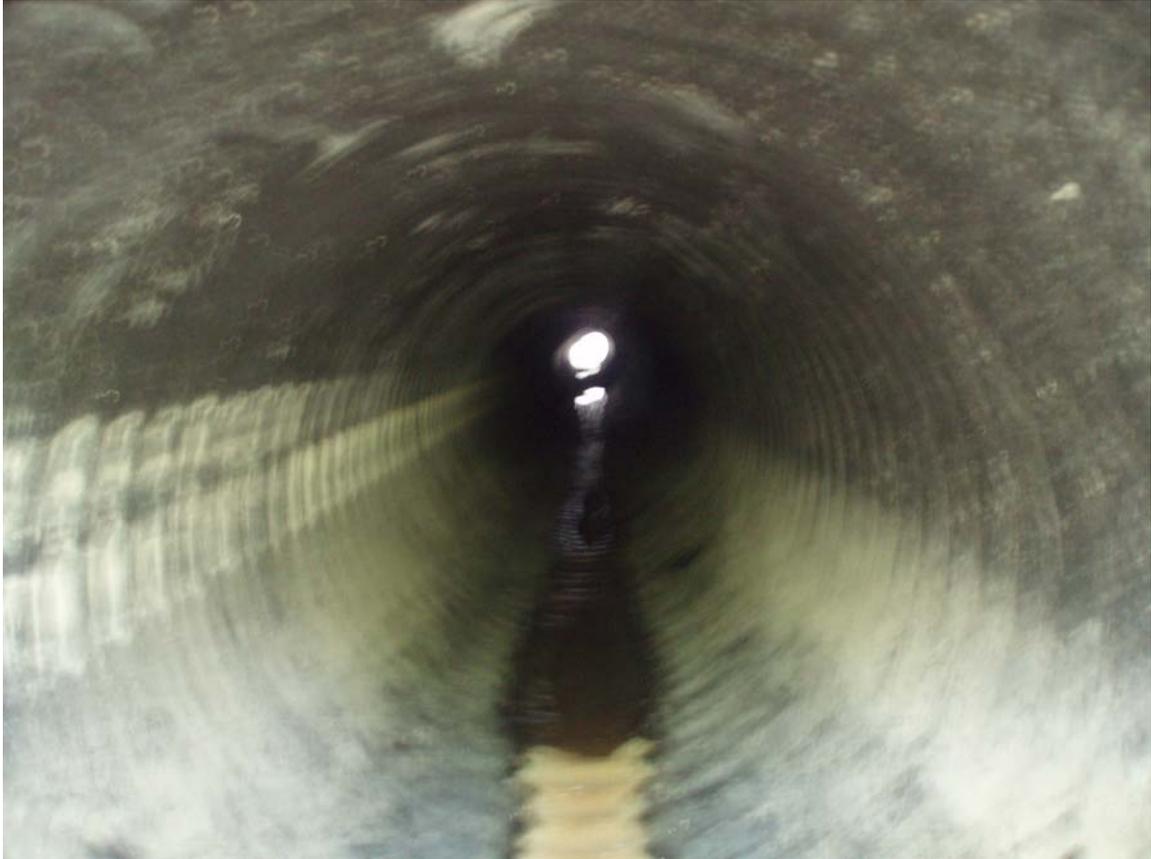
8-1-07, p-118, 24", 1520+00

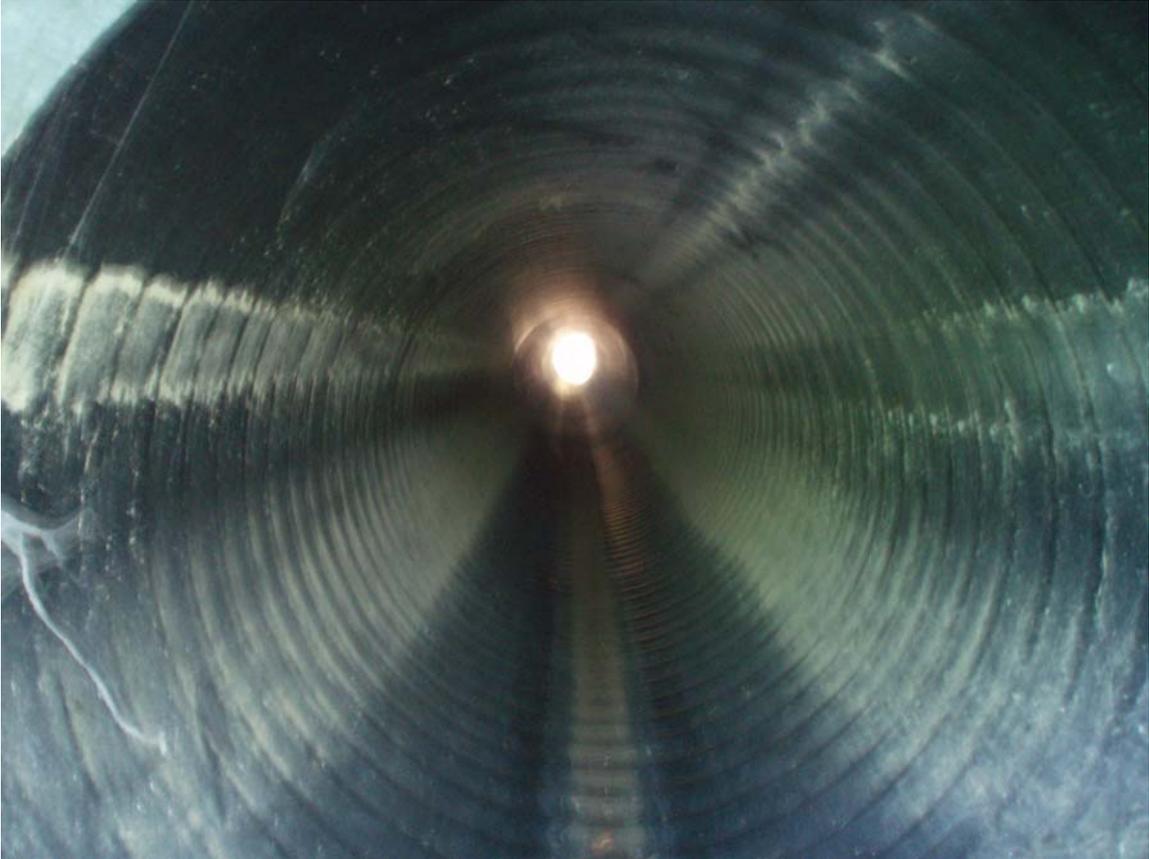
8-1-07, p-116, 24", 1511+63

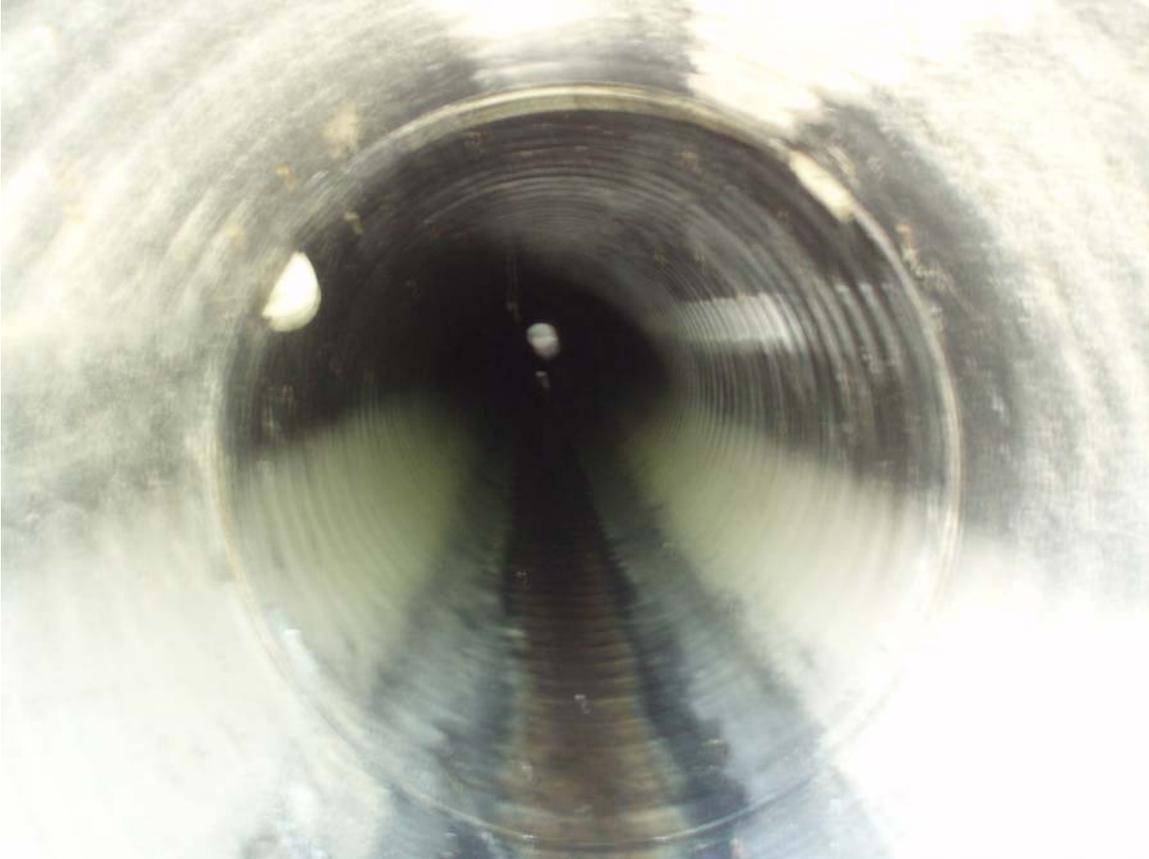
8-1-07, p-115, 24", 1507+00

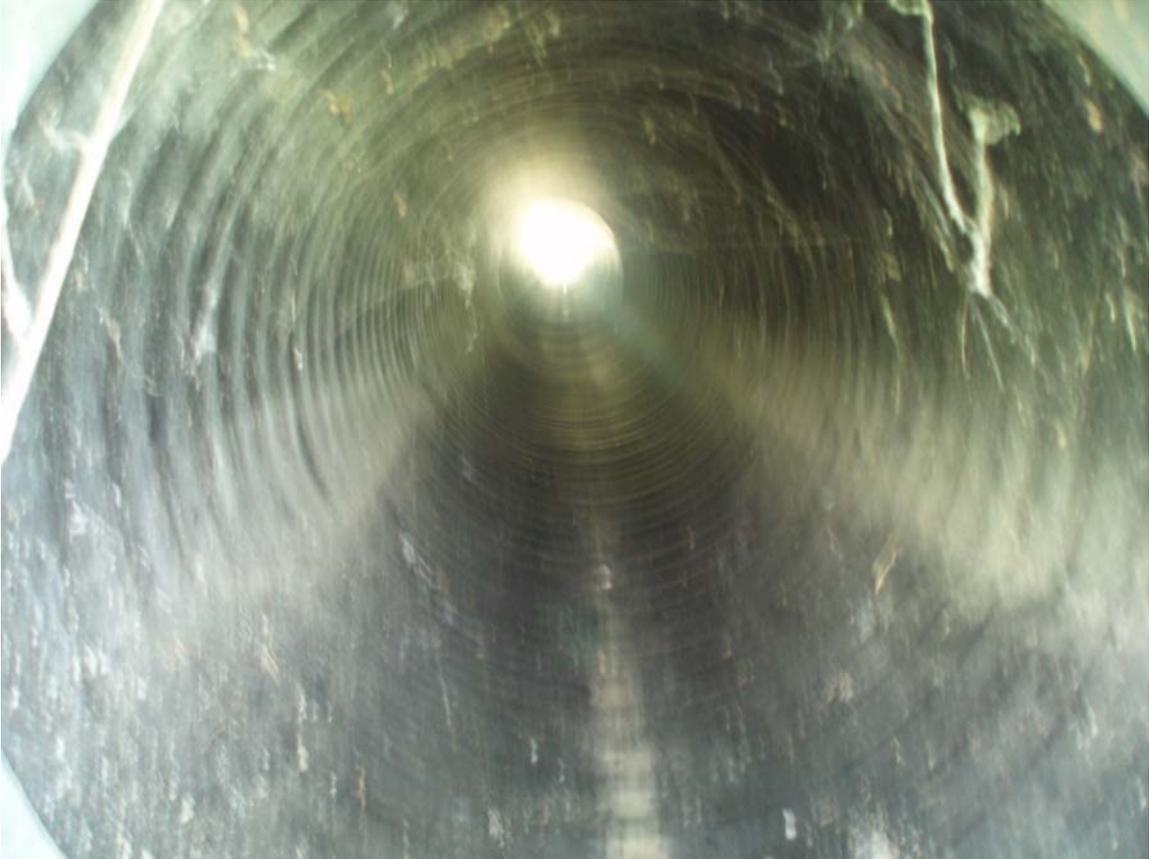
8-1-07, s-113, 18", 1498+00

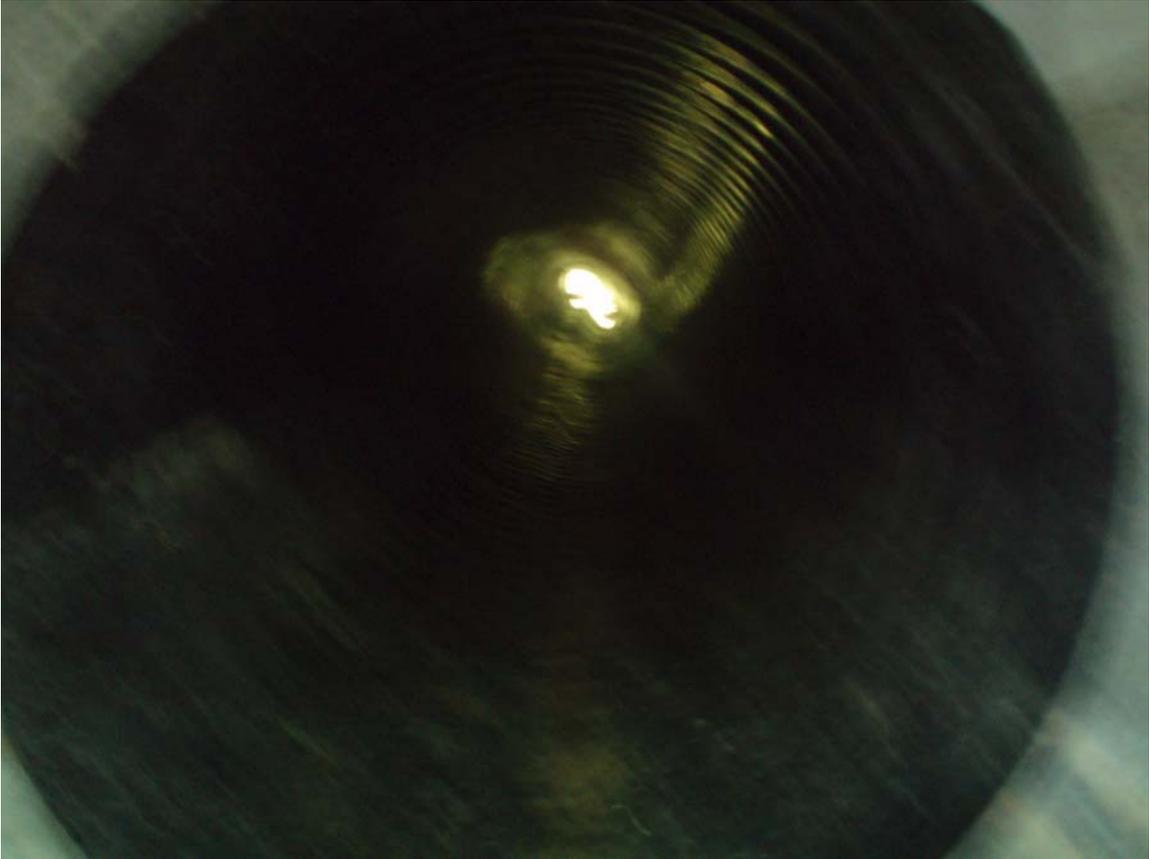
8-1-07, s-112, 18", 1490+00

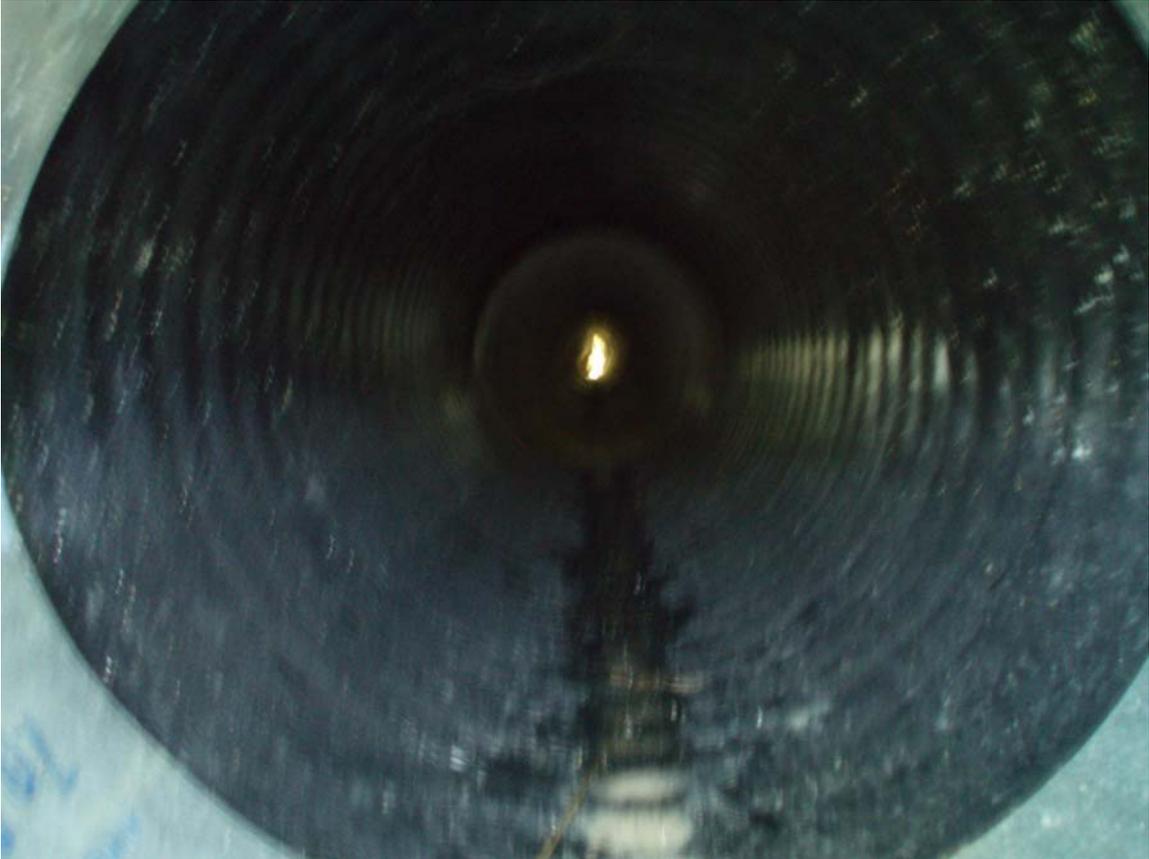
8-1-07, s-111, 18", 1483+00

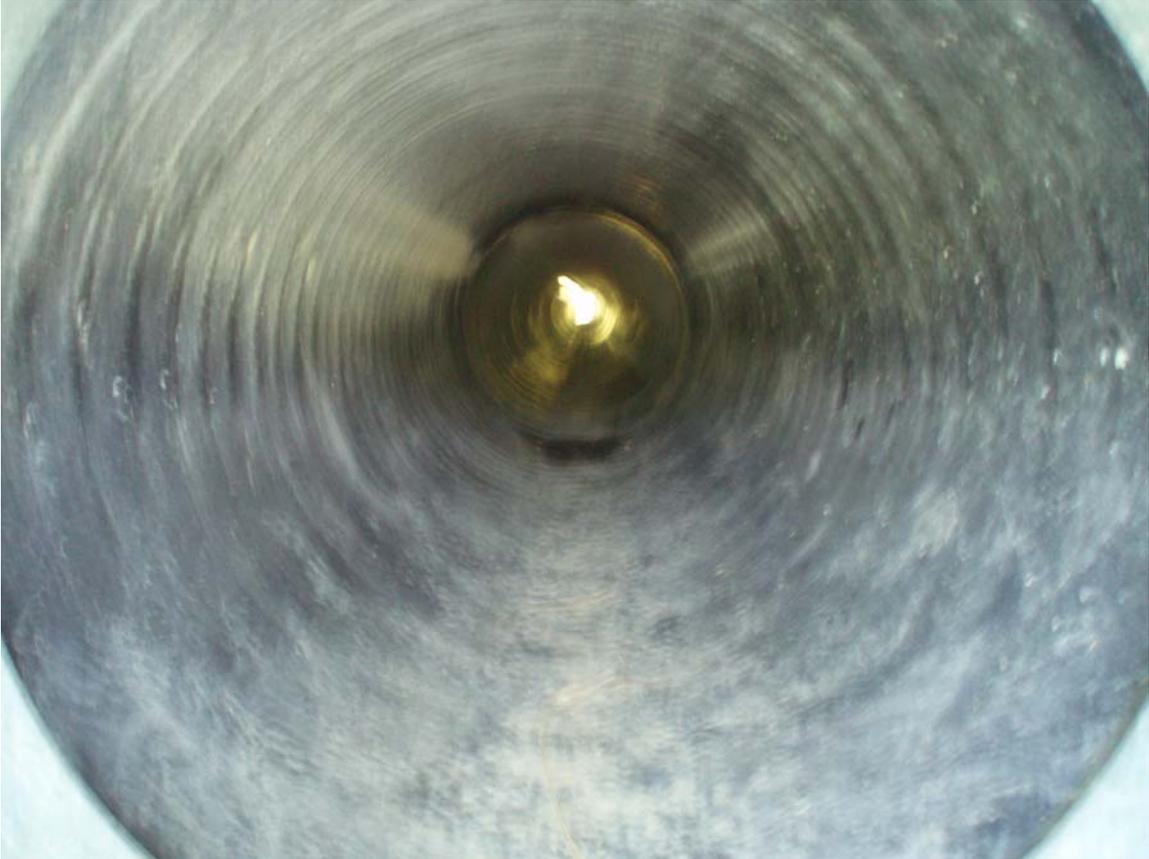
8-1-07, p-109, 24", 1466+00

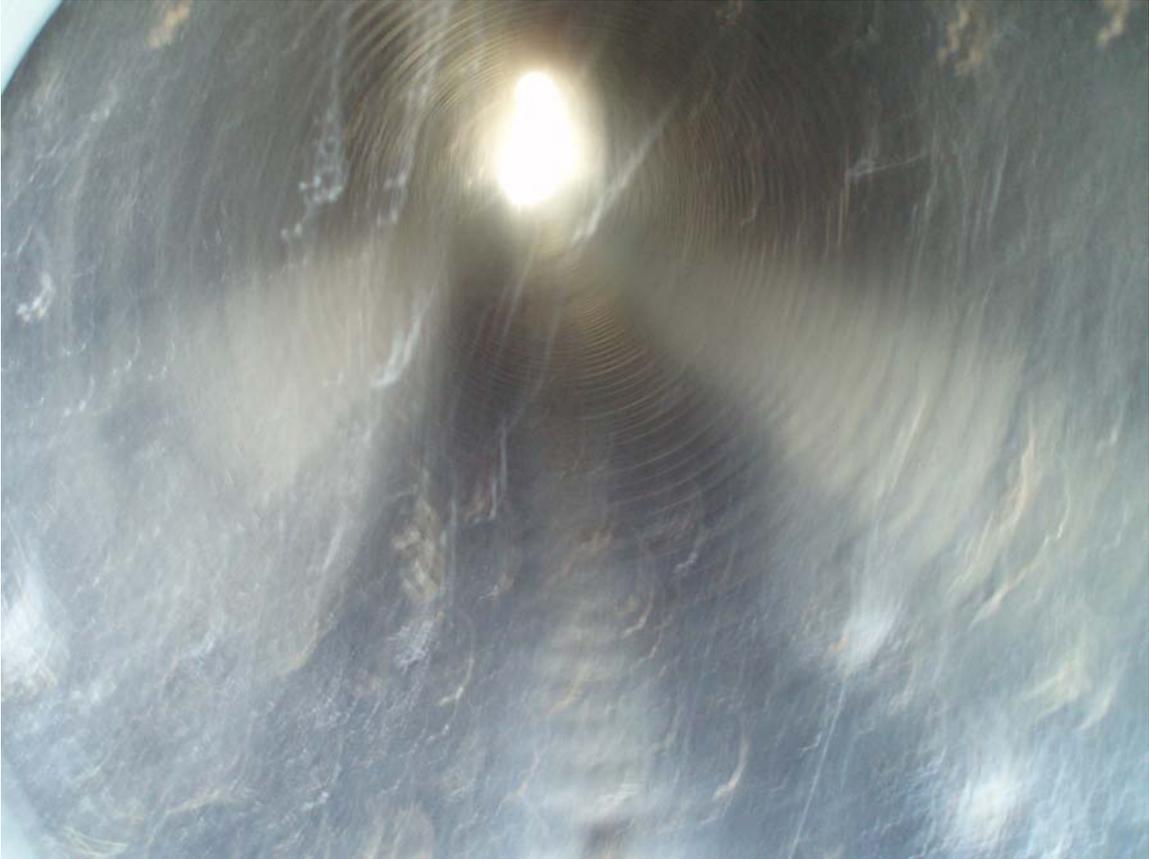
8-1-07, s-106, 18", 1450+00

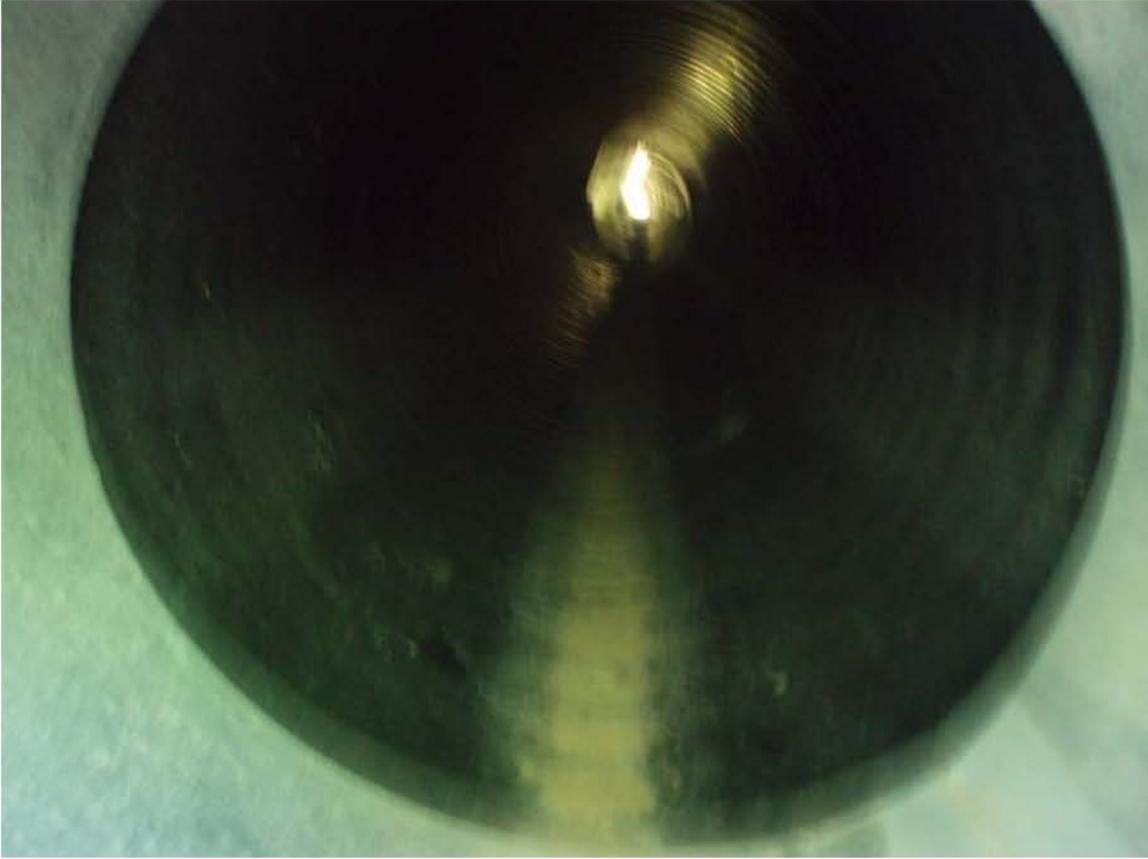
8-1-07, p-105, 30", 1443+24,

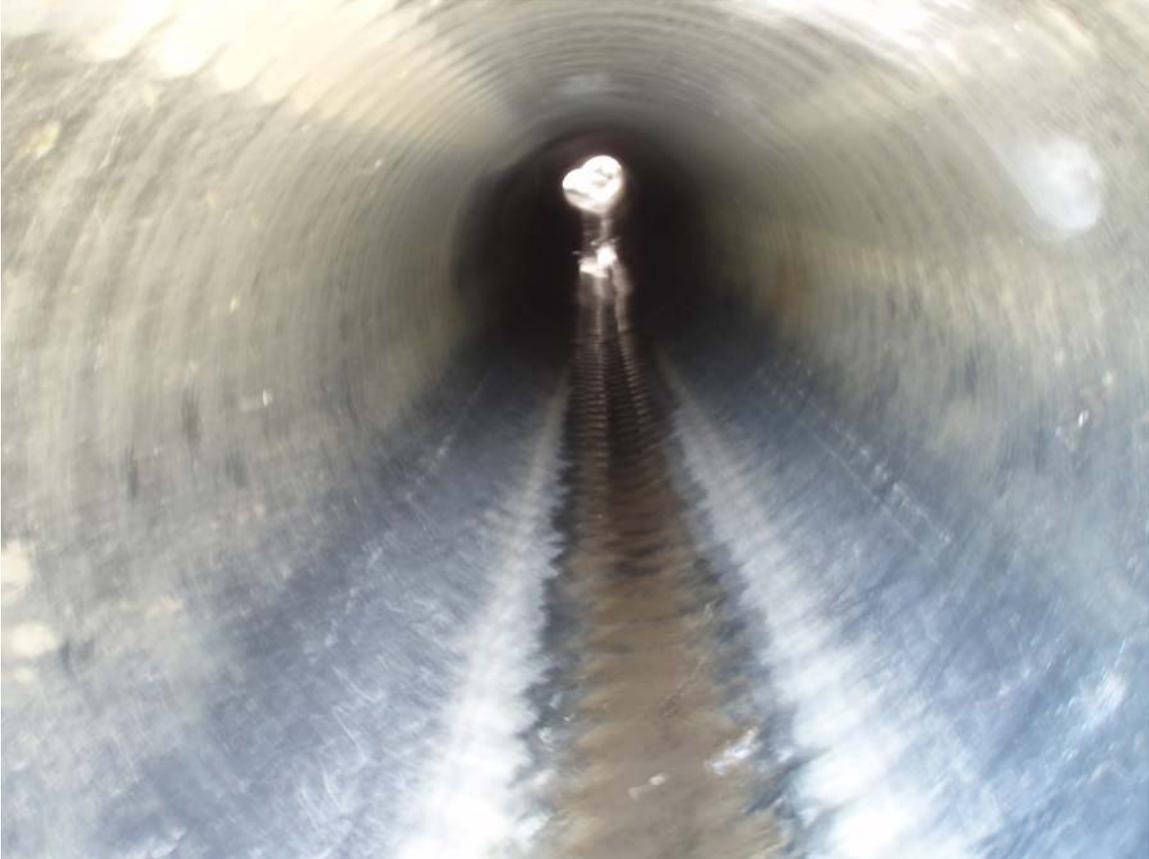
8-1-07, s-103, 15", 1438+00

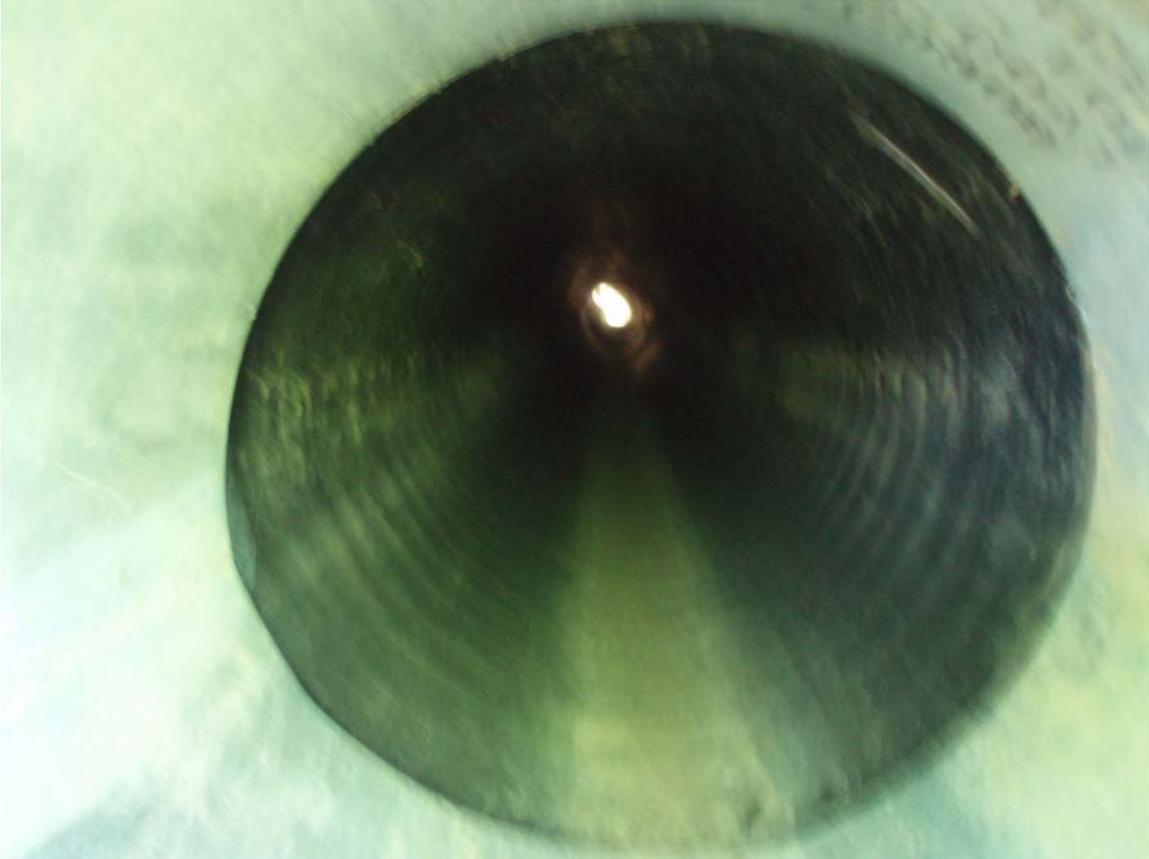
8-1-07, s-100, 18", 1427+00

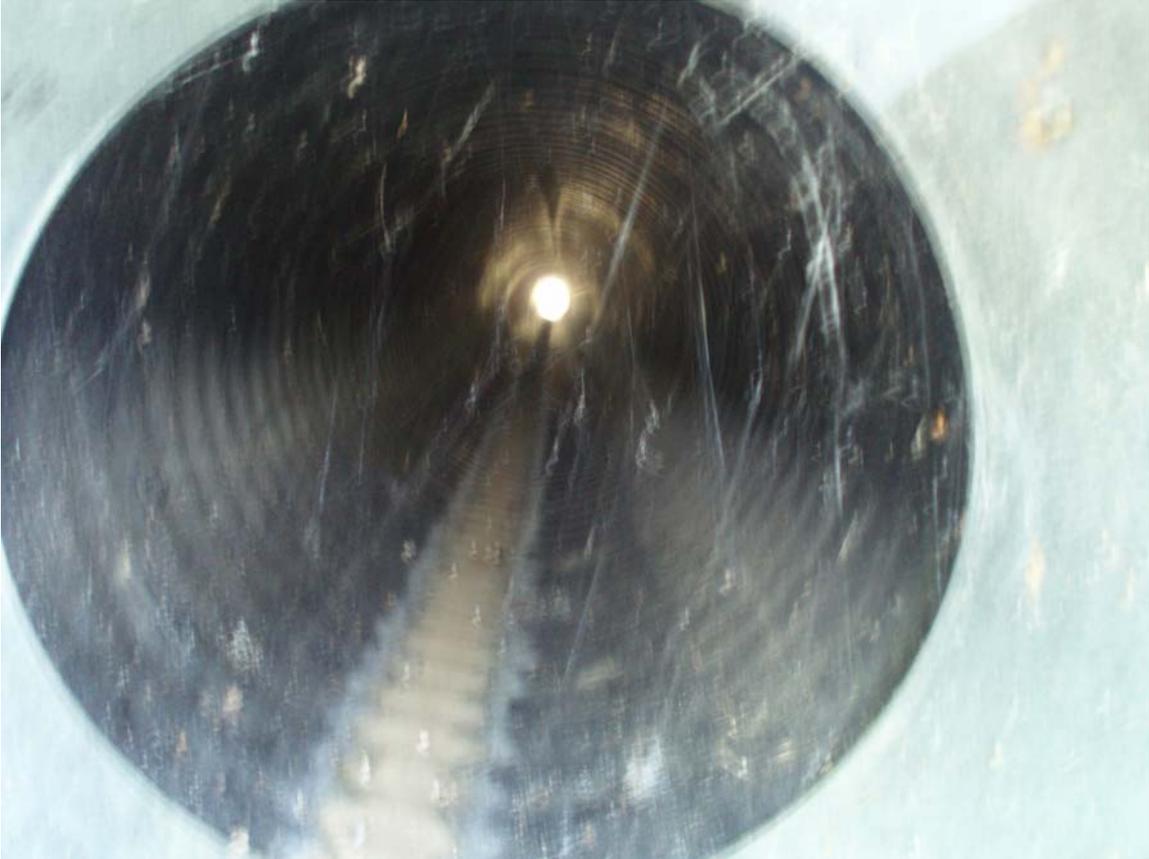
8-1-07, s-099, 24", 1425+00

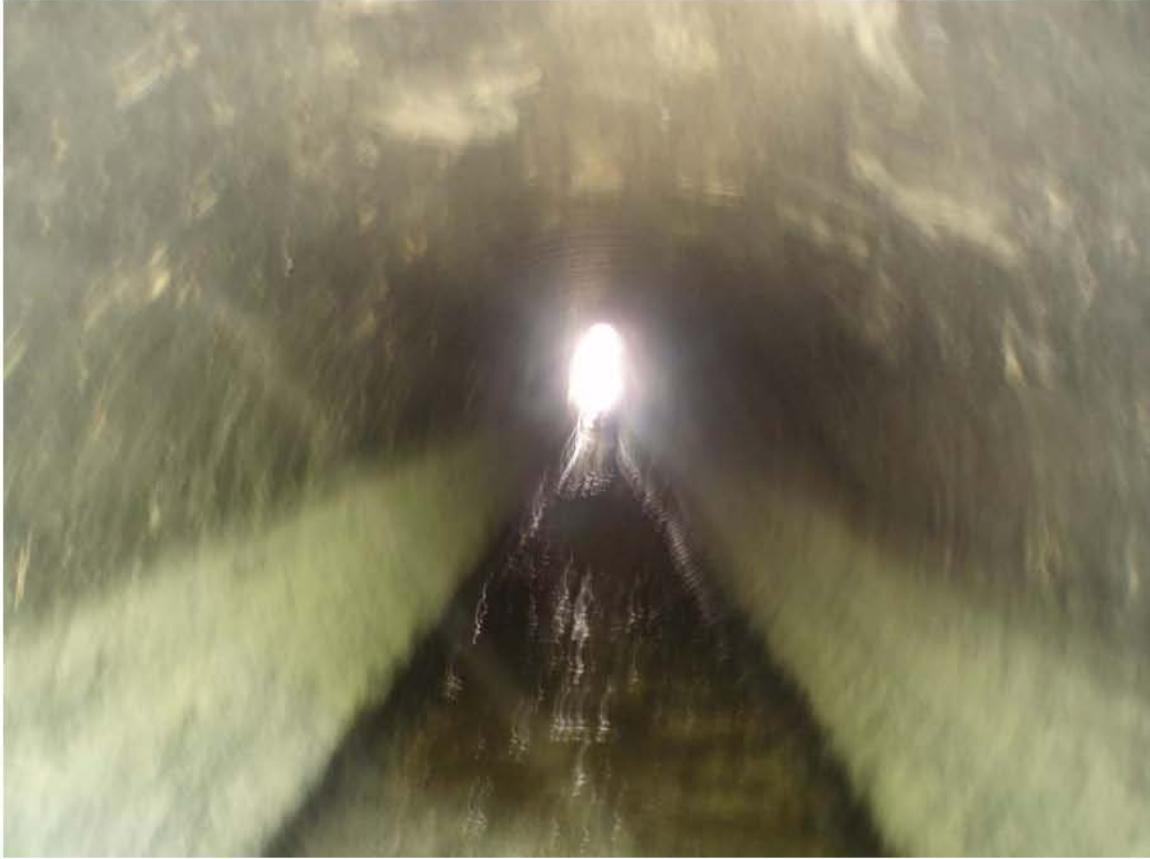
8-1-07, s-095A, 24", 1411+00
