Macon and Adair County, Route 63, Job J2P0485

Route 63, Howell Co., project J9P0497, HDPE double wall storm sewer, W. Side Rt.63

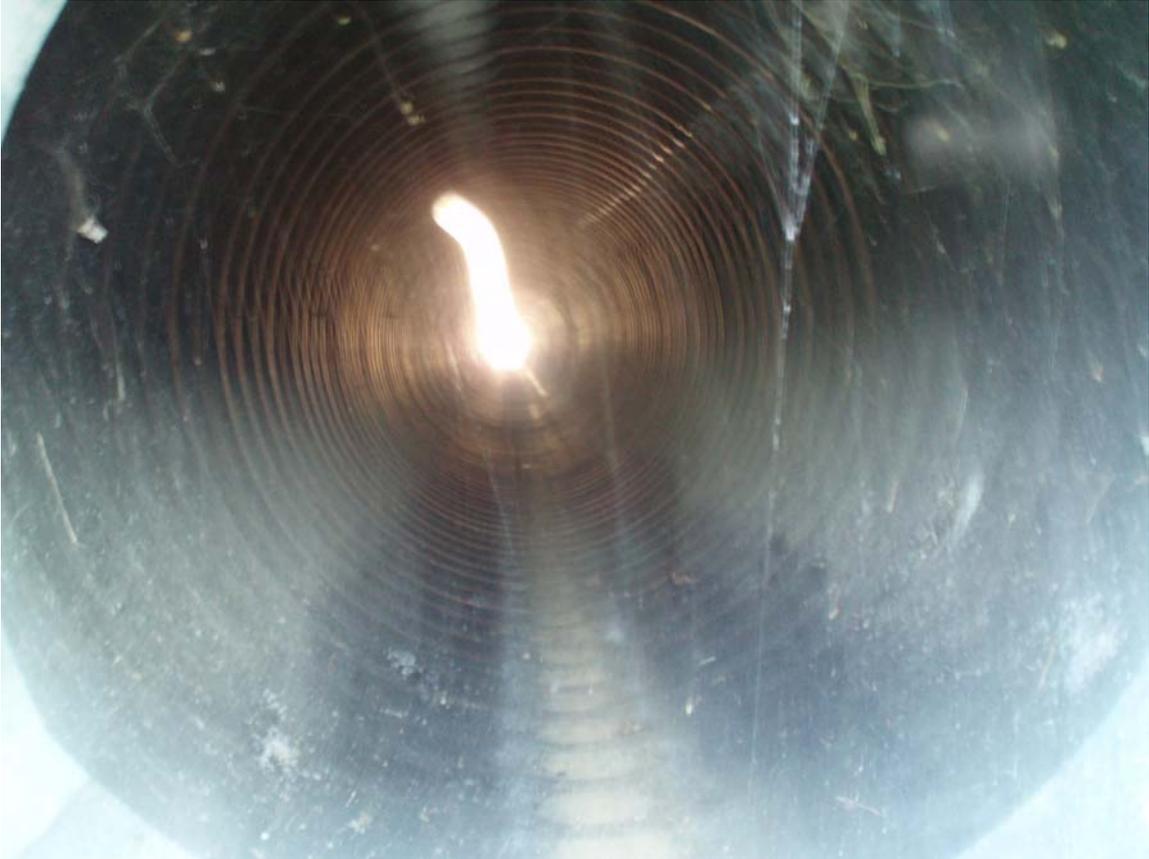
8-1-07, p-094, 24", 1404+94, outlet mower damage,

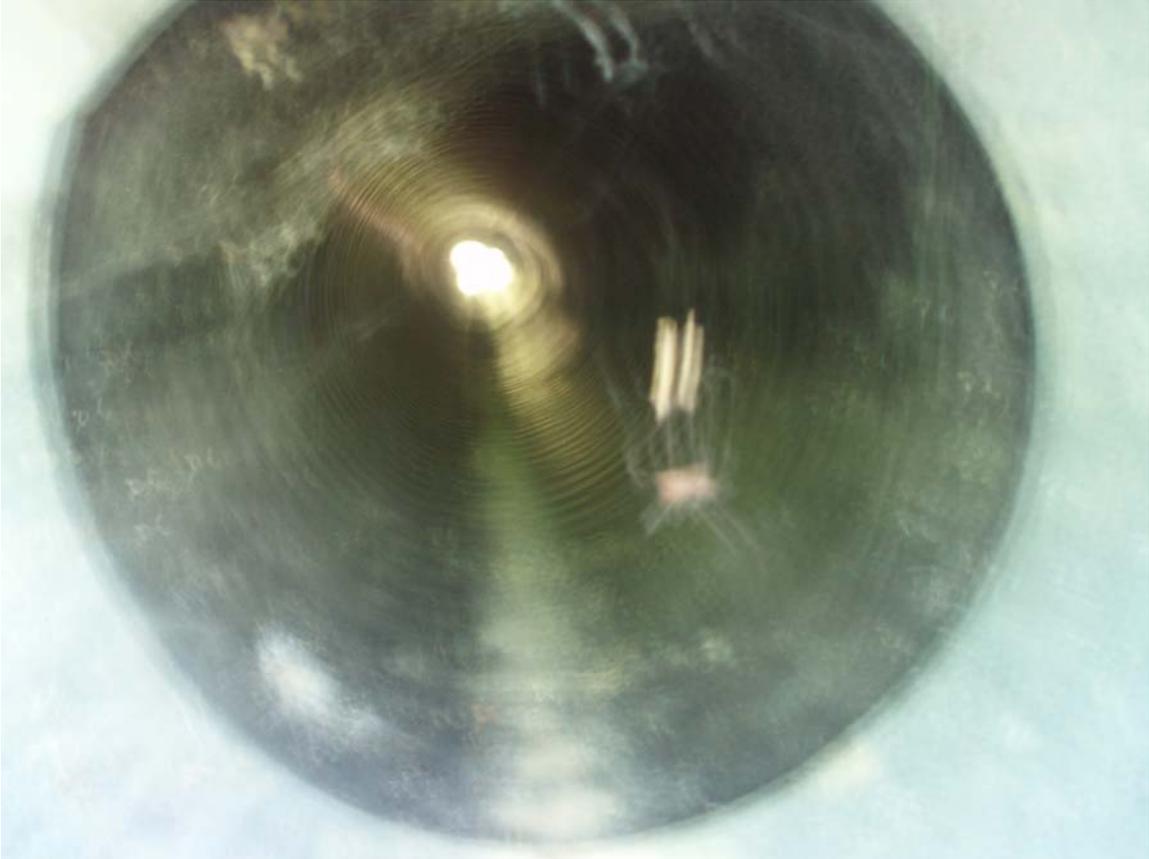
8-1-07, s-092, 18", 1391+00

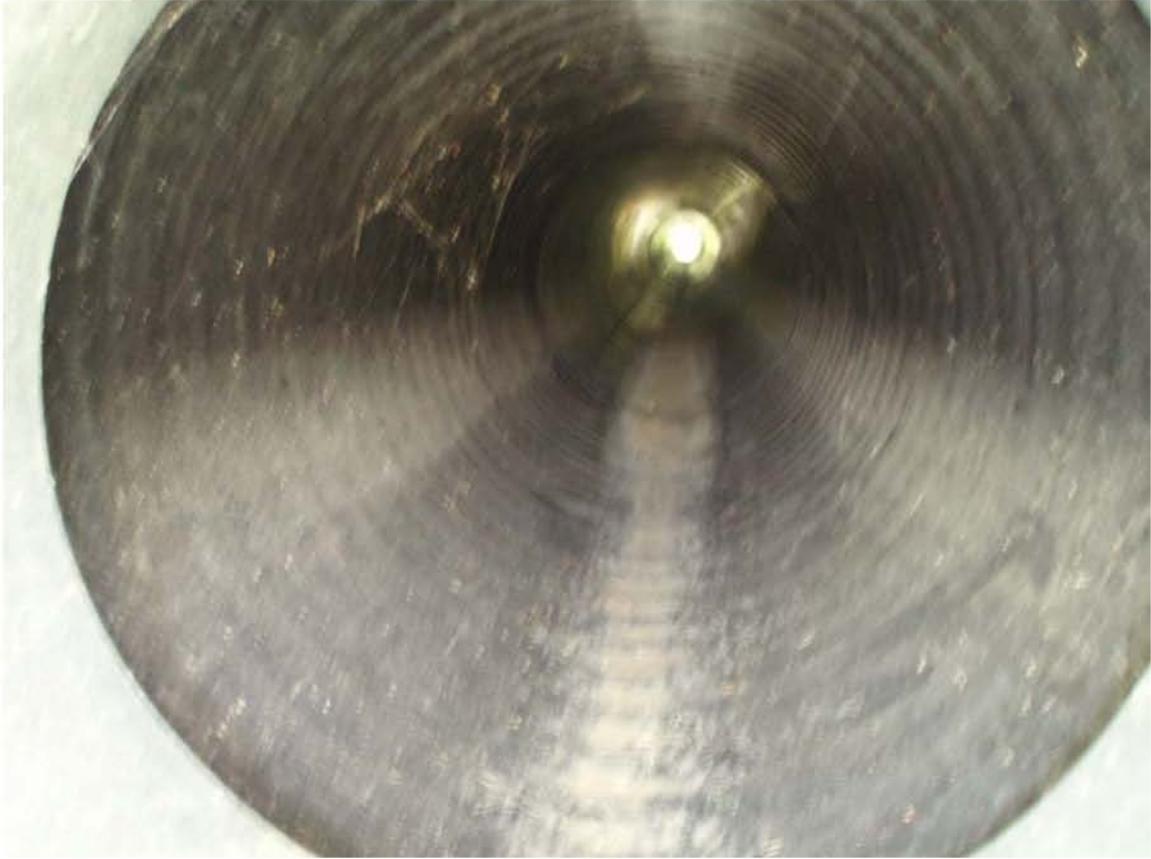
8-1-07, s-091, 24", 1384+00,

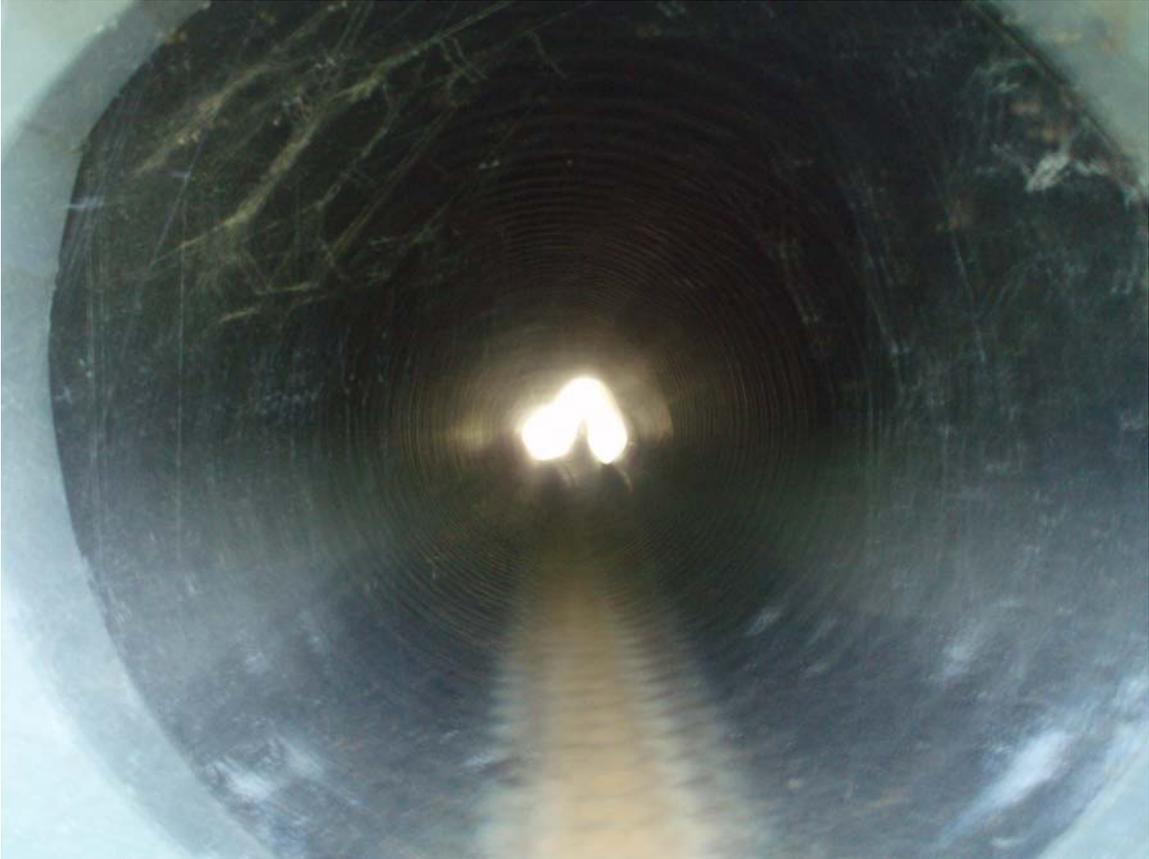
8-1-07, s-090, 18", 1367+00

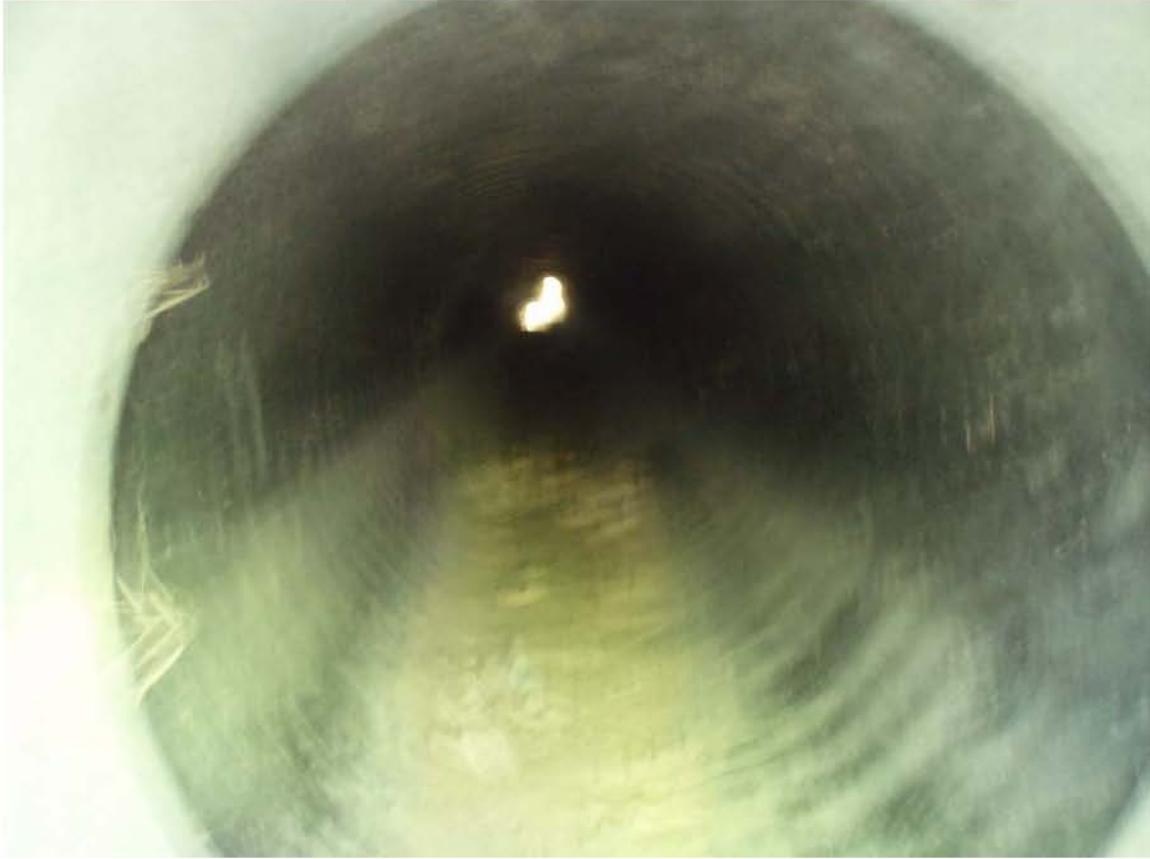
8-1-07, s-089, 18", 1360+00,

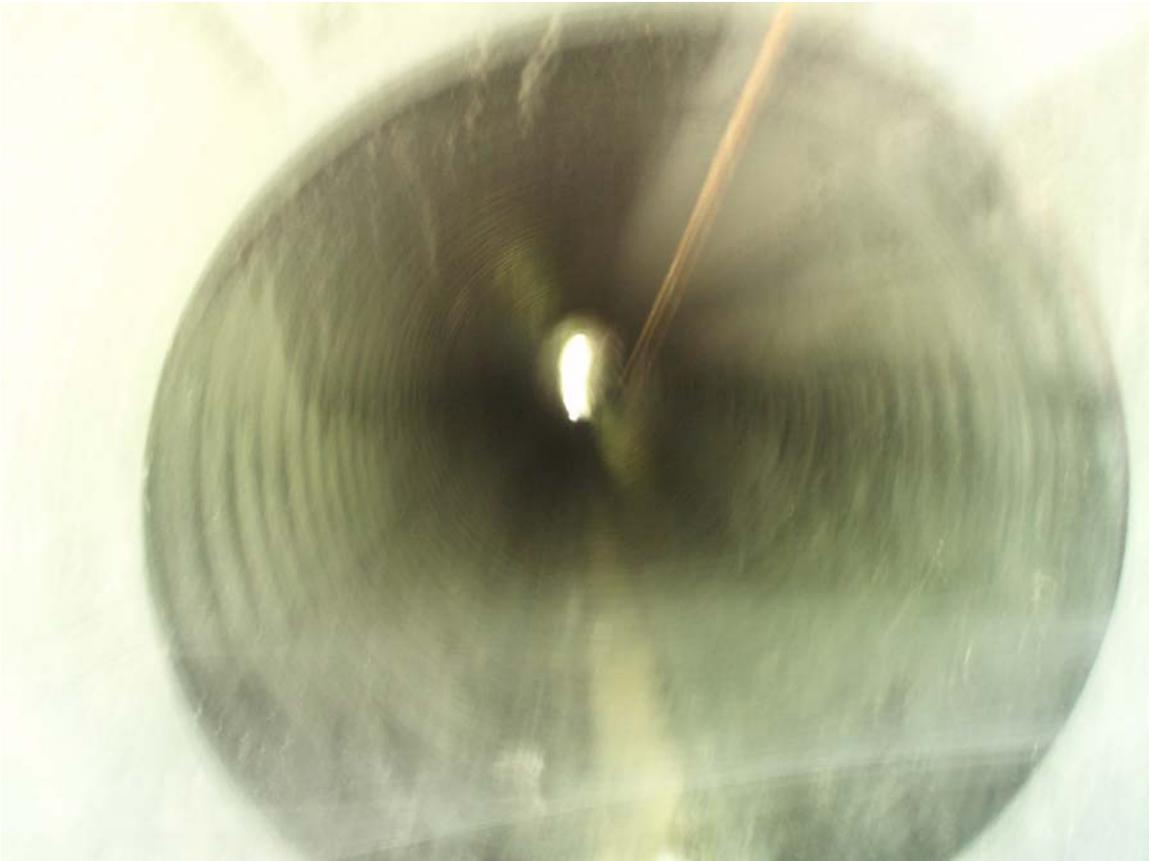
8-1-07, s-088, 24", 1353+00

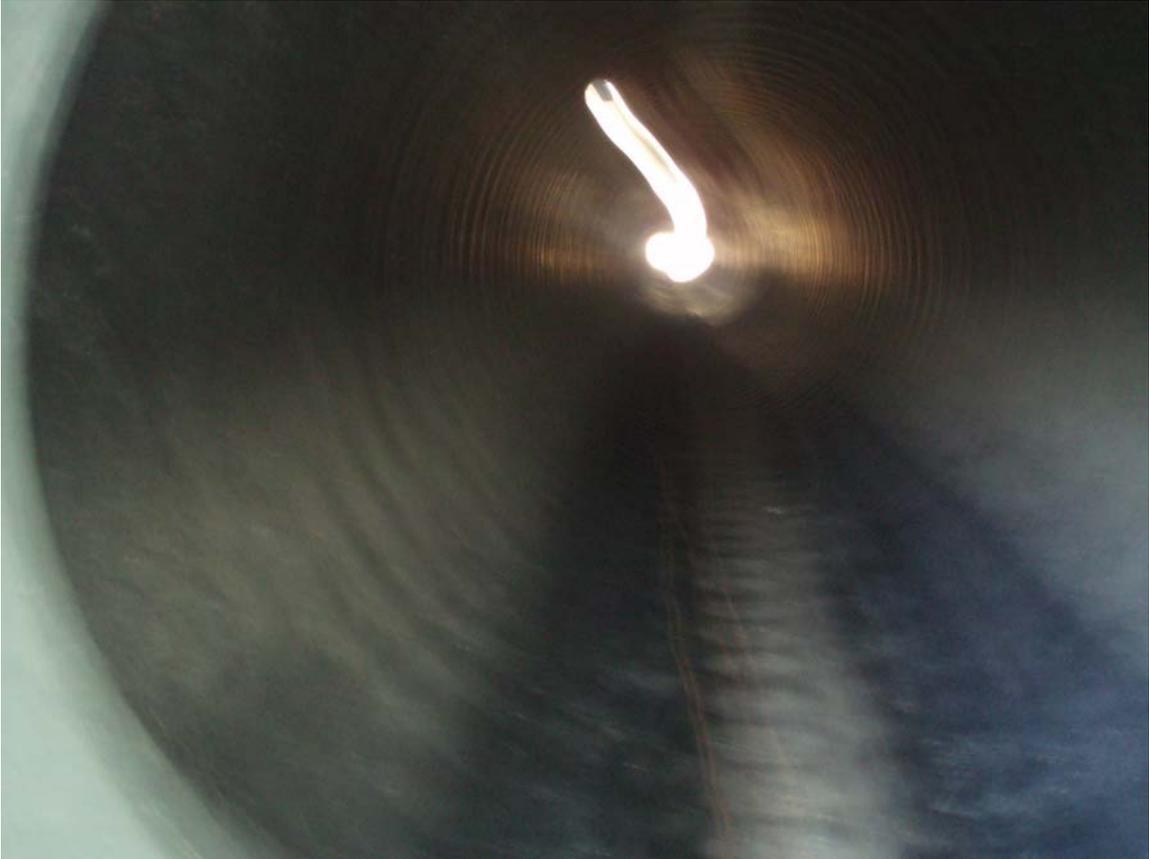
8-1-07, p-087, 30", 1351+32

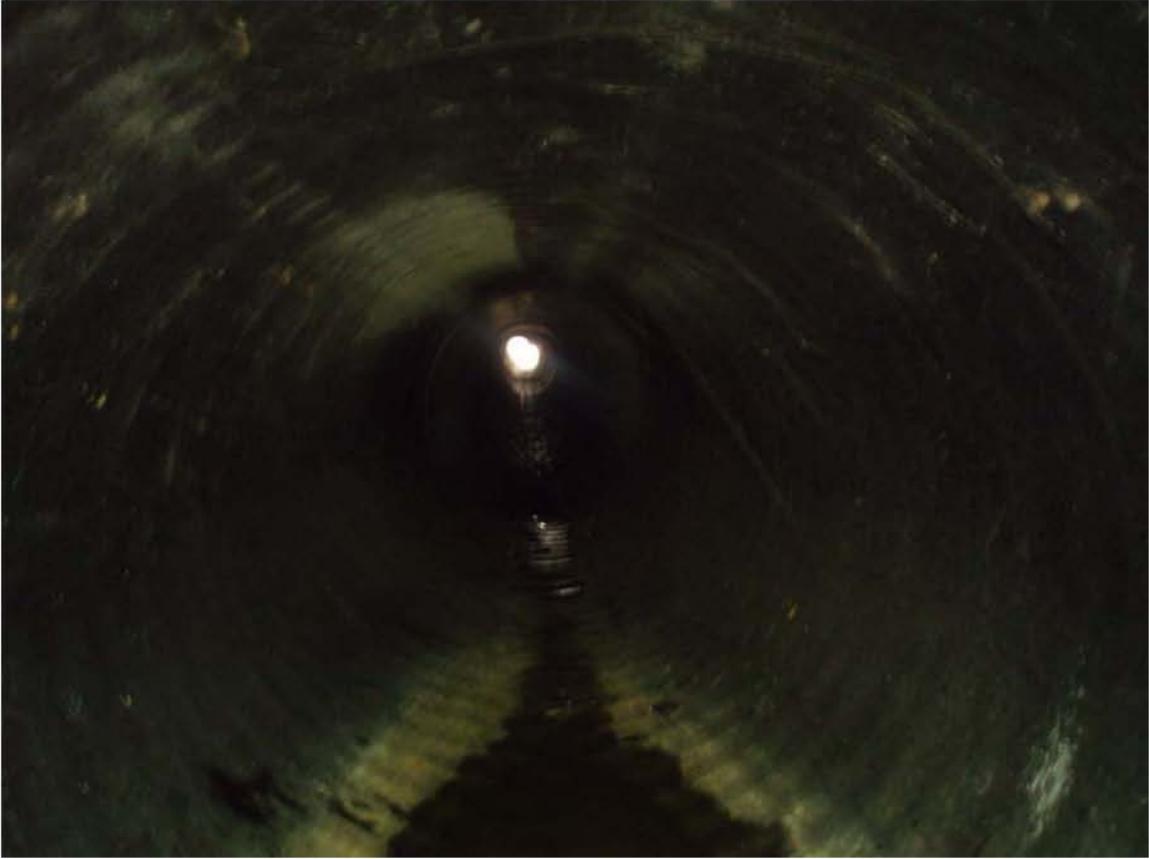
8-1-07, s-086, 18", 1345+52,

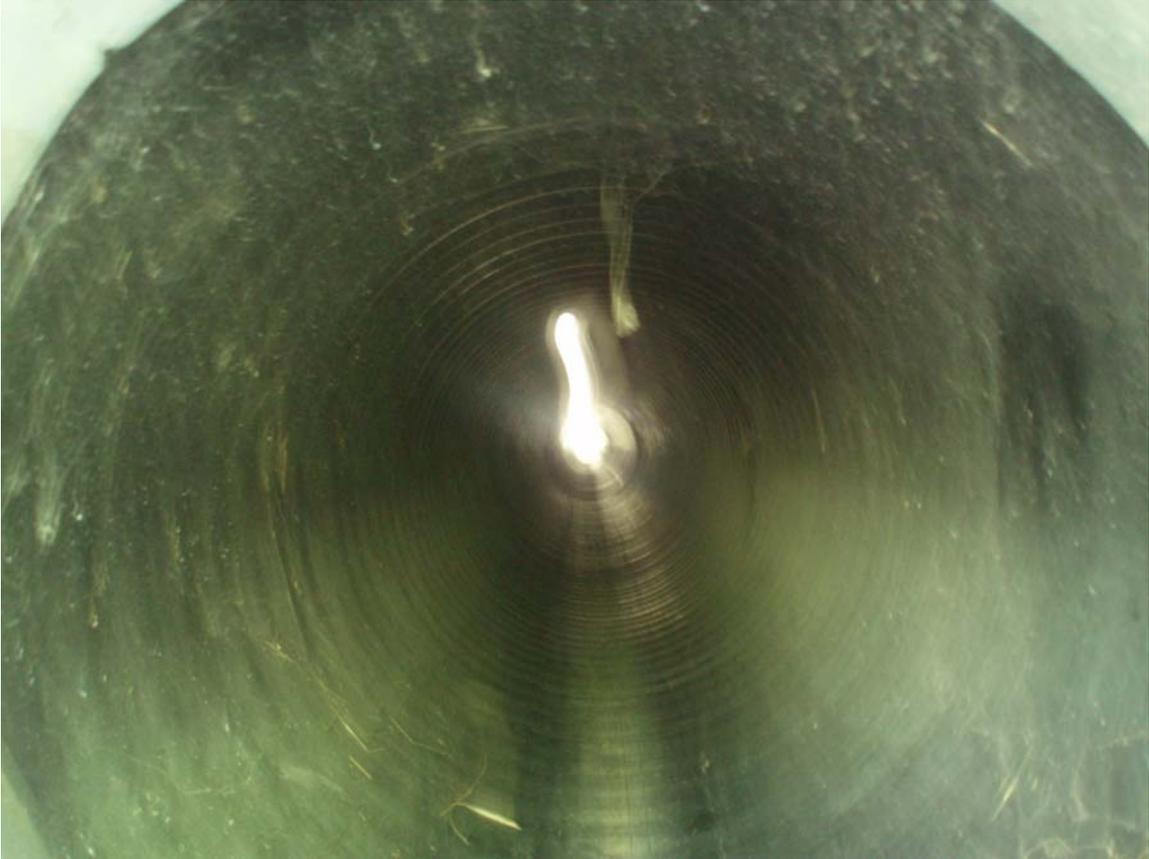
8-1-07, s-084, 18", 1339+00

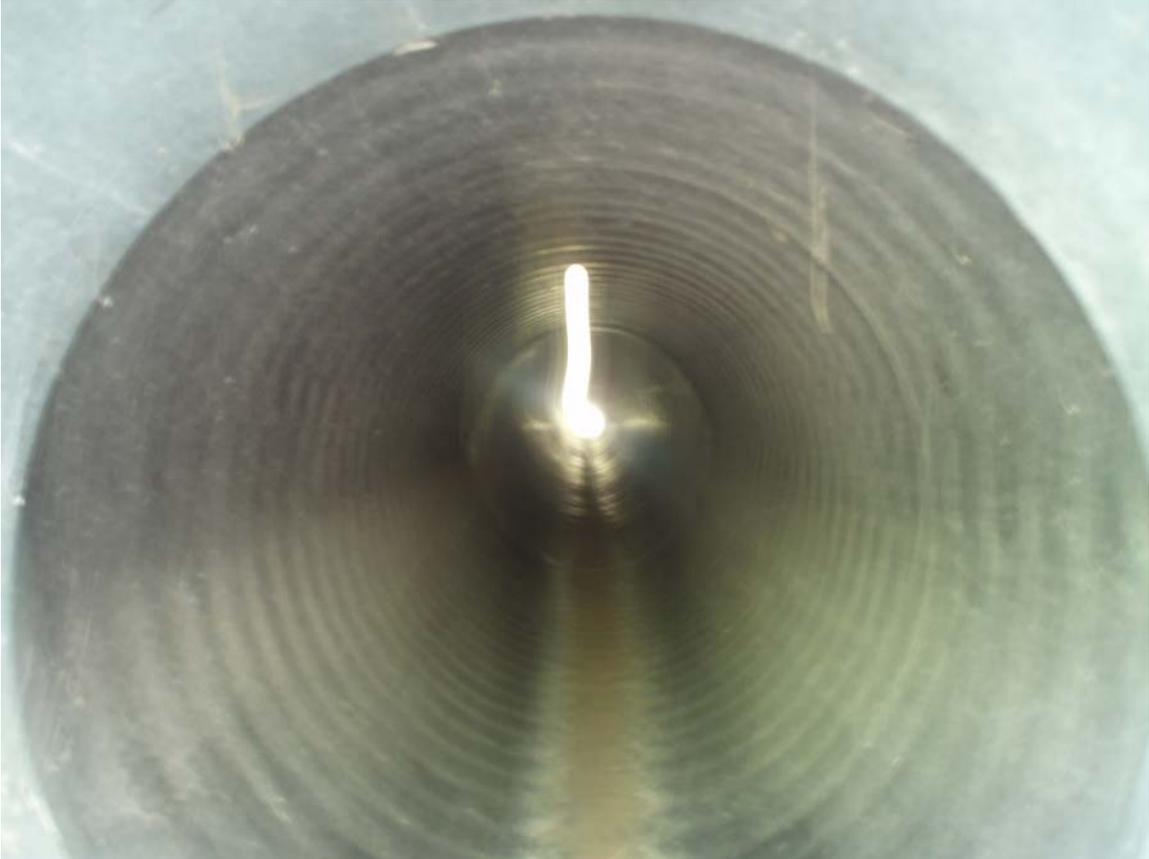
8-1-07, s-082, 18", 1331+00

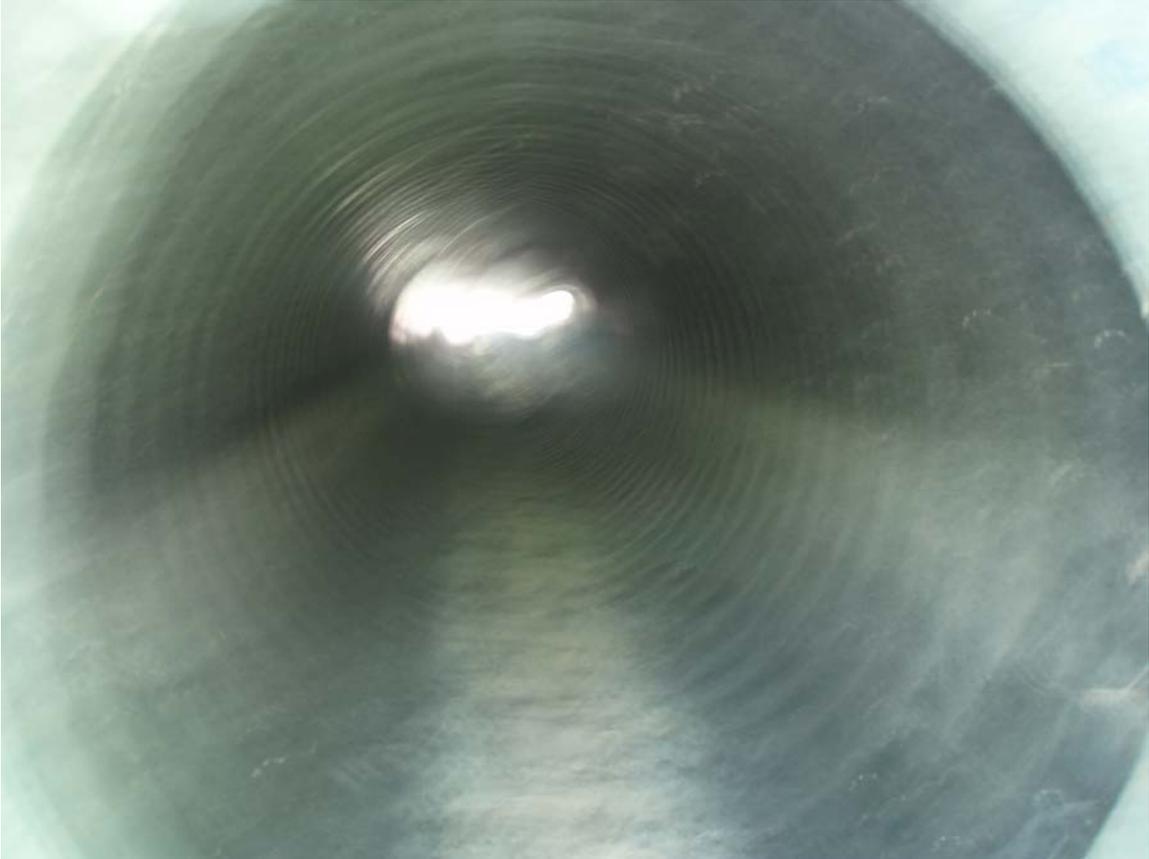
8-1-07, s-081, 18", 1326+00

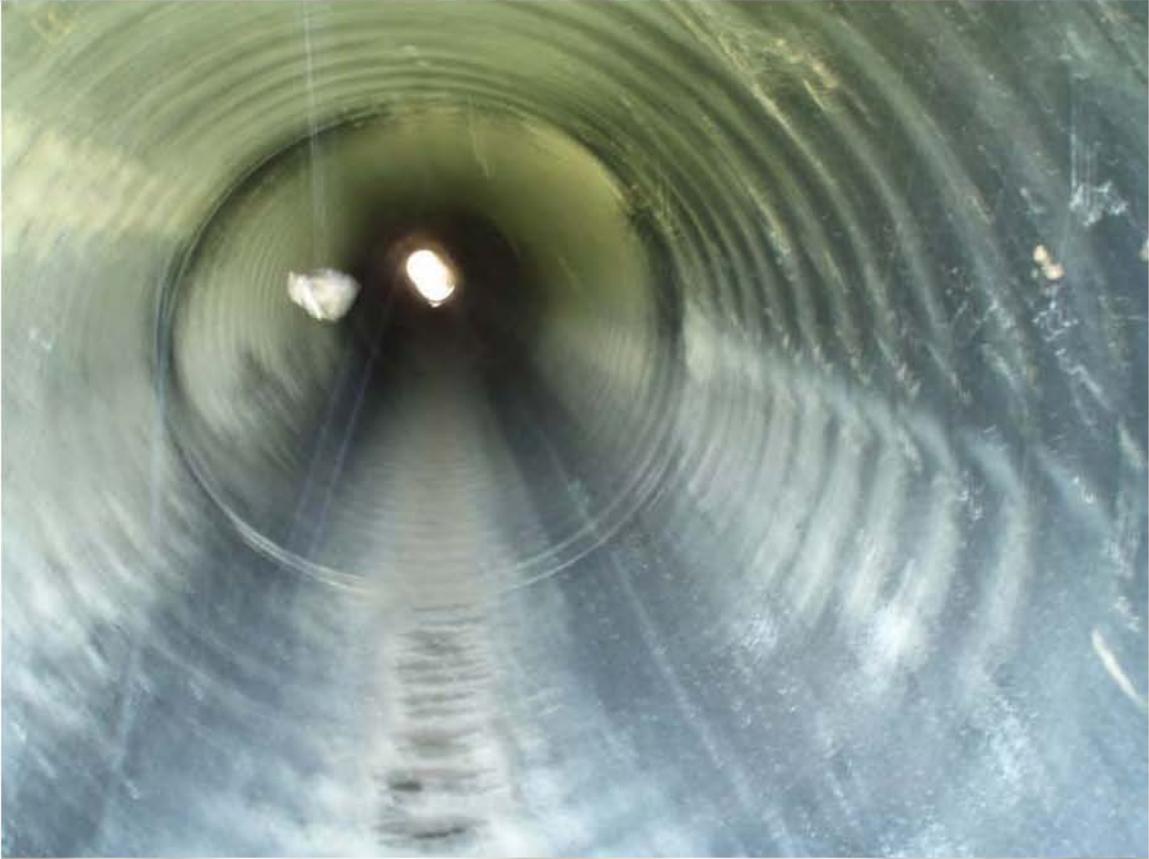
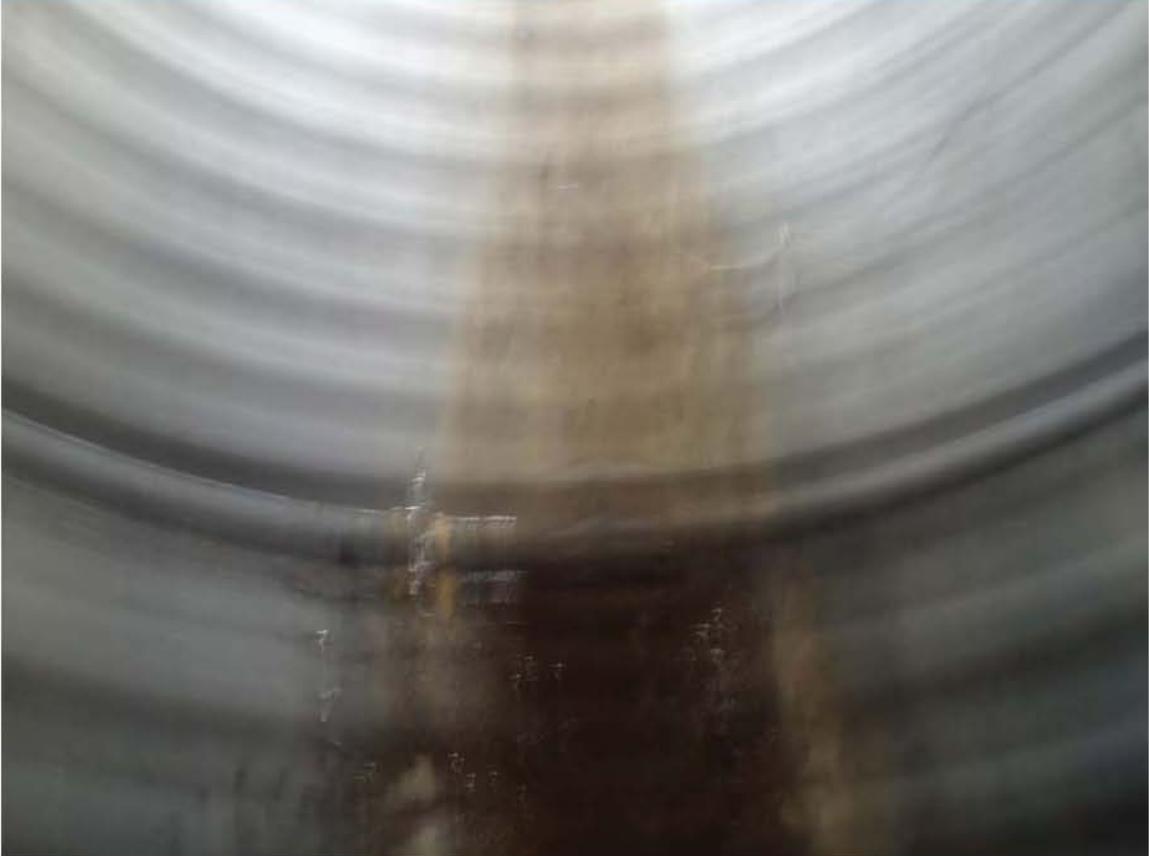
8-1-07, p-079, 30", 1320+68

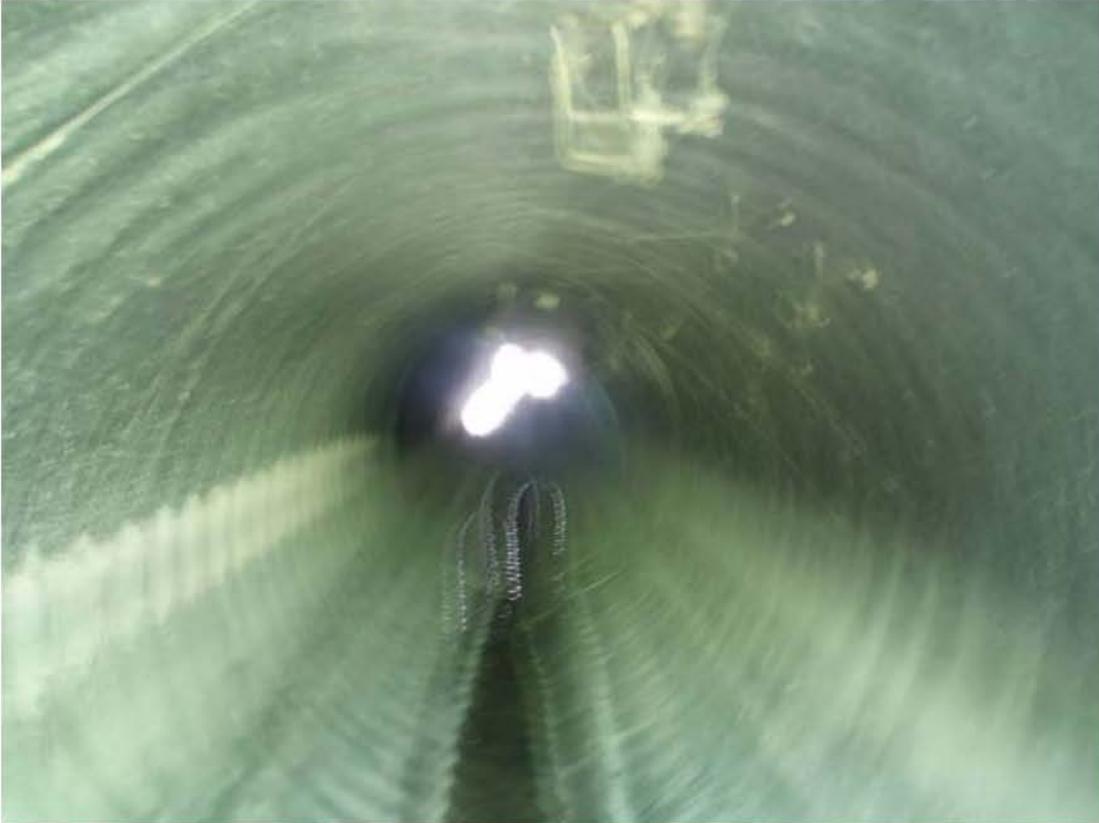
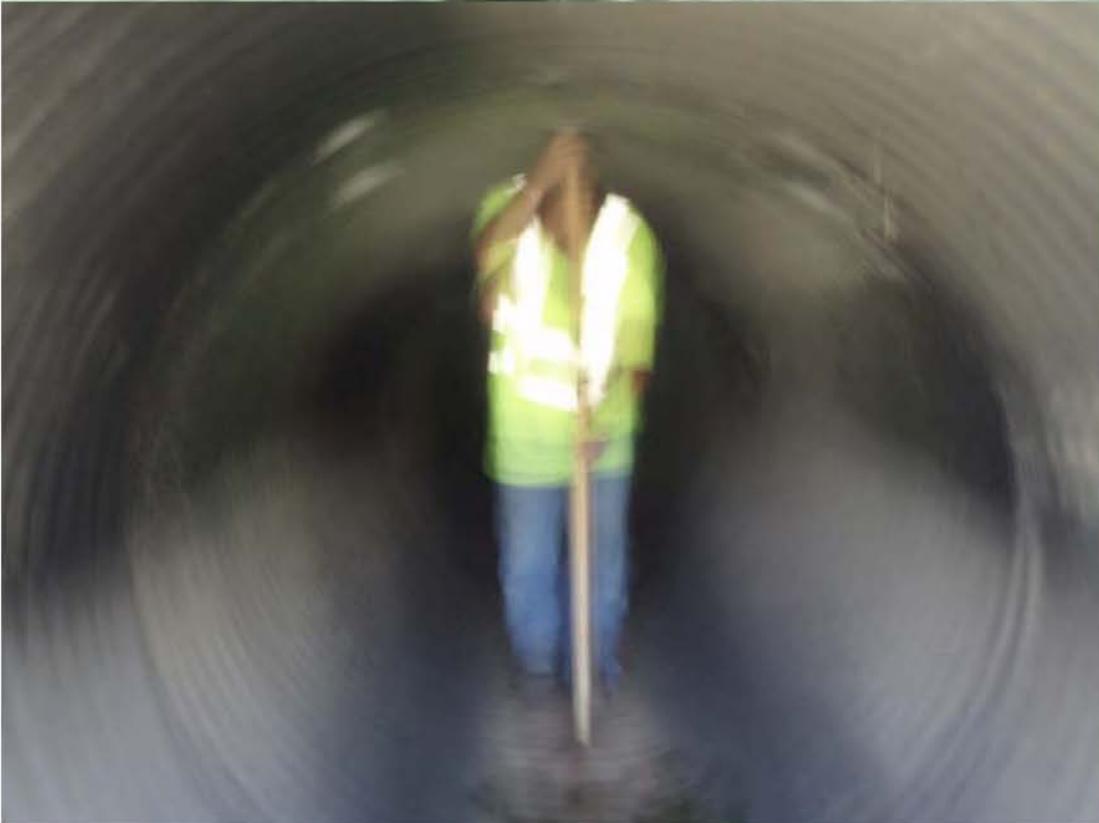
8-1-07, s-075, 48", 1317+15, 7<sup>th</sup> joint RCP 4" all the way around, concrete collar around

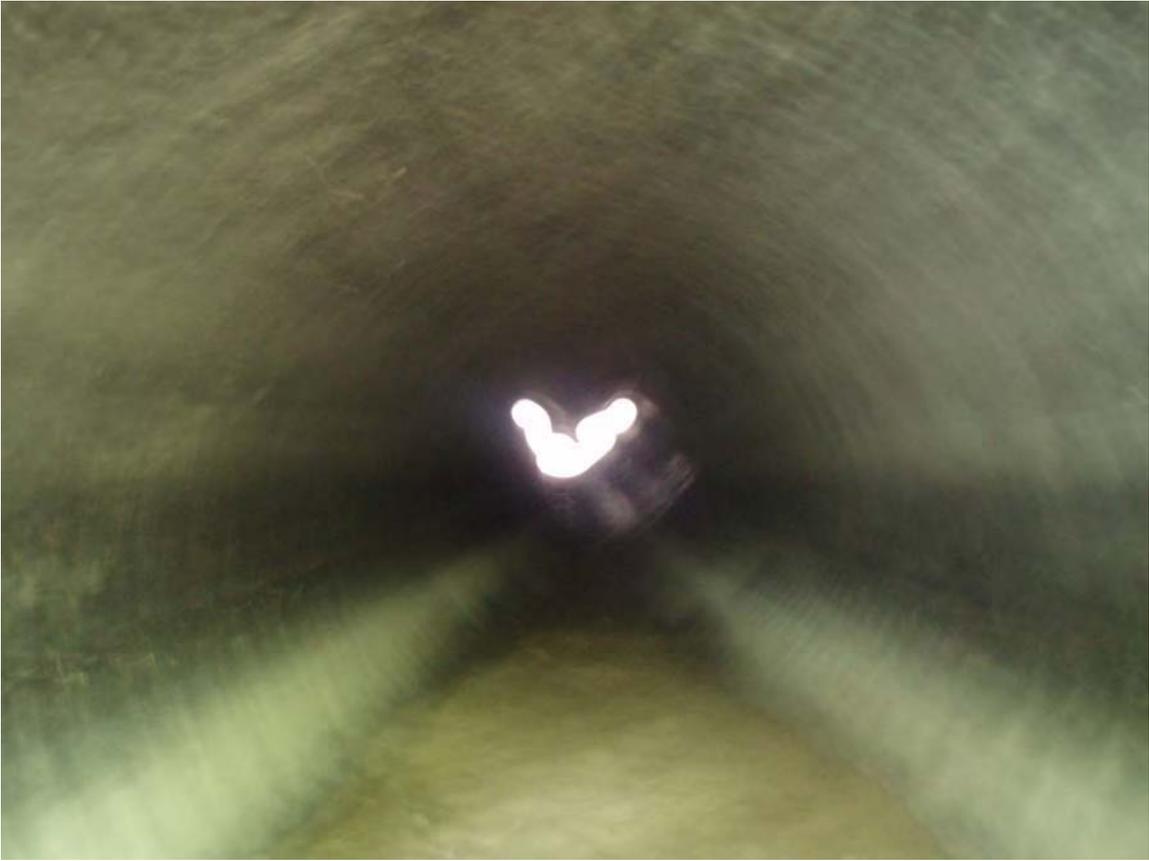
8-1-07, s-069, 24", 1291+00, 25% full of sediment, Flat on top,

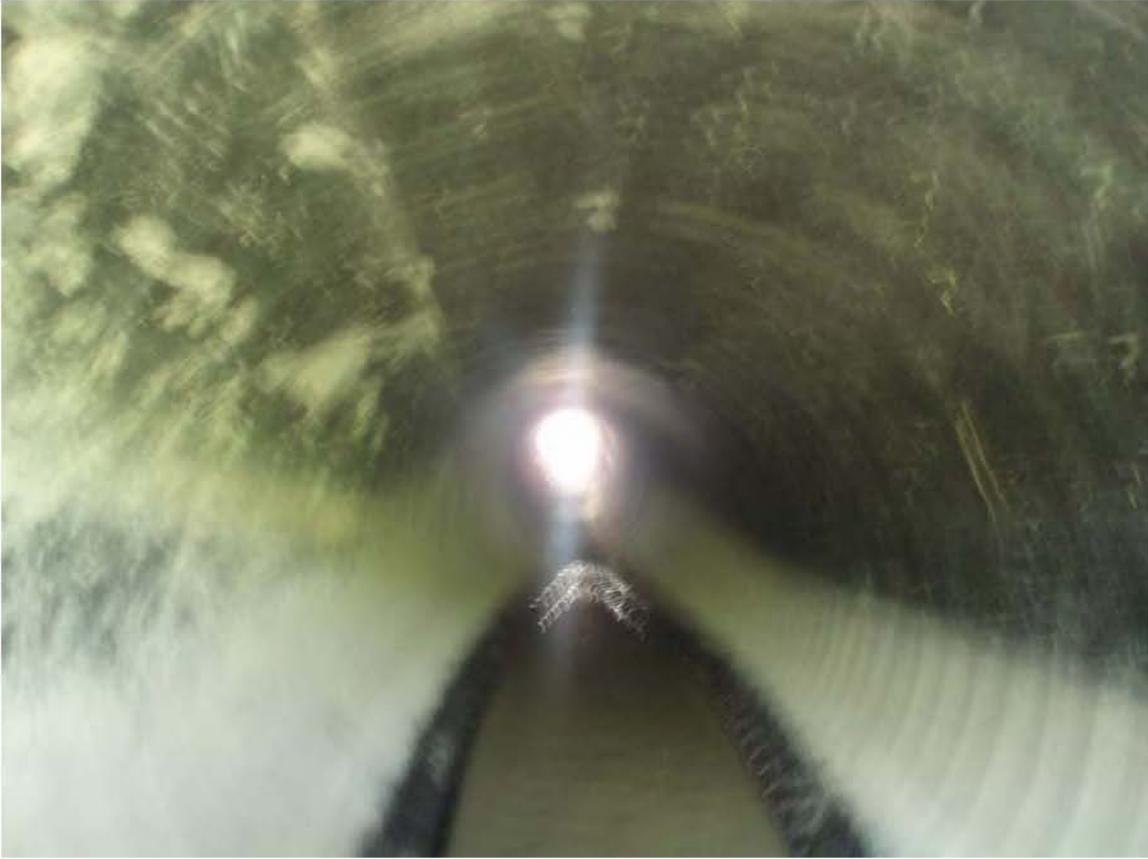
8-1-07, s-015, 24", 1022+00, Video and Mandrel OK,

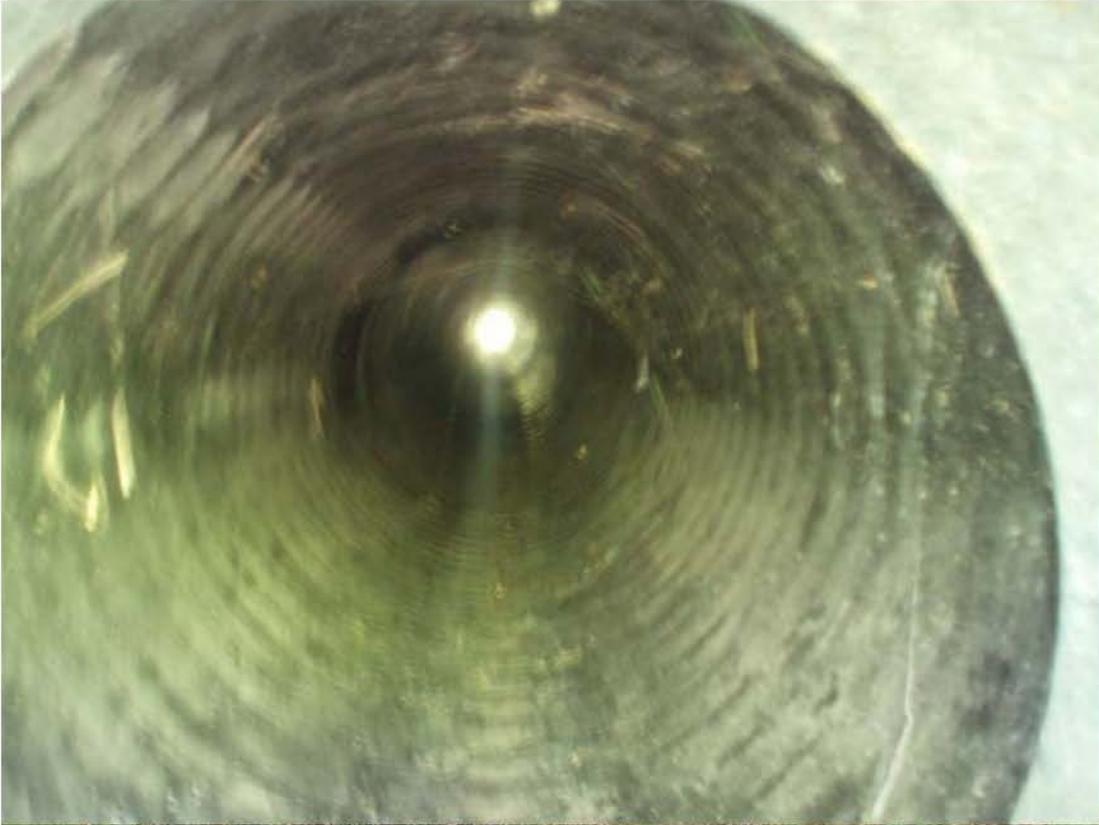
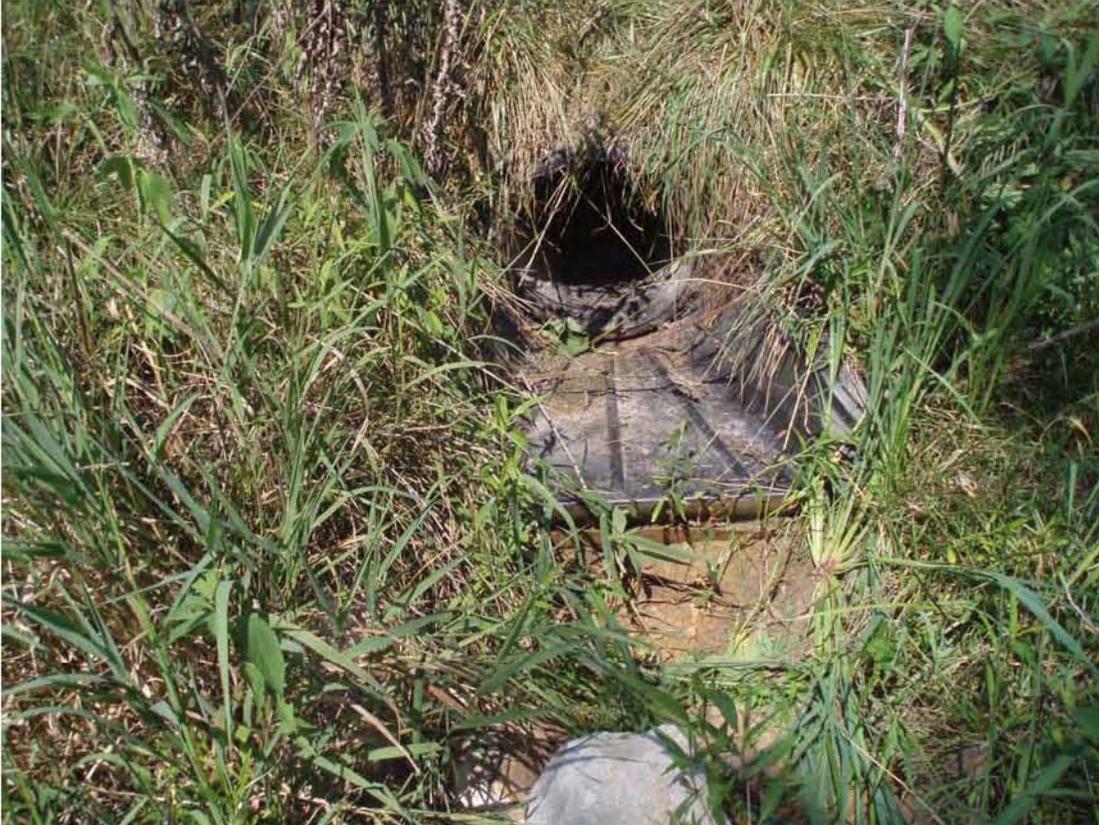
8-1-07, s-017, 18", Eroded around FLE

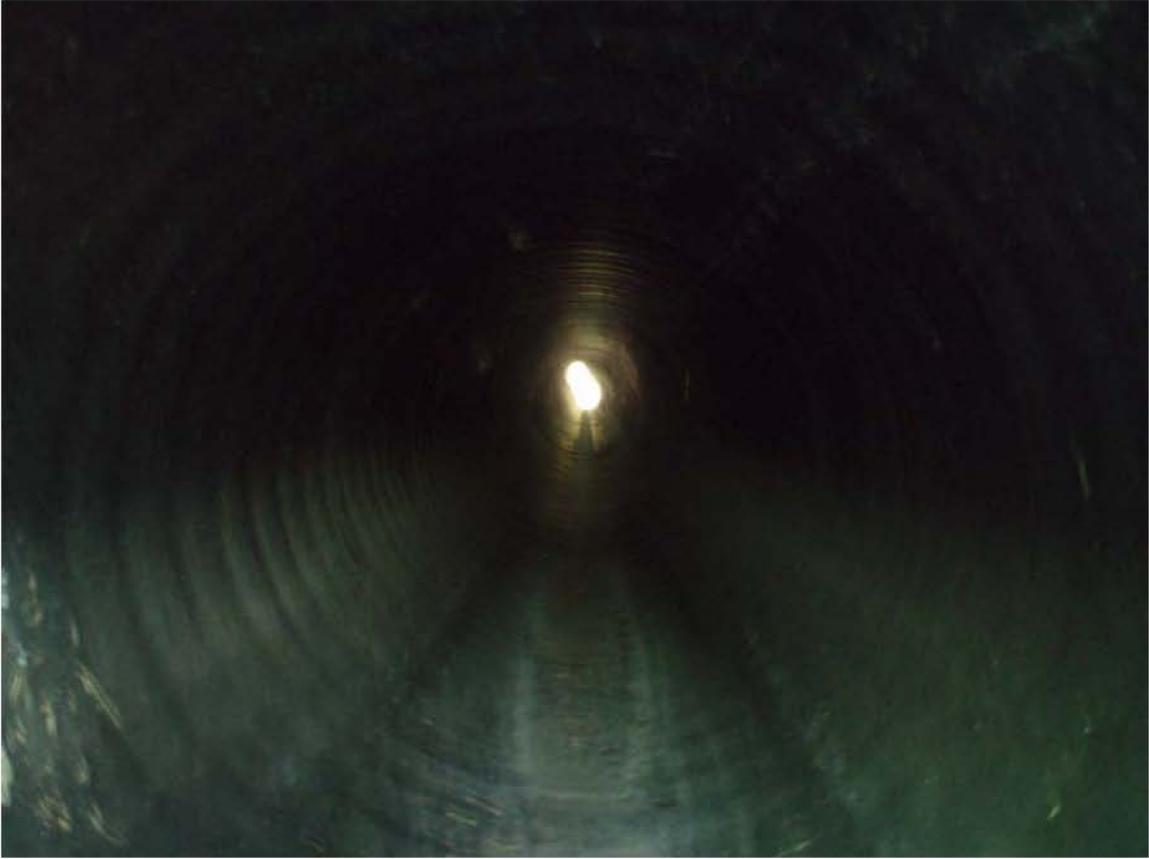
8-2-07, p-027, 15", 1068+00, 10% debris fill,

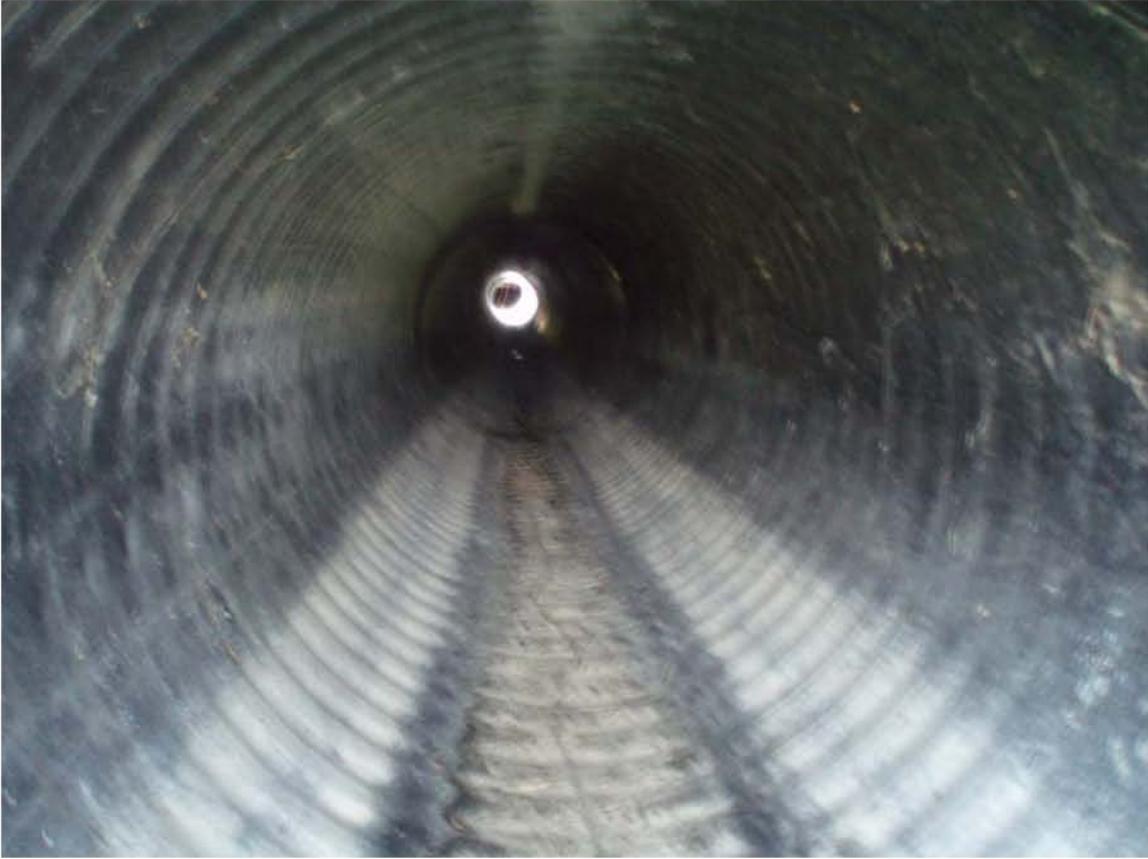
8-2-07, s-033, 42", 1088+31, calibrated stick tested OK,

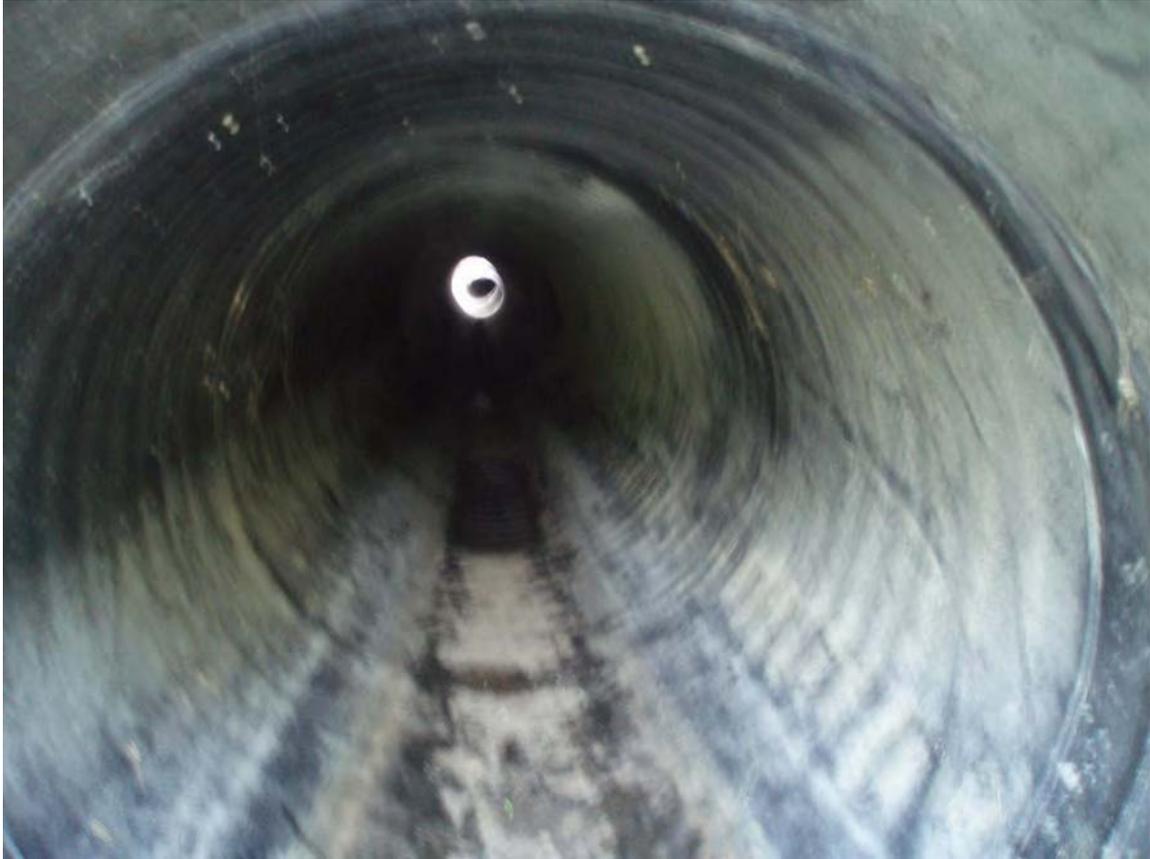
8-2-07, s-038, 42", 1122+03, 12" vert. Crack covered 1 to 3 o'clock at end of pipe , calibrated stick through – deflection , 5%.

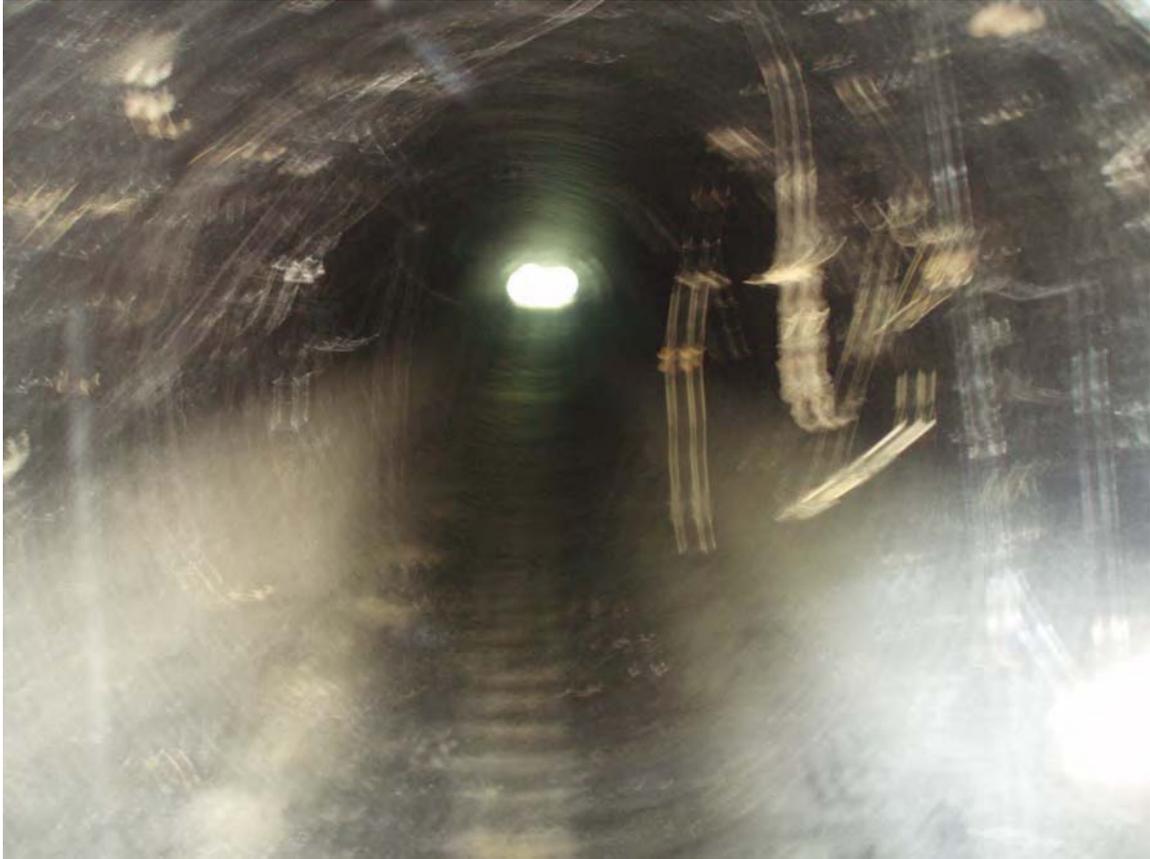
8-2-07, s-040, 18", 1130+00
