Macon and Adair County, Route 63, Job J2P0485

Route 63, Howell Co., project J9P0497, HDPE double wall storm sewer, W. Side Rt.63

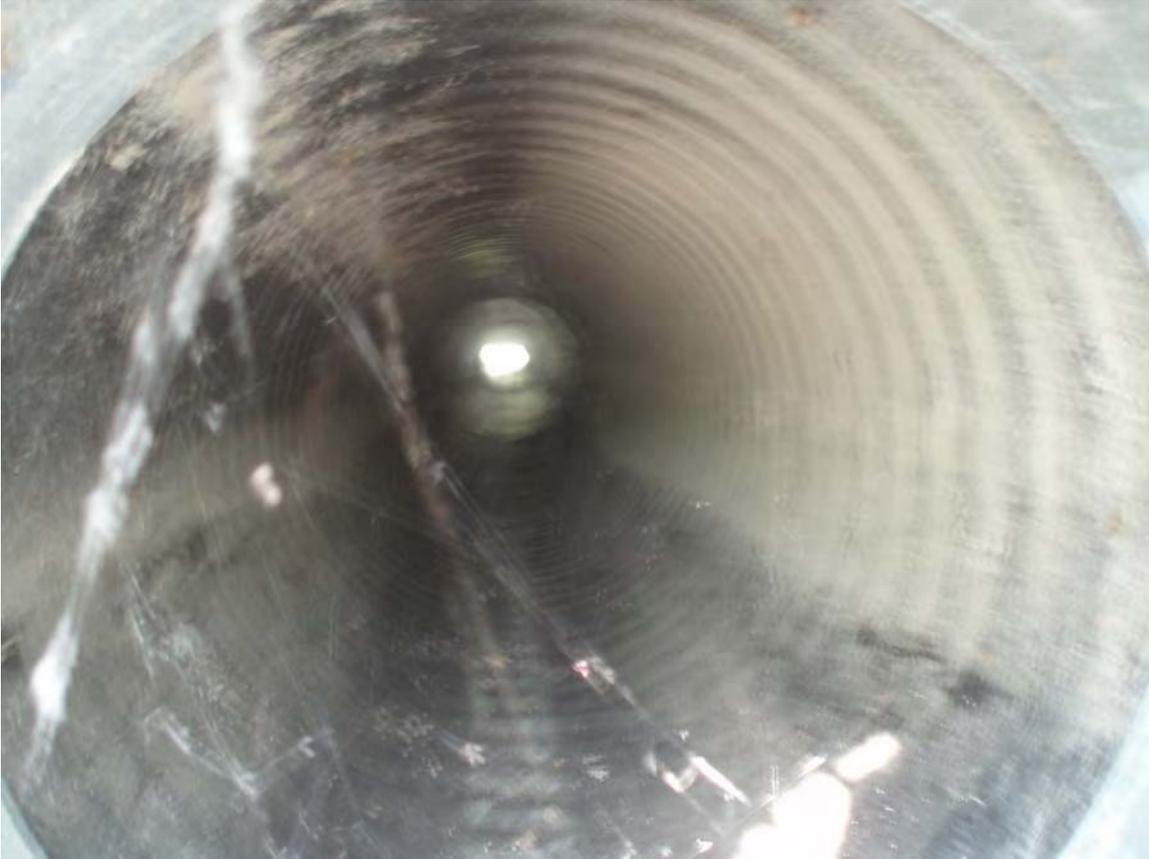
8-2-07, s-041, 24", 1136+00

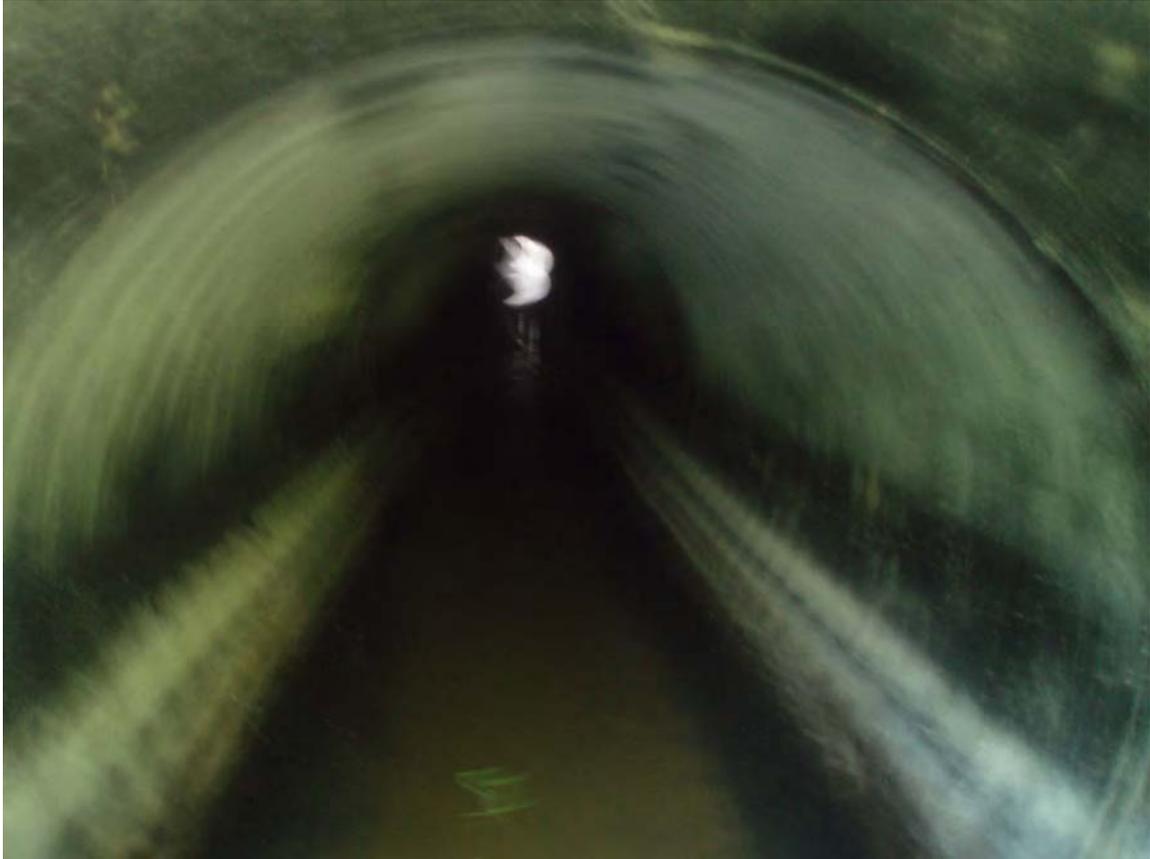
8-2-07, s-043, 18", 1139+00

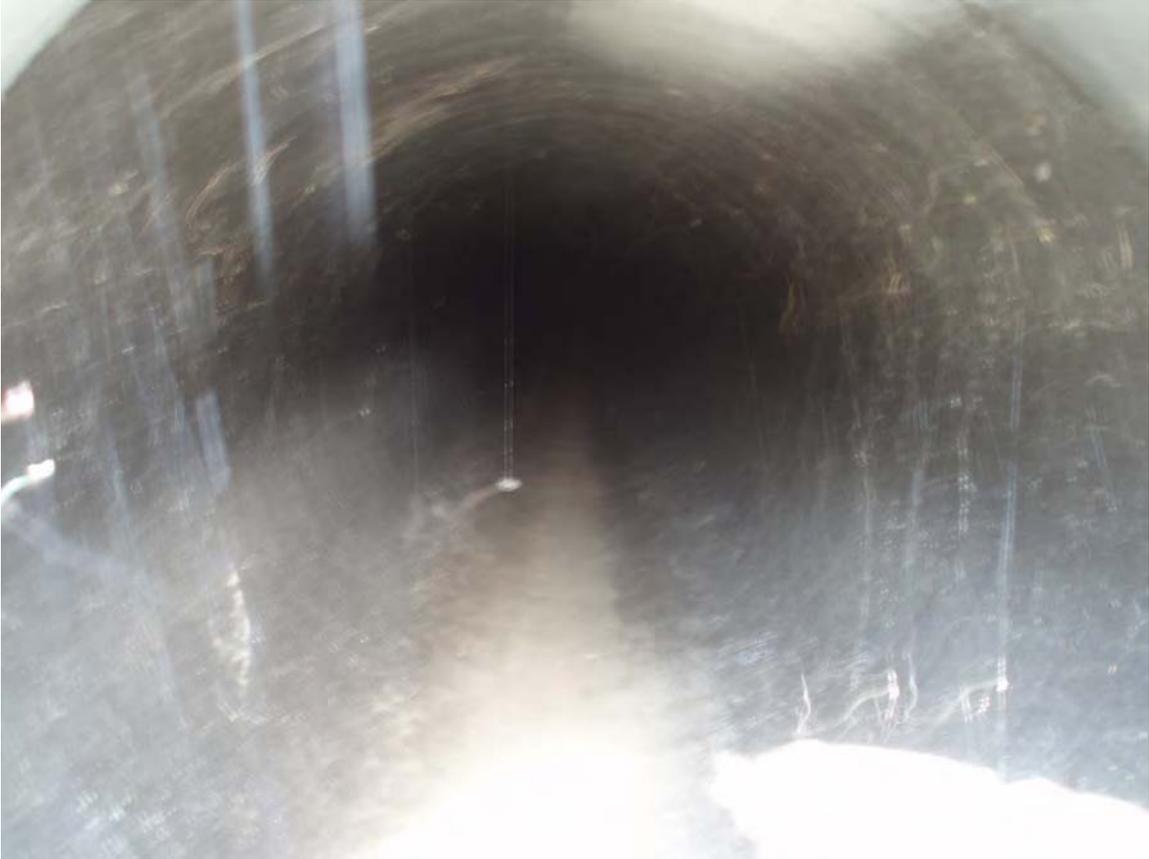
8-2-07, s-046, 42", 1148+95, 6" of water

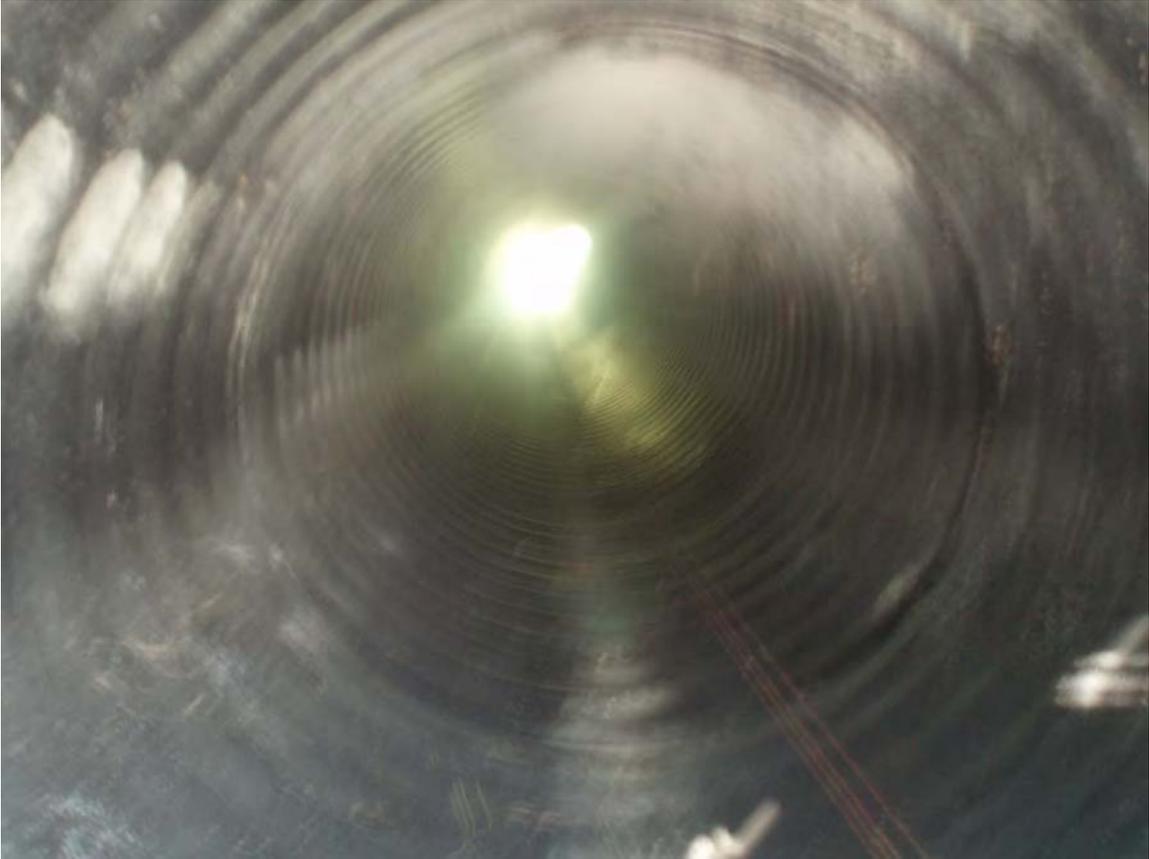
8-2-07,s-047A, 24" 1155+54, Steel extension at Inflow, OF inspected.

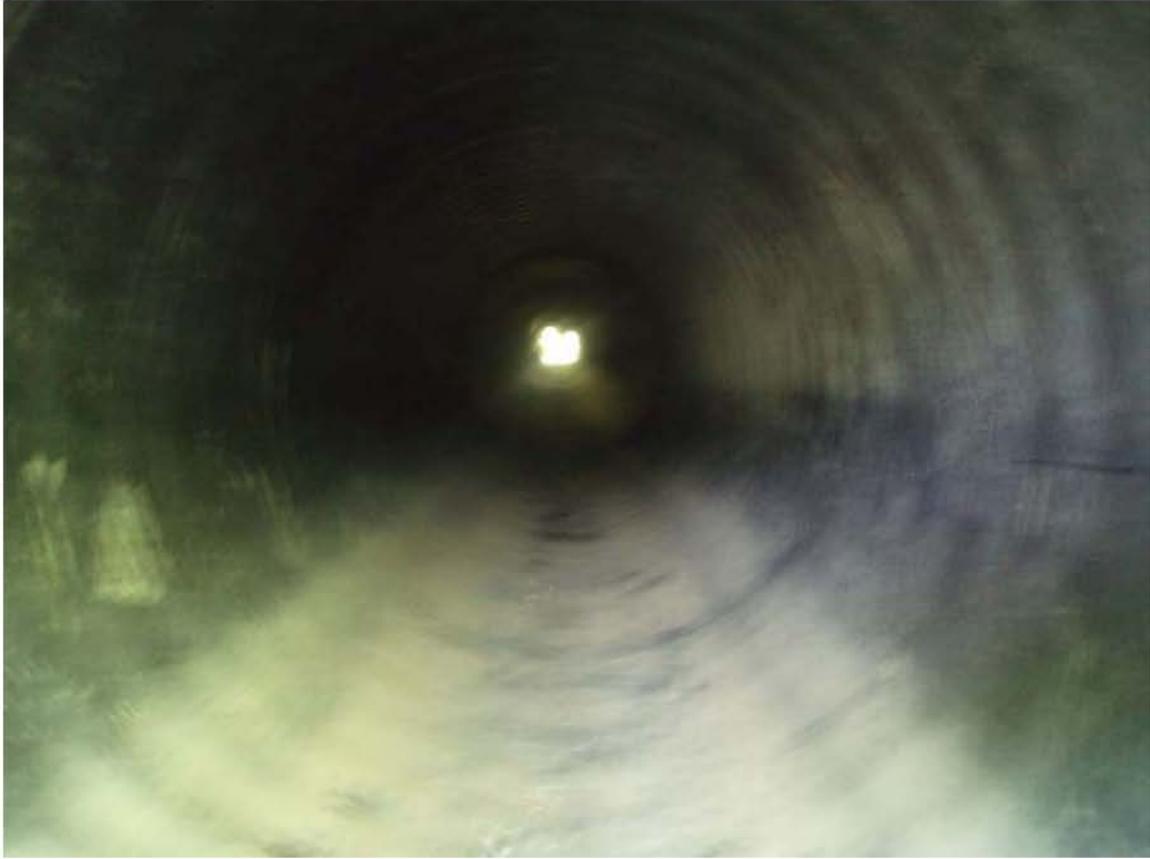
8-2-07, s-048, 30", 1161+45

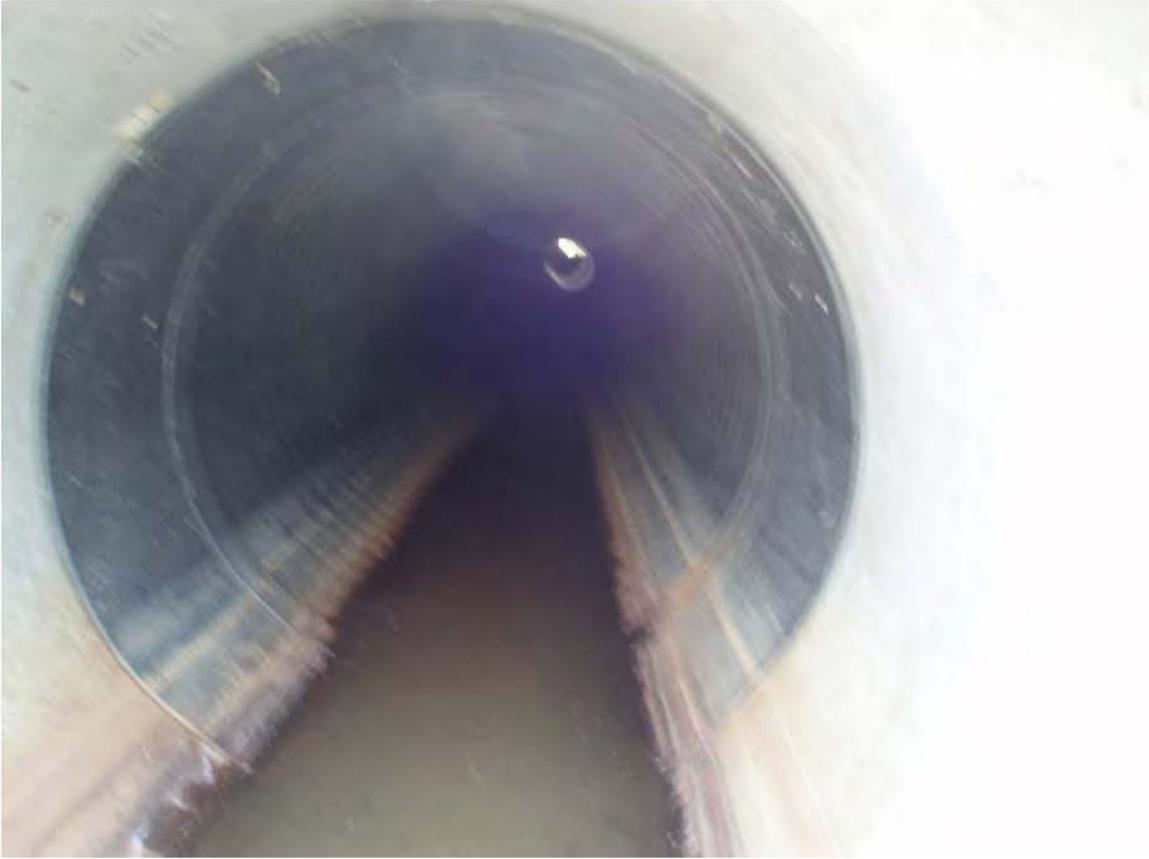
8-2-07, s-050, 15" 1176+00

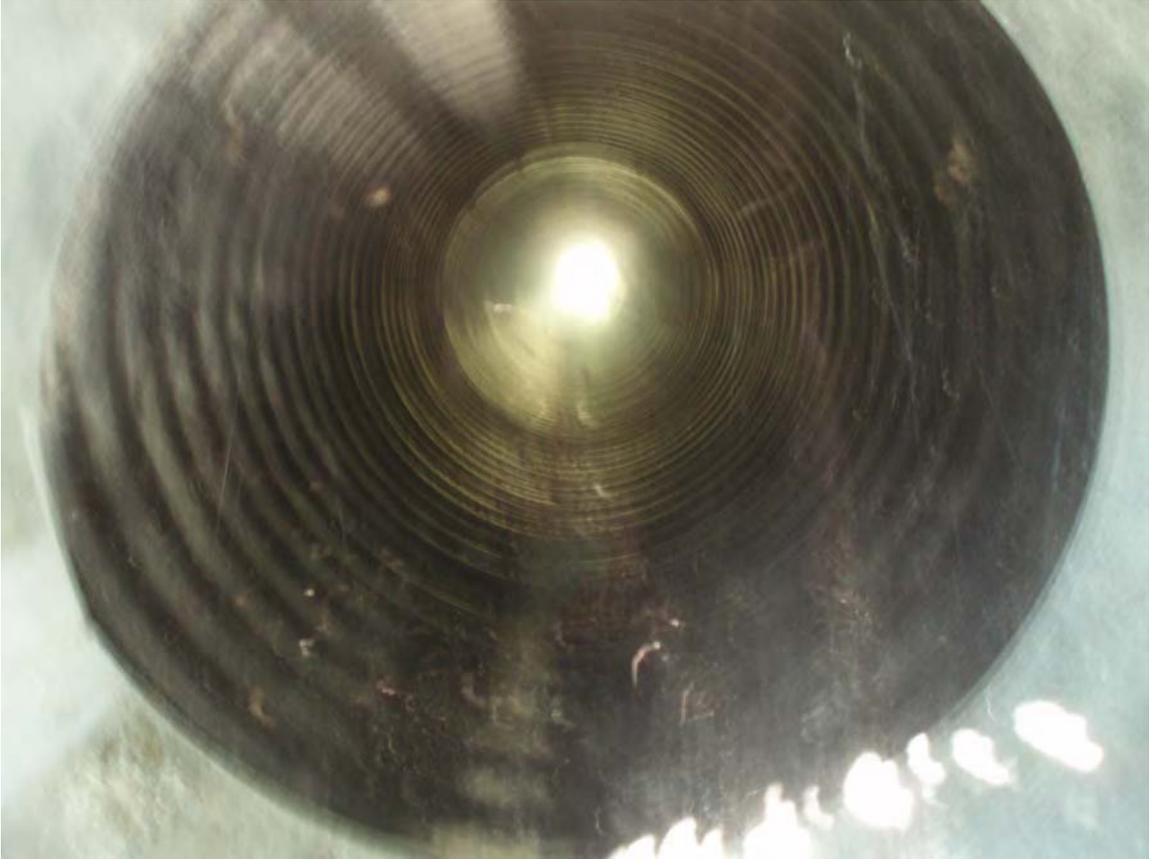
8-2-07, s-051A, 42", 1181+24

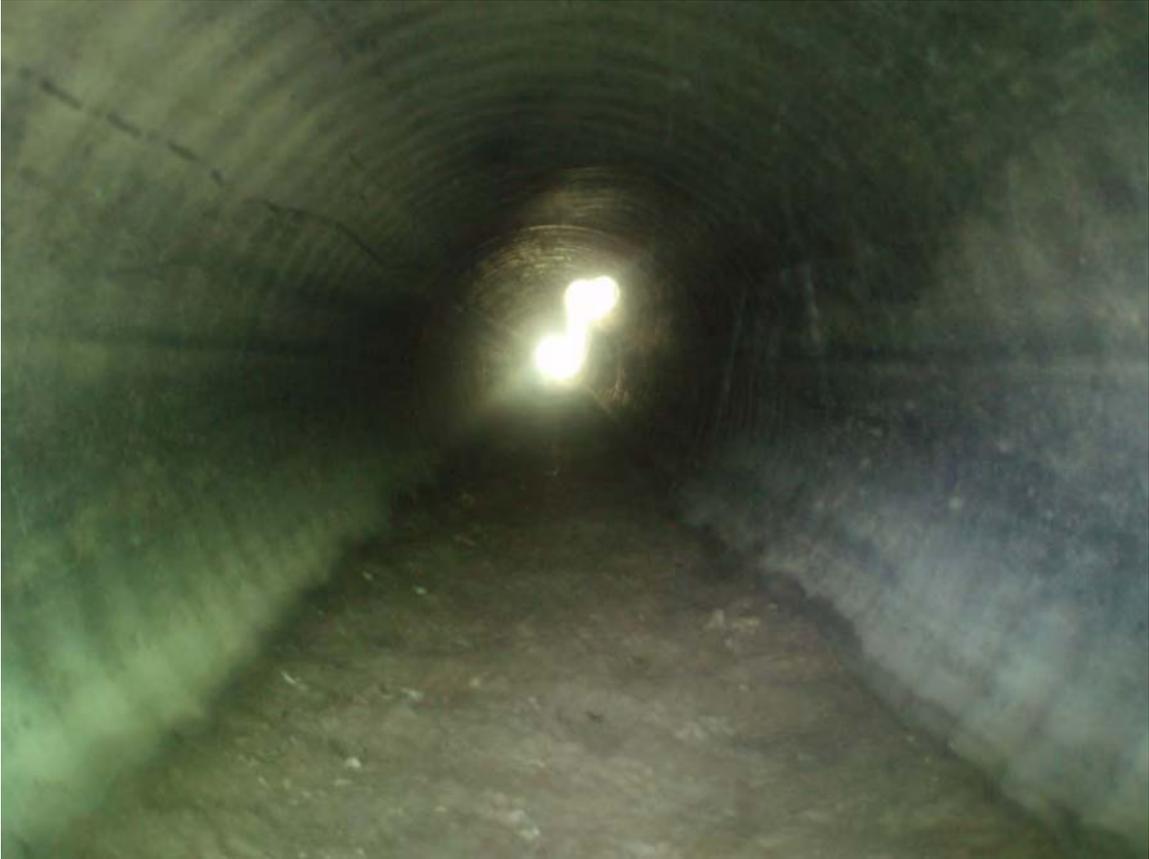
8-2-07, s-053, 18", 1193+00

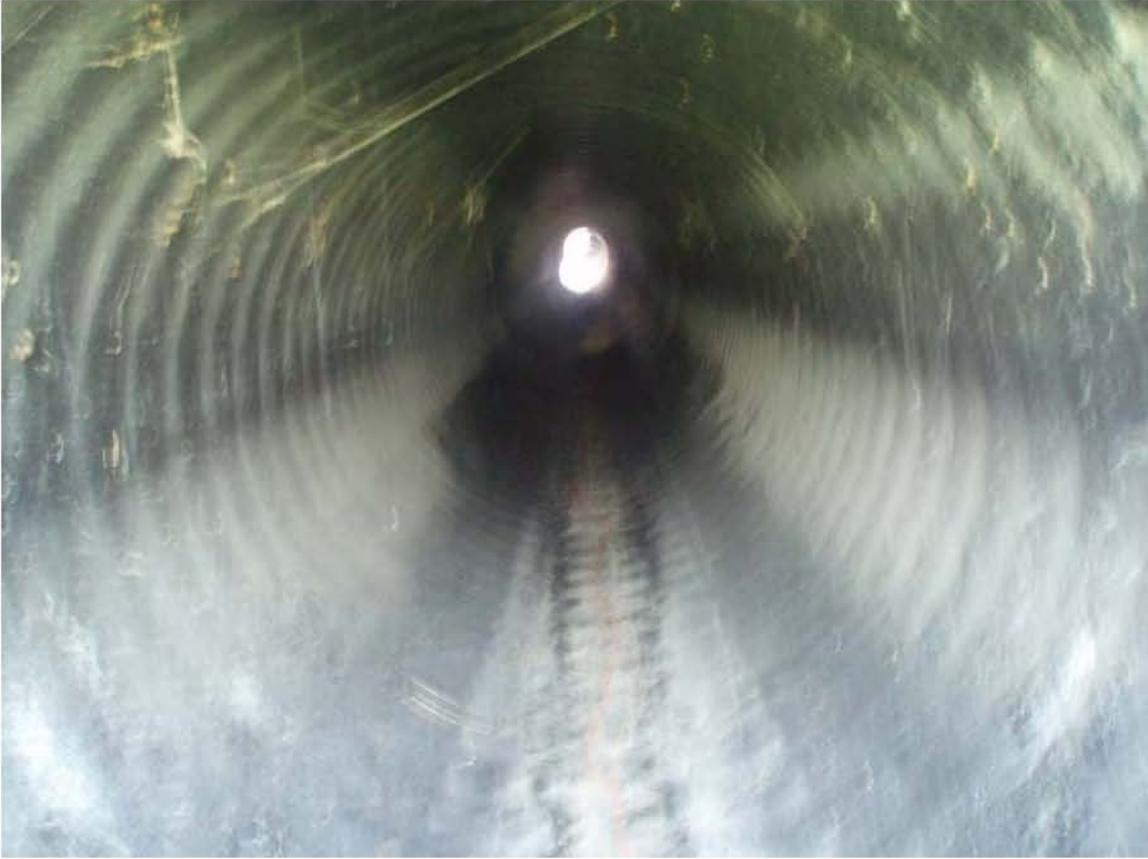
8-2-07, s-054, 18", 1201+00

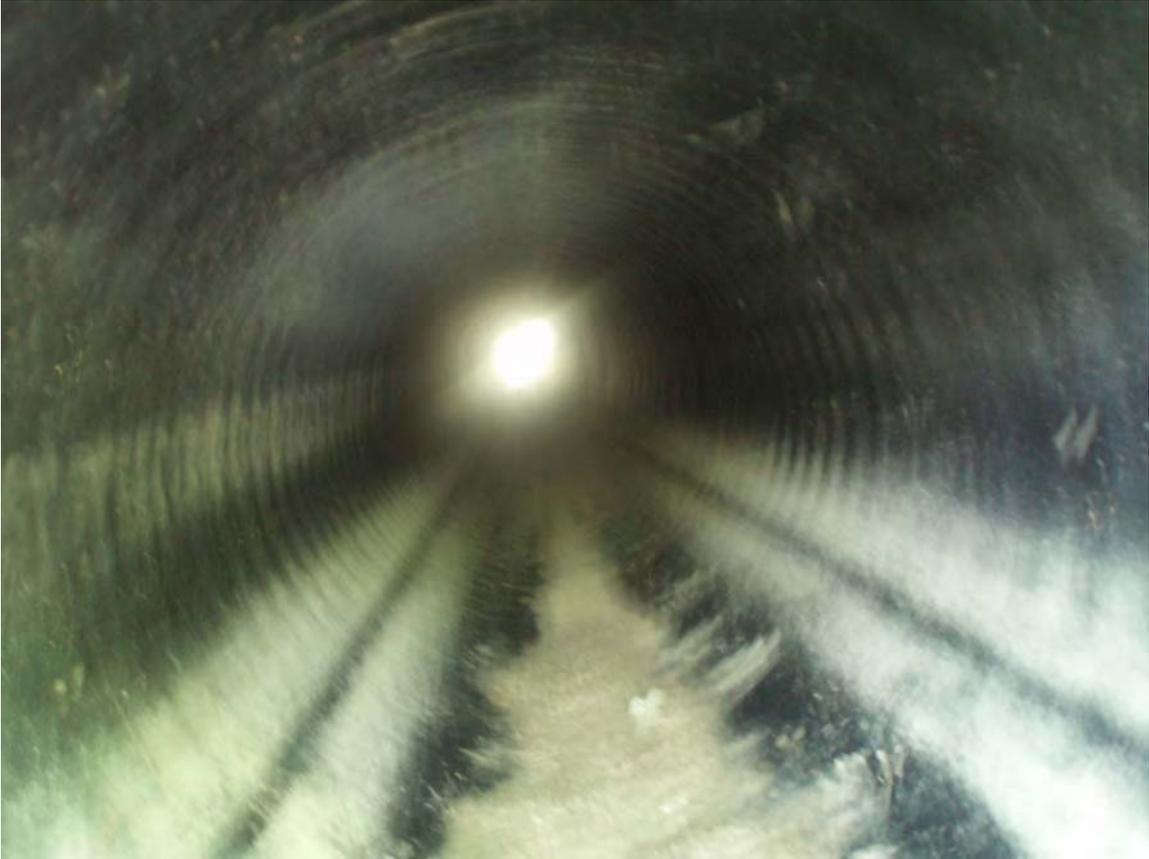
8-2-07, s-055, 36", 1207+81,

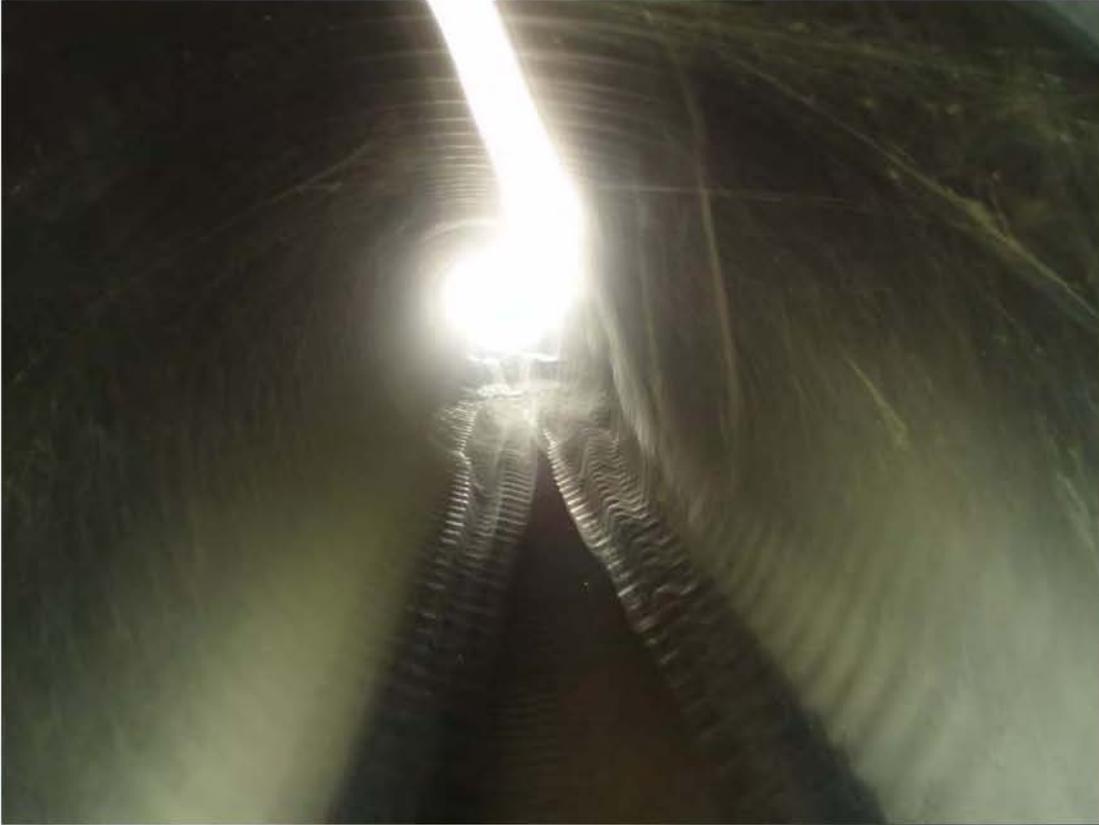
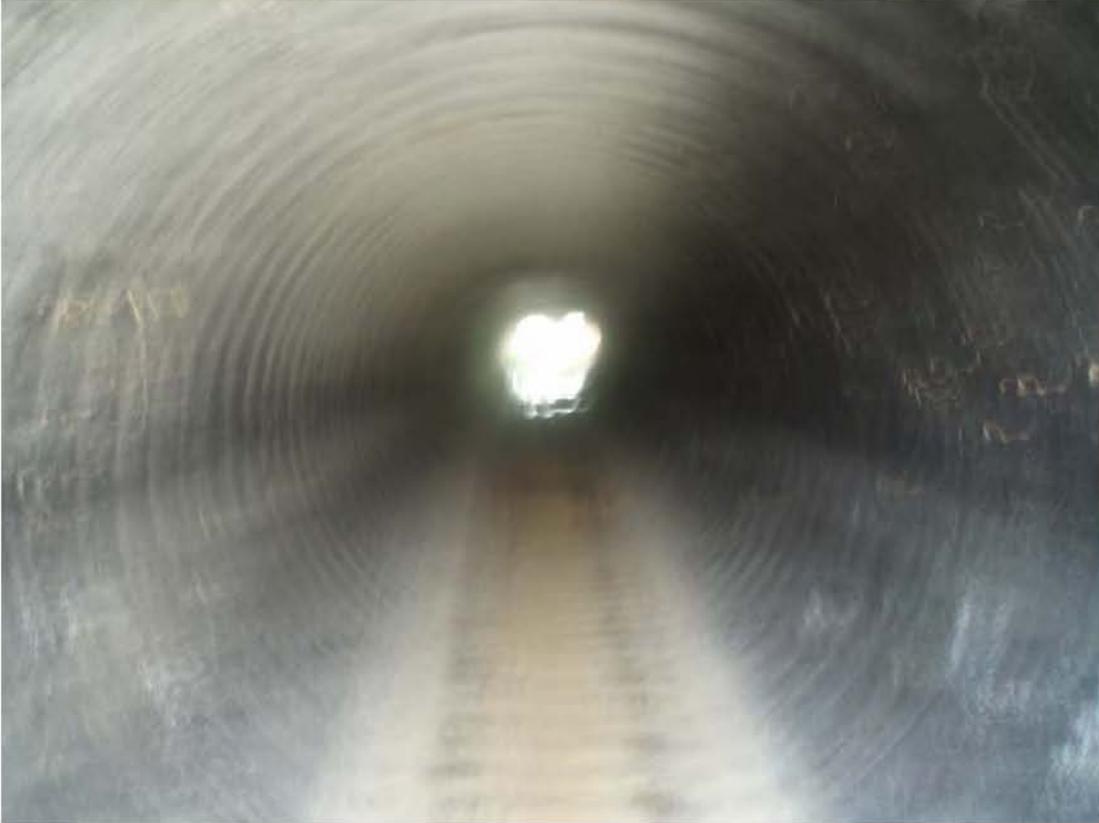
8-2-07, s-056, 18", 1220+00

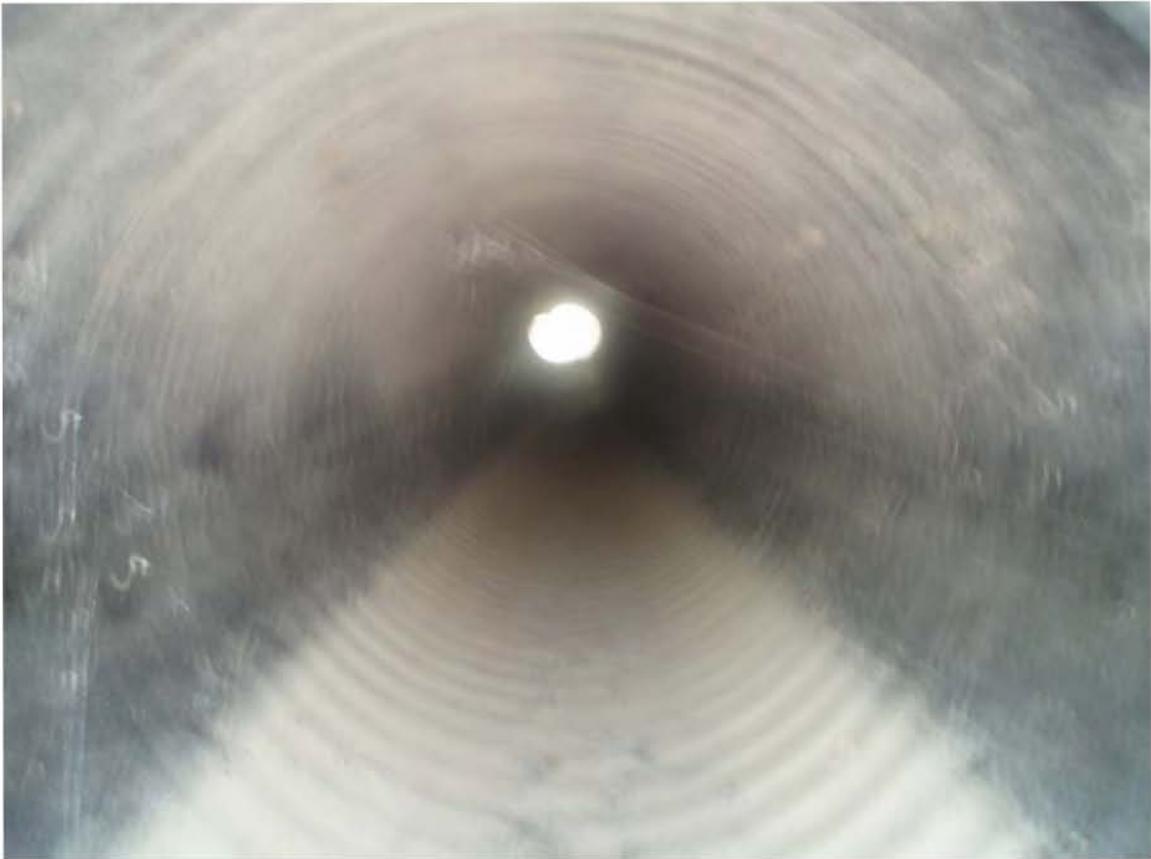
8-2-07, s-057, 42", 1224+89

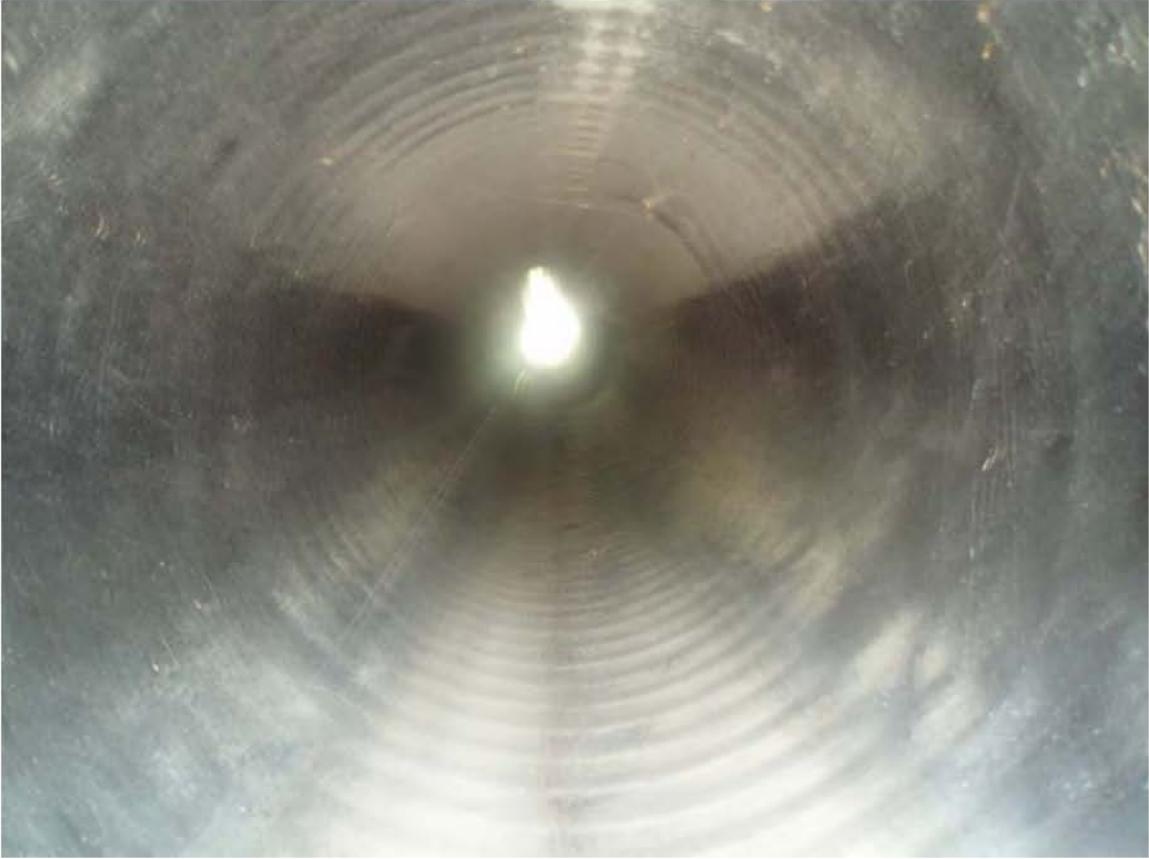
8-2-07, s-057A, 24", 1224+72

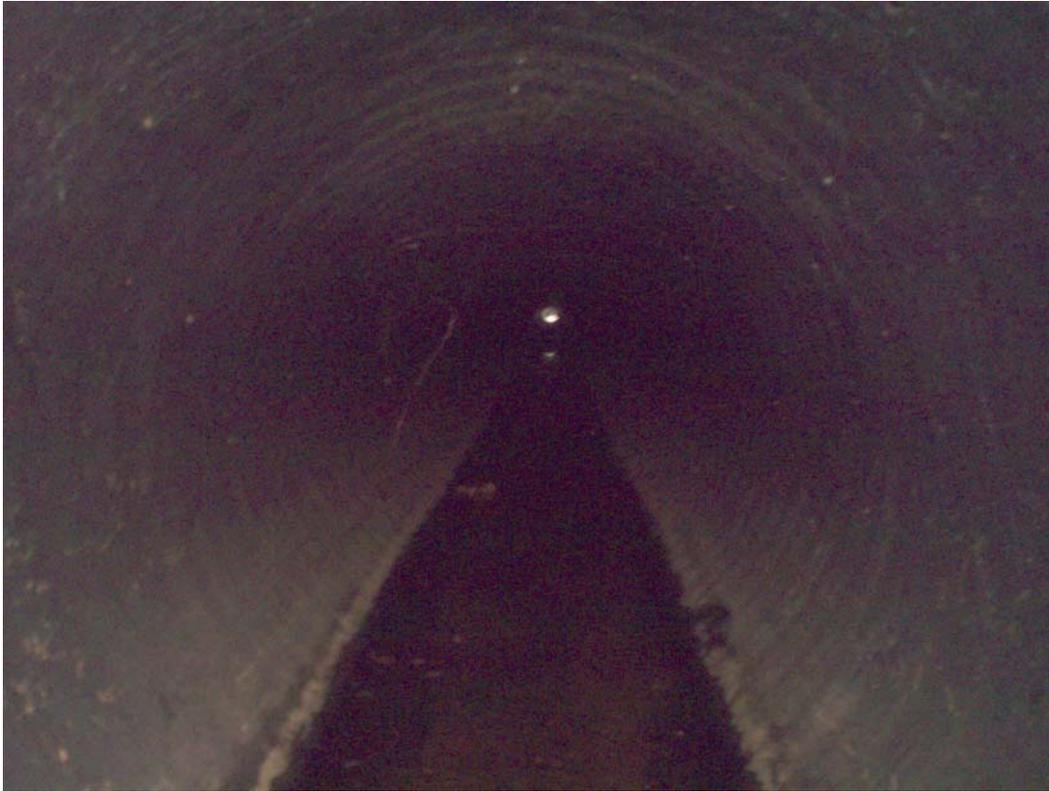
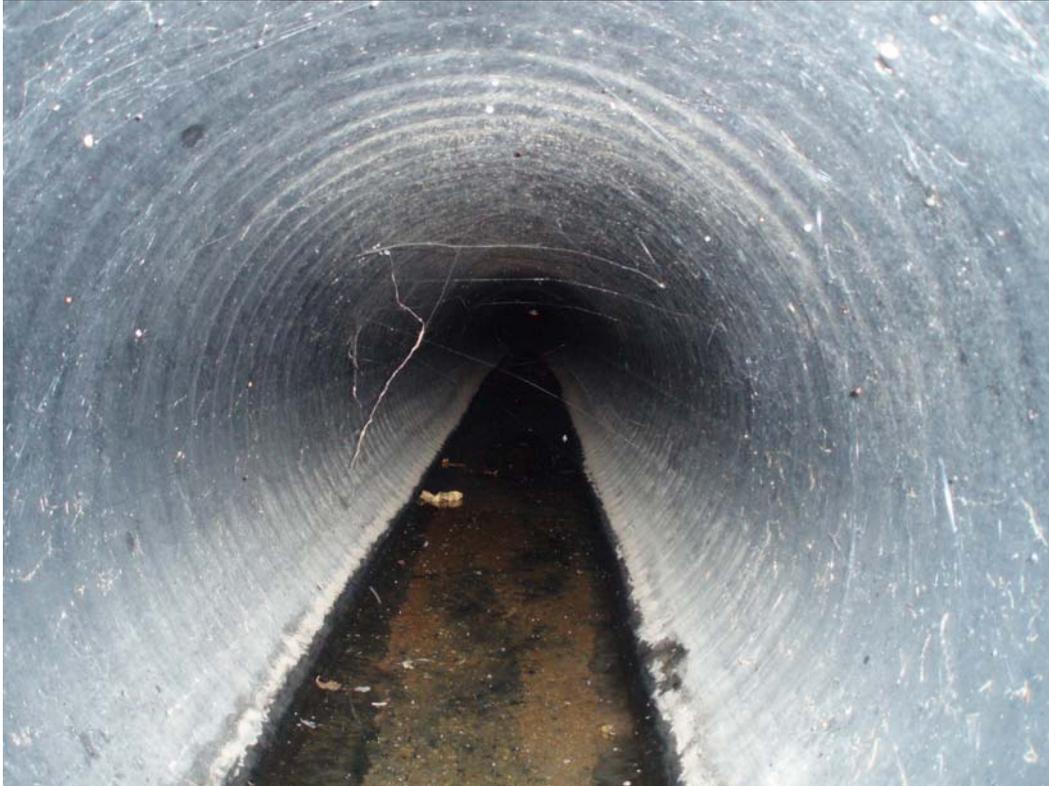
8-6-07, 24" NB & 30" SB, Sta. 1319+36. Put Mandrel through NB pipe – OK,

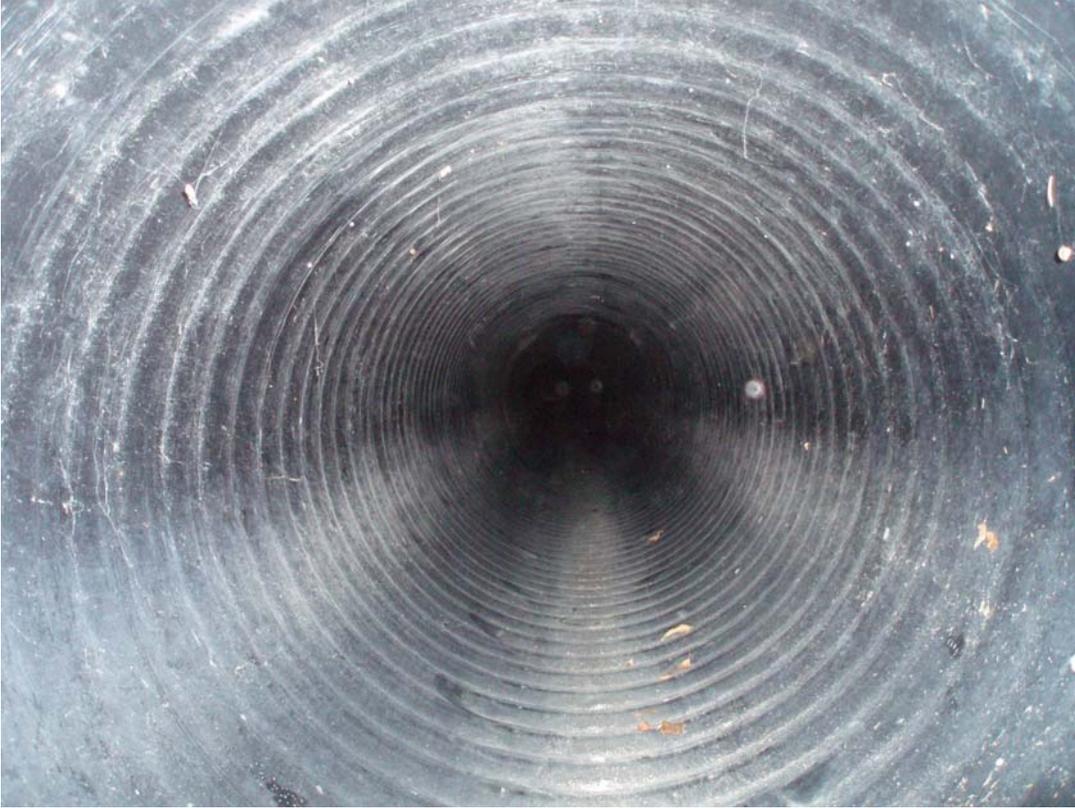
8-6-07, 30" NB & 30" SB, Sta. 1323+25. crawled through all 30" pipe – OK,

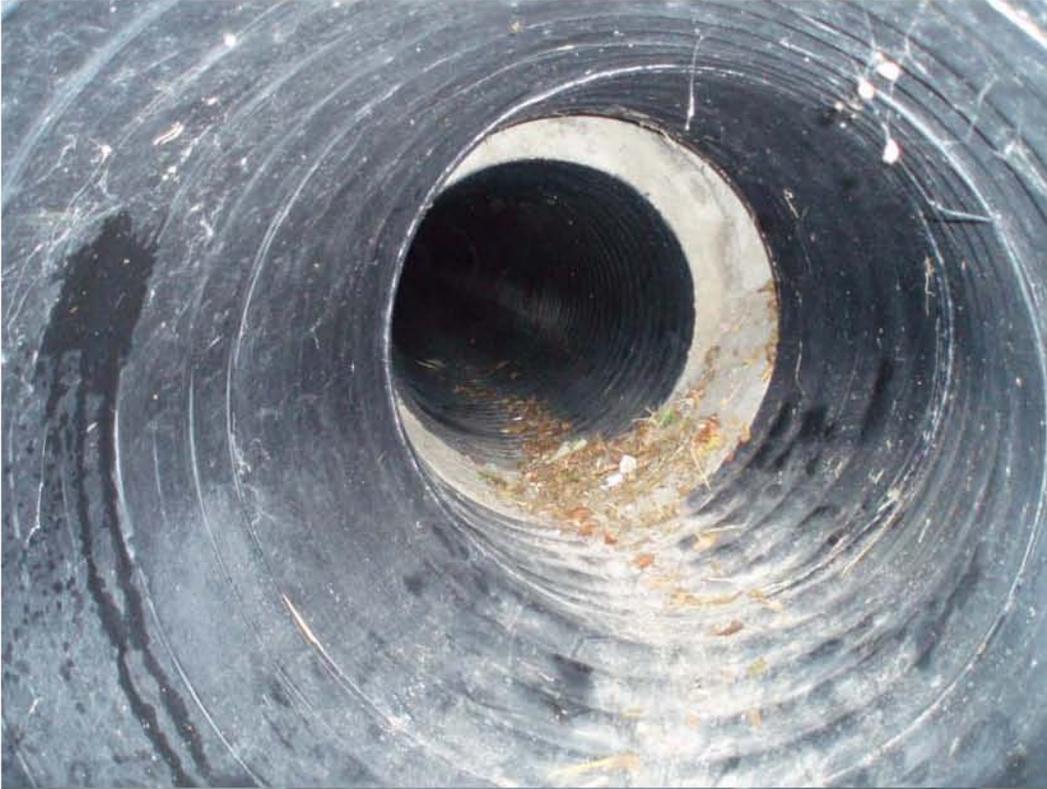
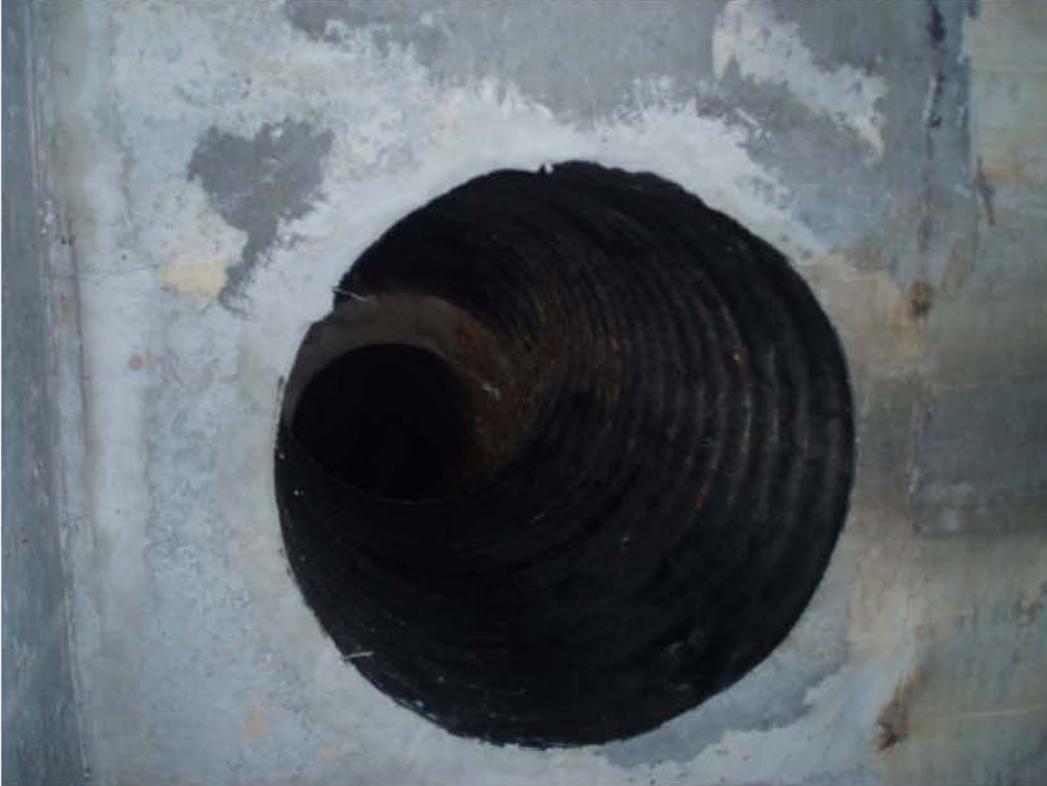
8-6-07, 30" NB, Sta. 1324+83, 1<sup>st</sup> outlet is into a Mod. Type D D.I., there is an elbow coming out of to the S. and 5' - 30" HDPE coming out of N. wall of a 6' x6' box culvert. box culvert.

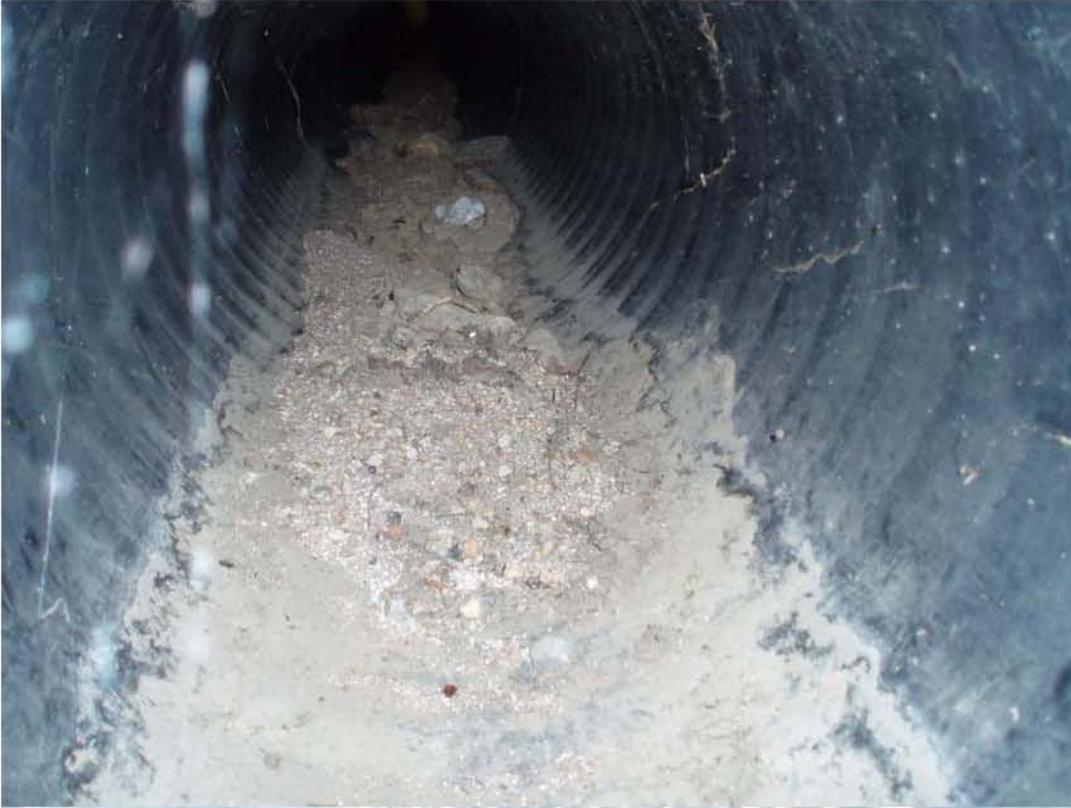
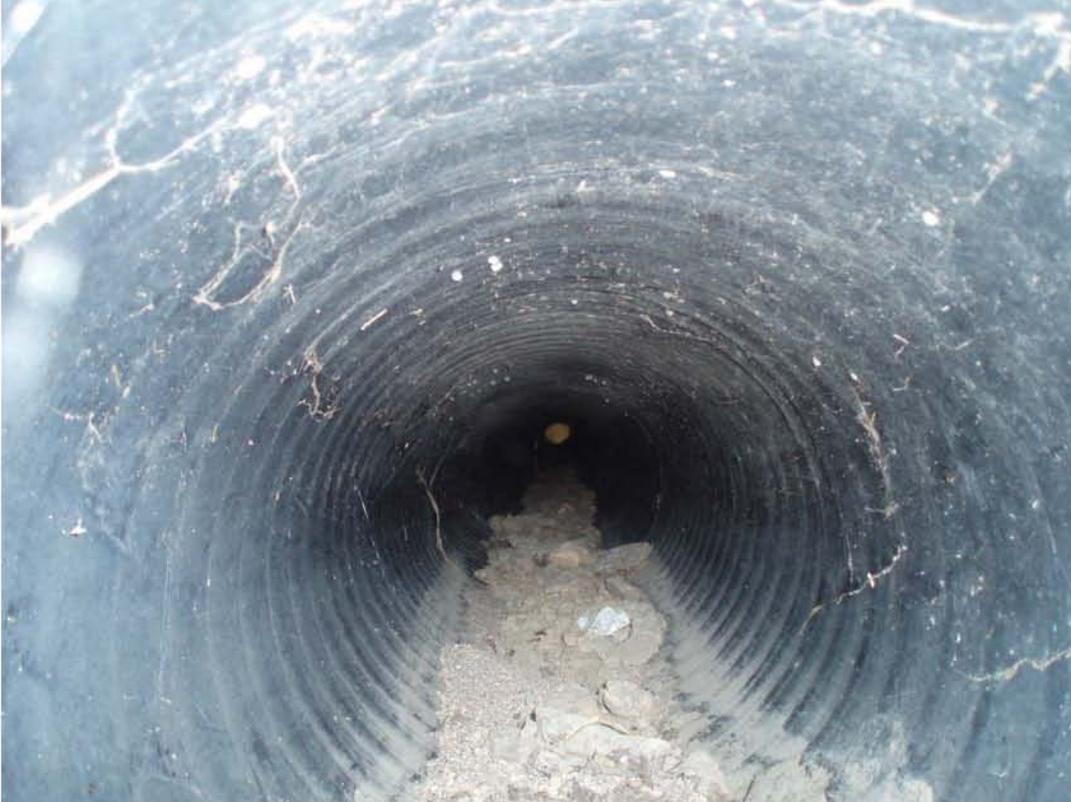
8-6-07, 15" NB & 15" SB, Sta. 1345+60, pipe looked good but a lot of debris.

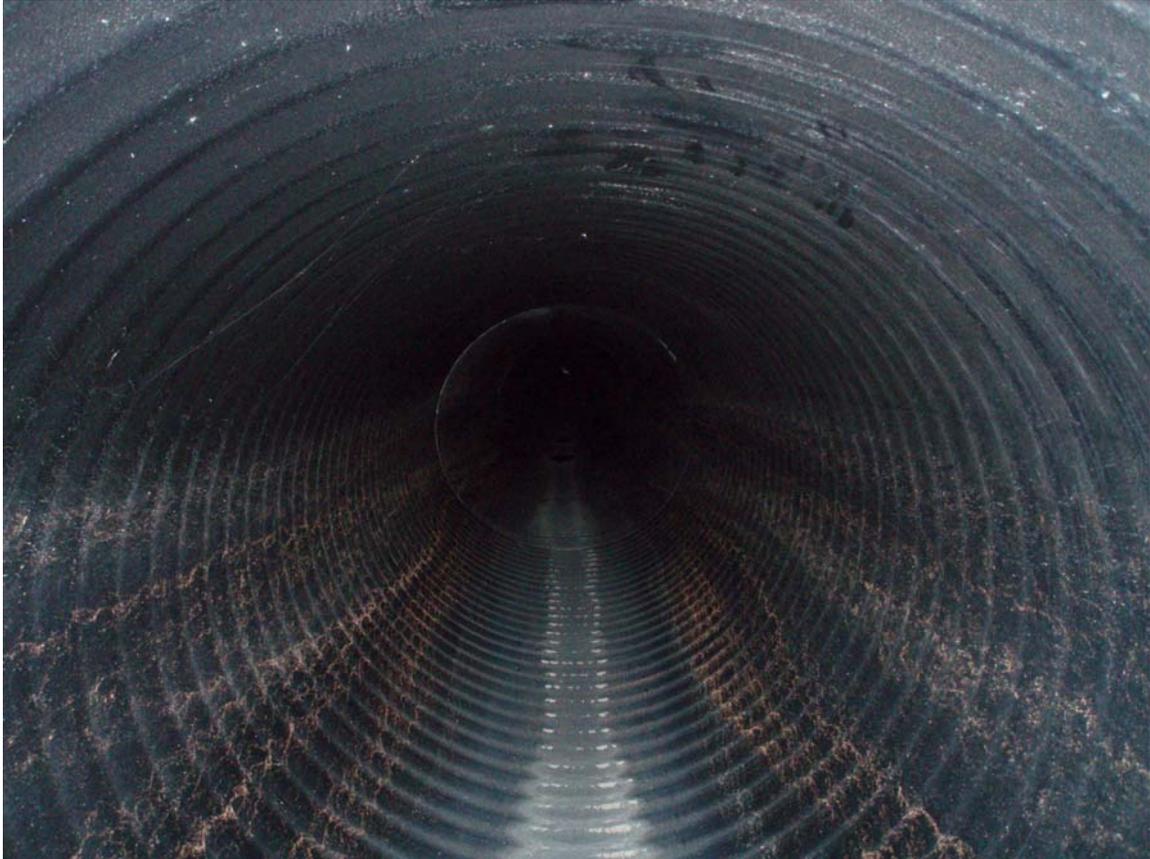
8-7-07, 18"NB & 12"SB, Sta. 1335+75, debris in invert both directions. Tried to video 12" only went up 10', 18" (pictured) sent video up 100'±.

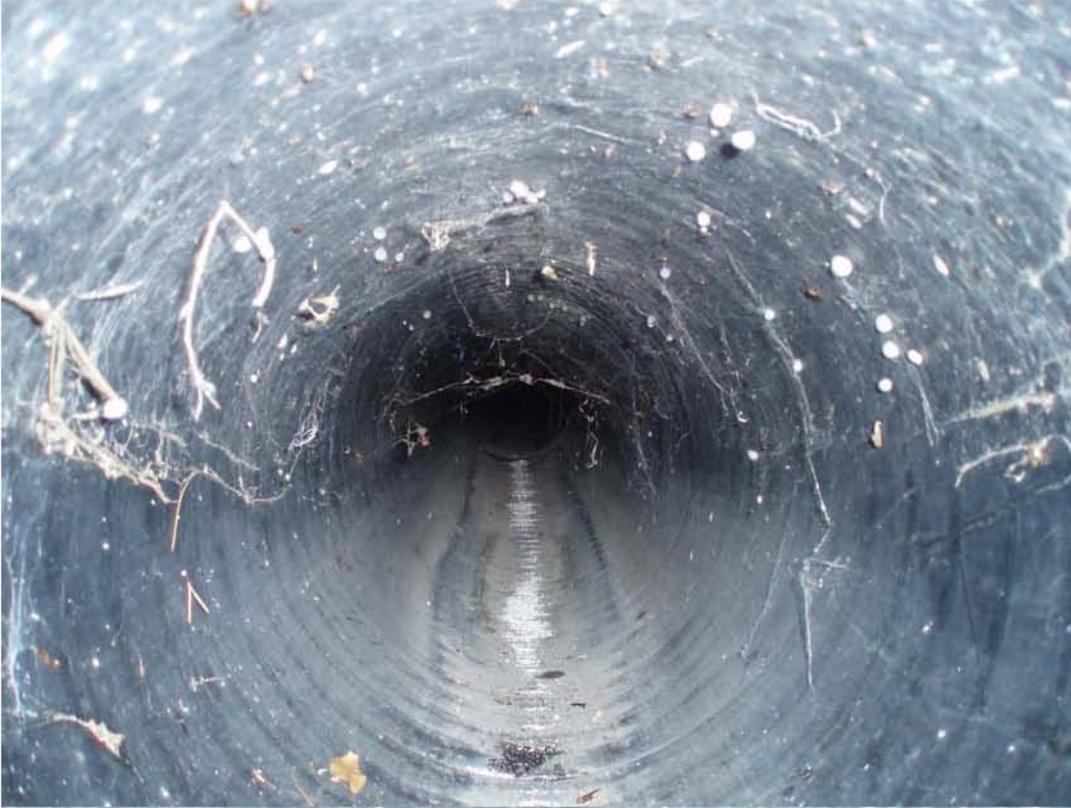
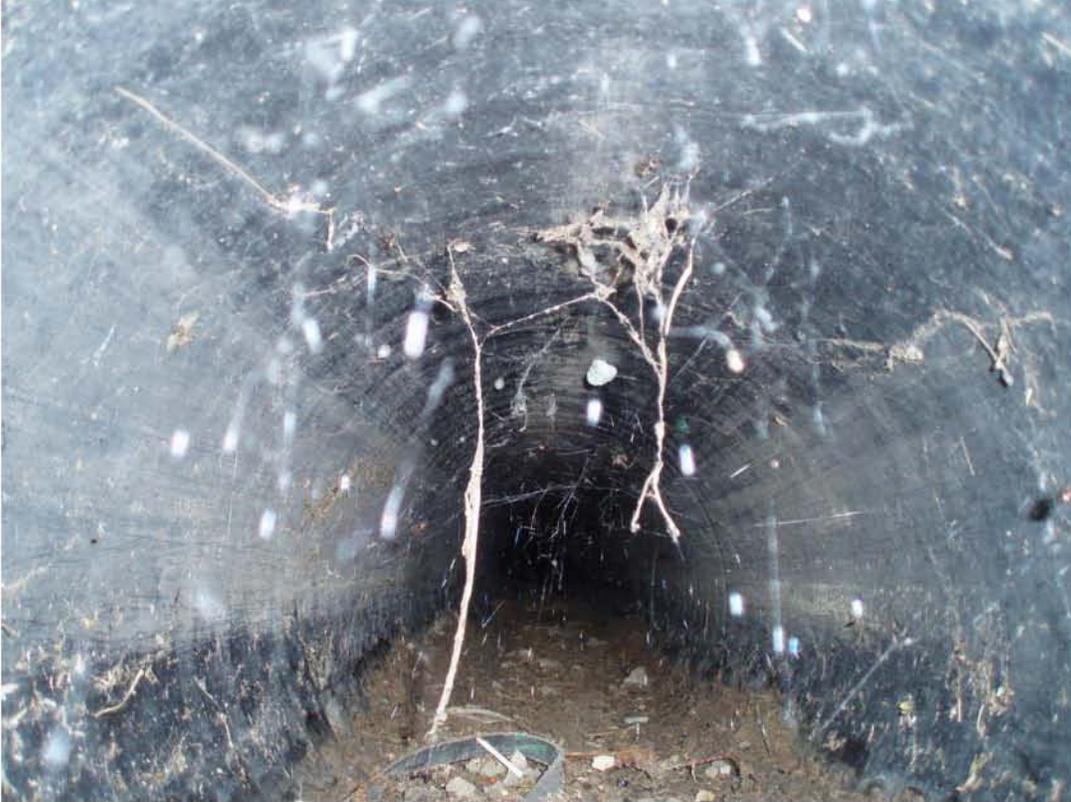
8-7-07, 15" NB & 12" SB, Sta. 1336+50, couldn't video 12" - 2'-3" debris in invert.
