Macon and Adair County, Route 63, Job J2P0485

Route 63, Howell Co., project J9P0497, HDPE double wall storm sewer, W. Side Rt.63

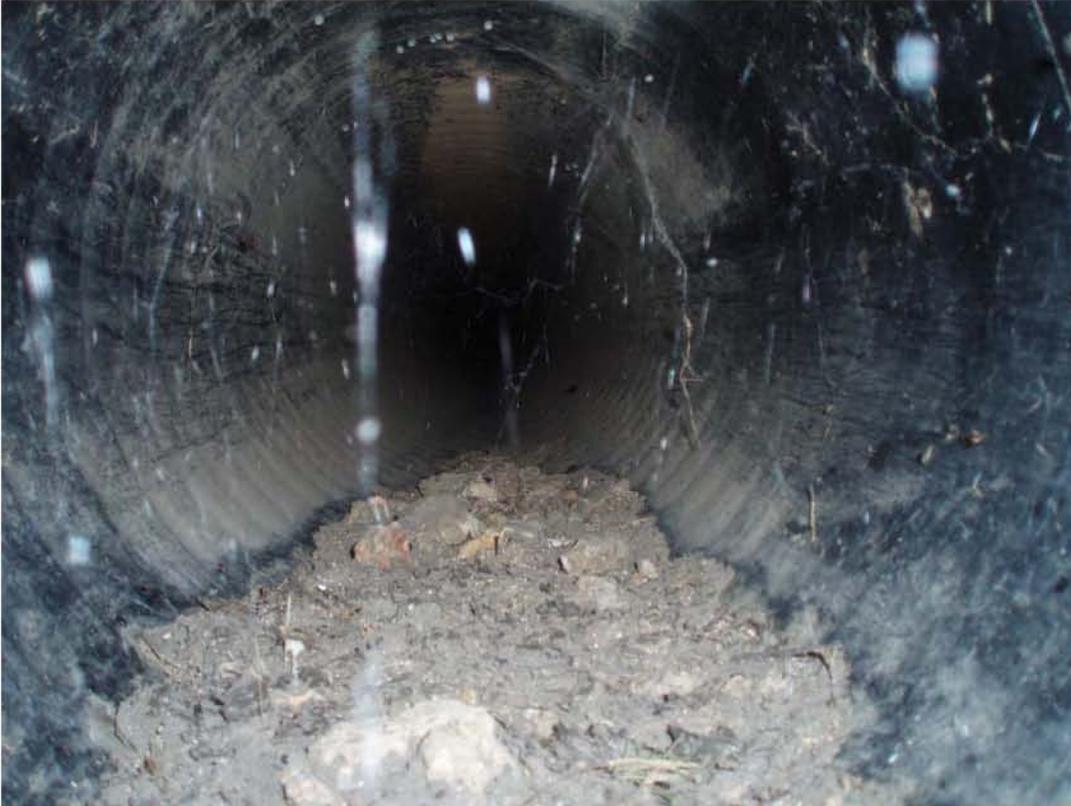
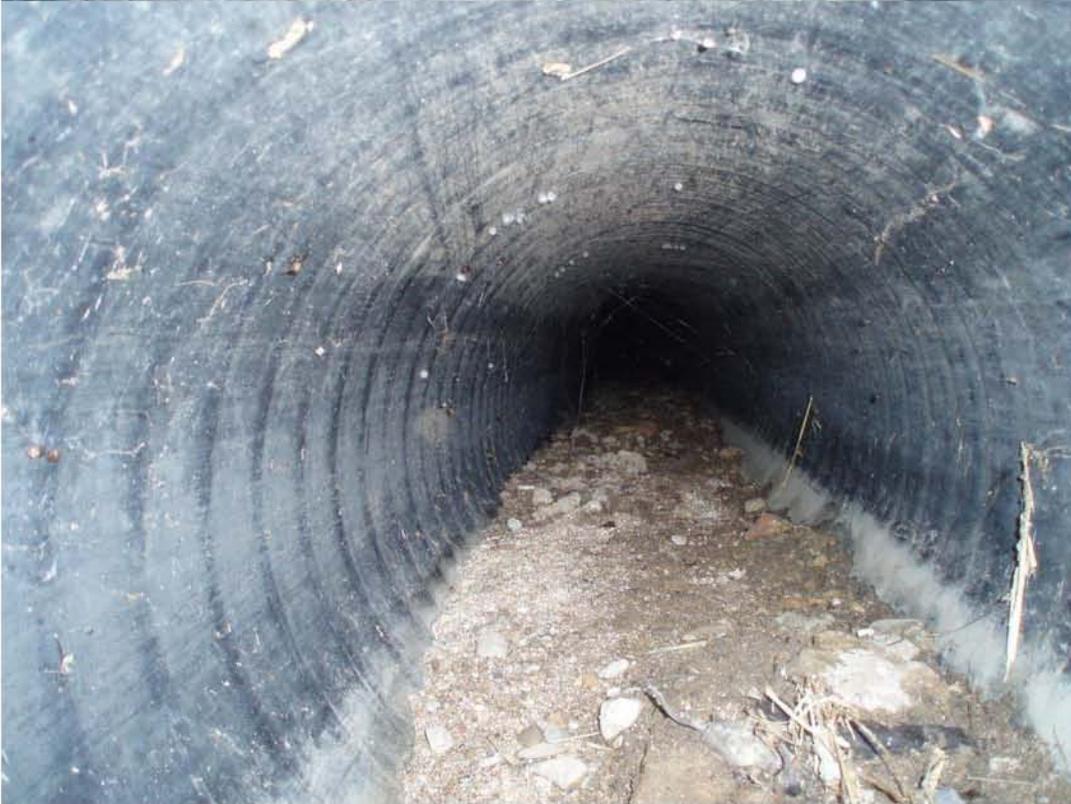
8-7-07, 18"NB & 15" SB, Sta. 1333+50, Deflection appears OK – debris both ways.

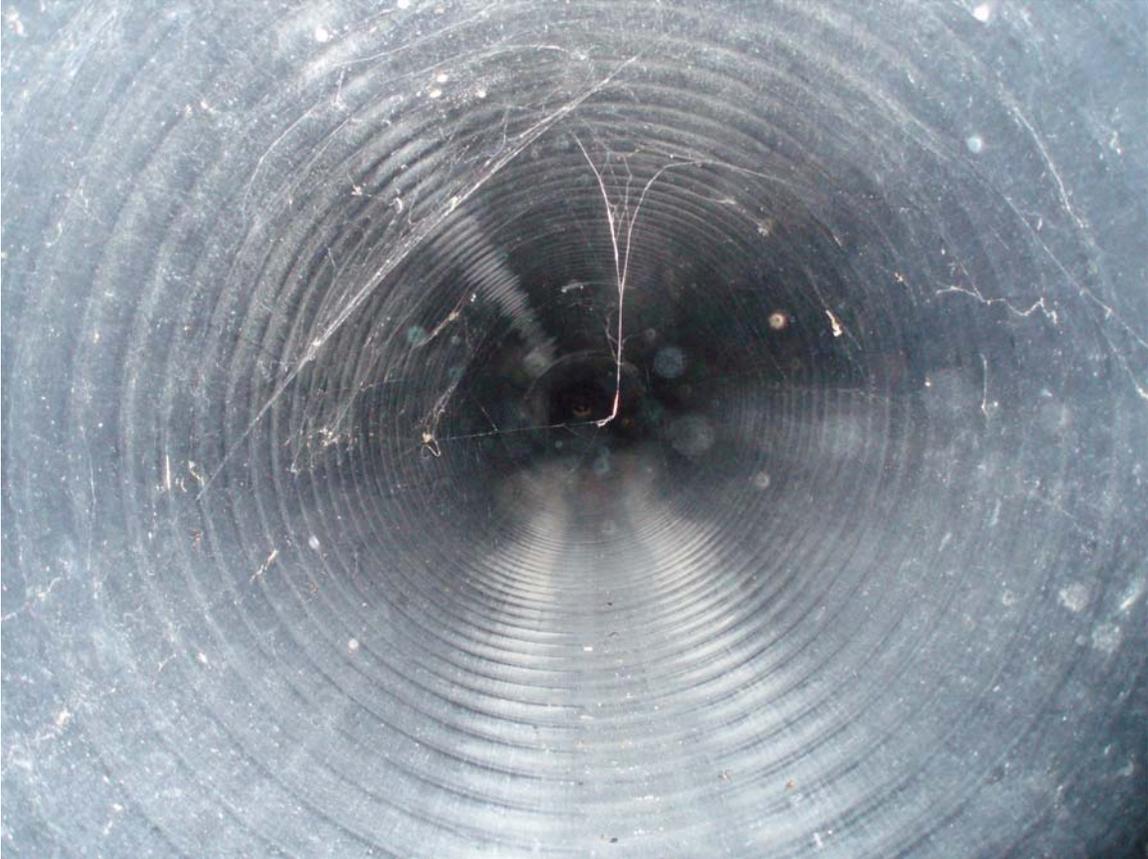
8-7-07, 24", Sta. 1323+75 to 1325+25 Lt., looks good runs into 6'x6' box culvert at north end, shown.

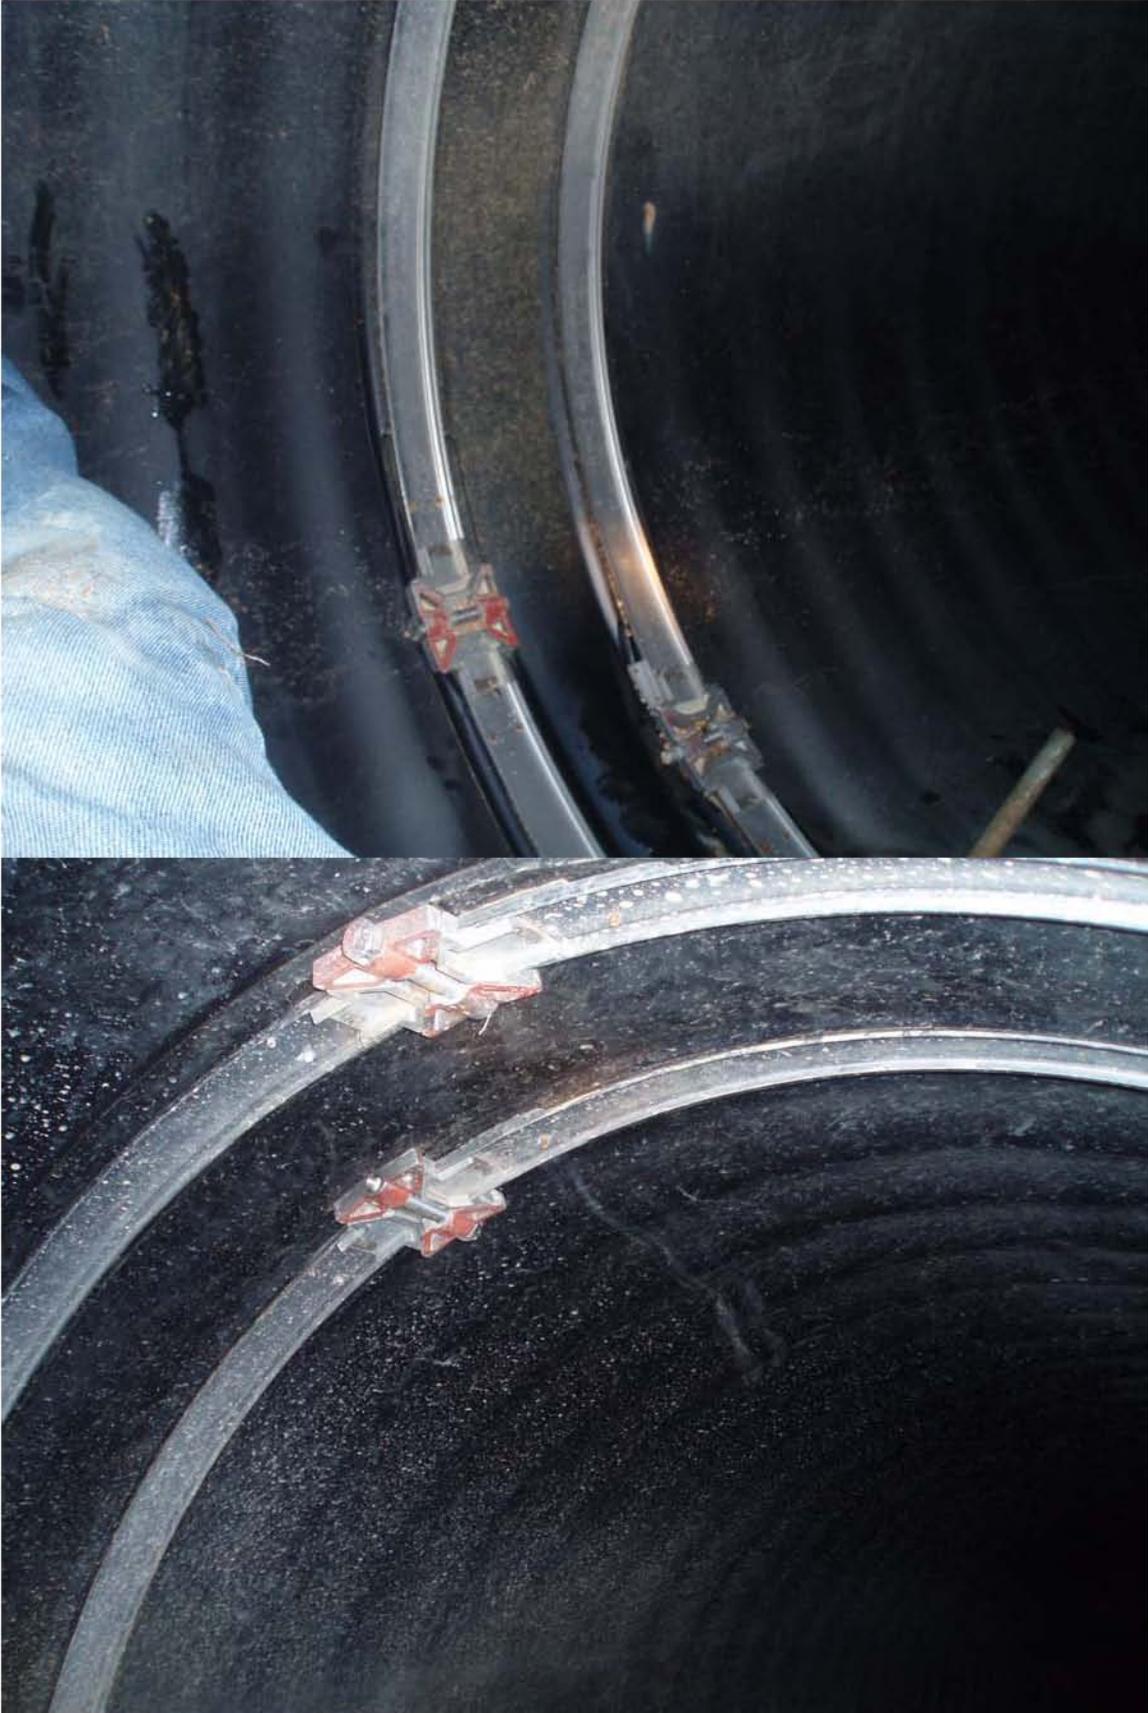
8-7-07, 48", Sta.1363+58 to 1348+00; just at 5% deflection in top photo at approx. Sta. 1360+50, 1" more than 5% (7.5%  $\pm$ ) at bottom @ Sta. 1361+30. NOTE: each 20' stick of pipe at >5% deflection to Sta. 1356+03, 400'+ of pipe out of specs.

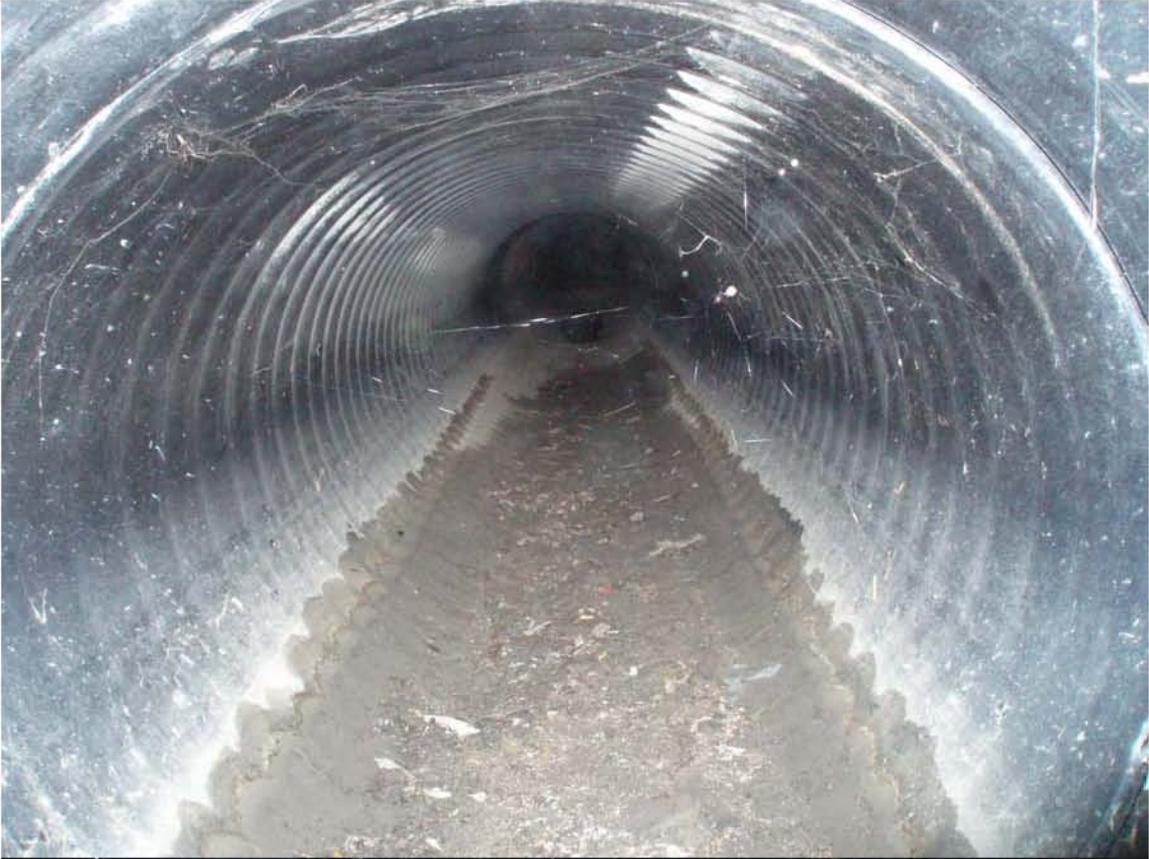
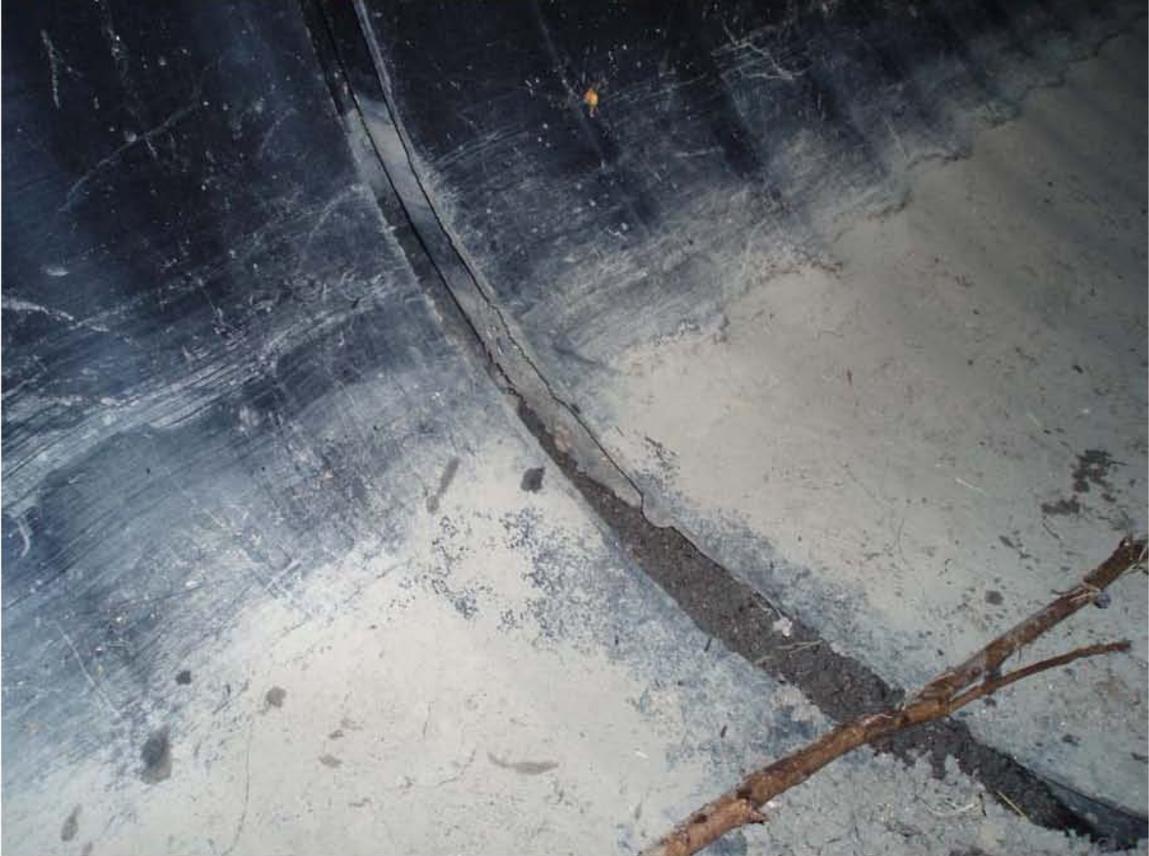
8-7-07, 36", NB & EB, Sta. 1340+48.45 to 4+31.81 Broadway St., ADS rep. & MoDOT technician both crawled through whole 444' run to look at 175' Radius section. Bottom 3 photos show welds on HDPE for 6 - 12° bends plus split couplings used. Everything still looks good.

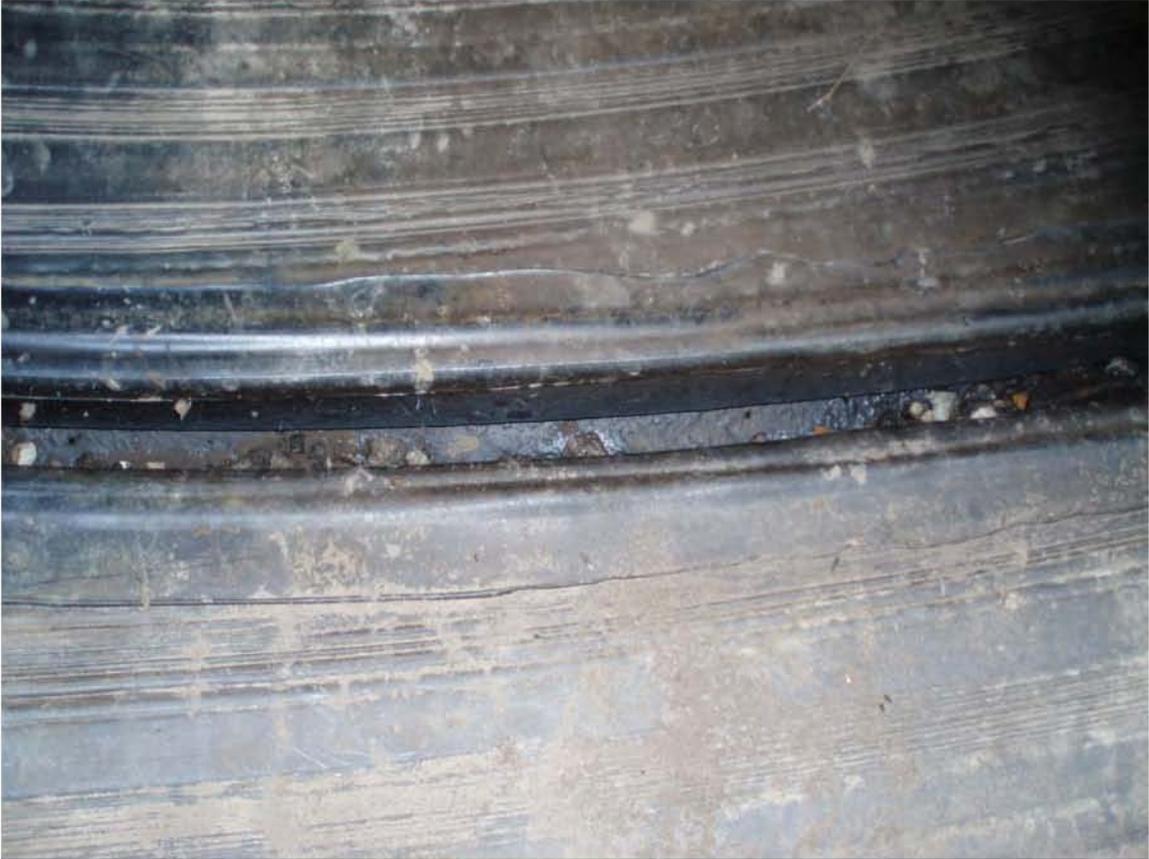
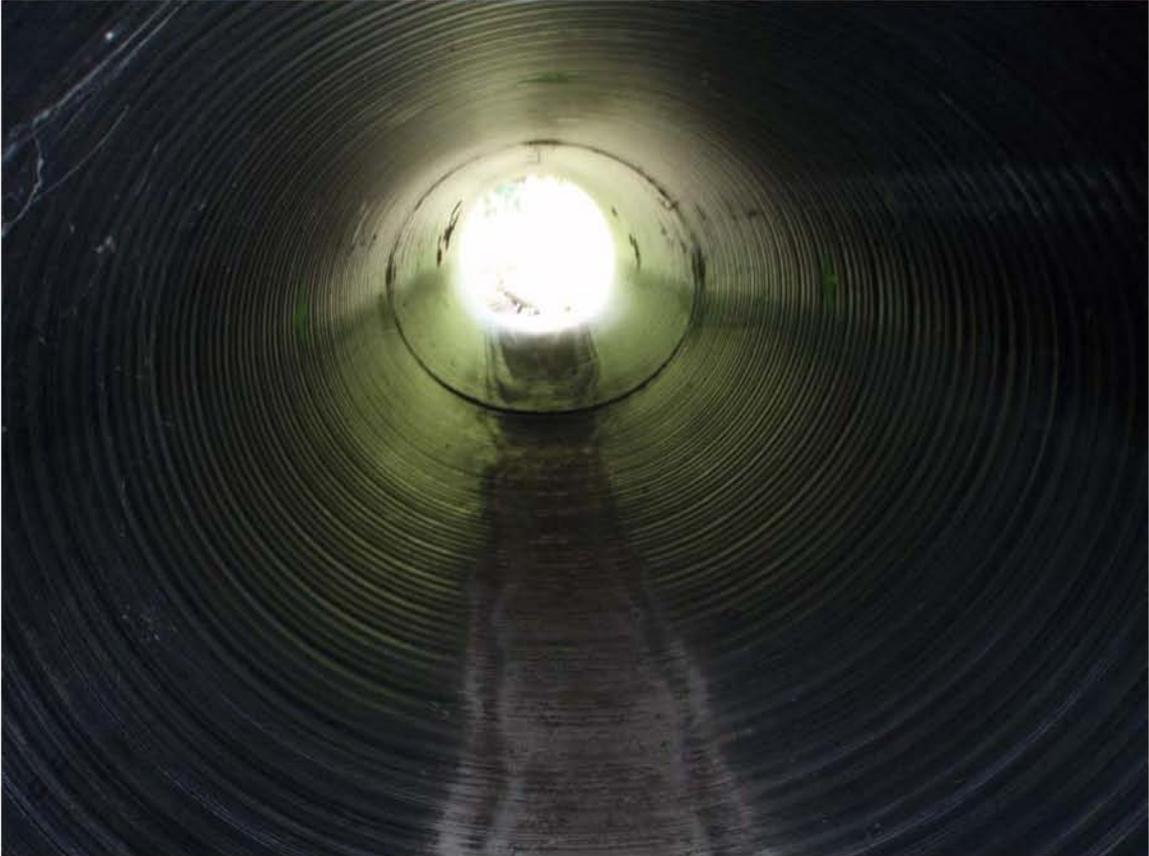
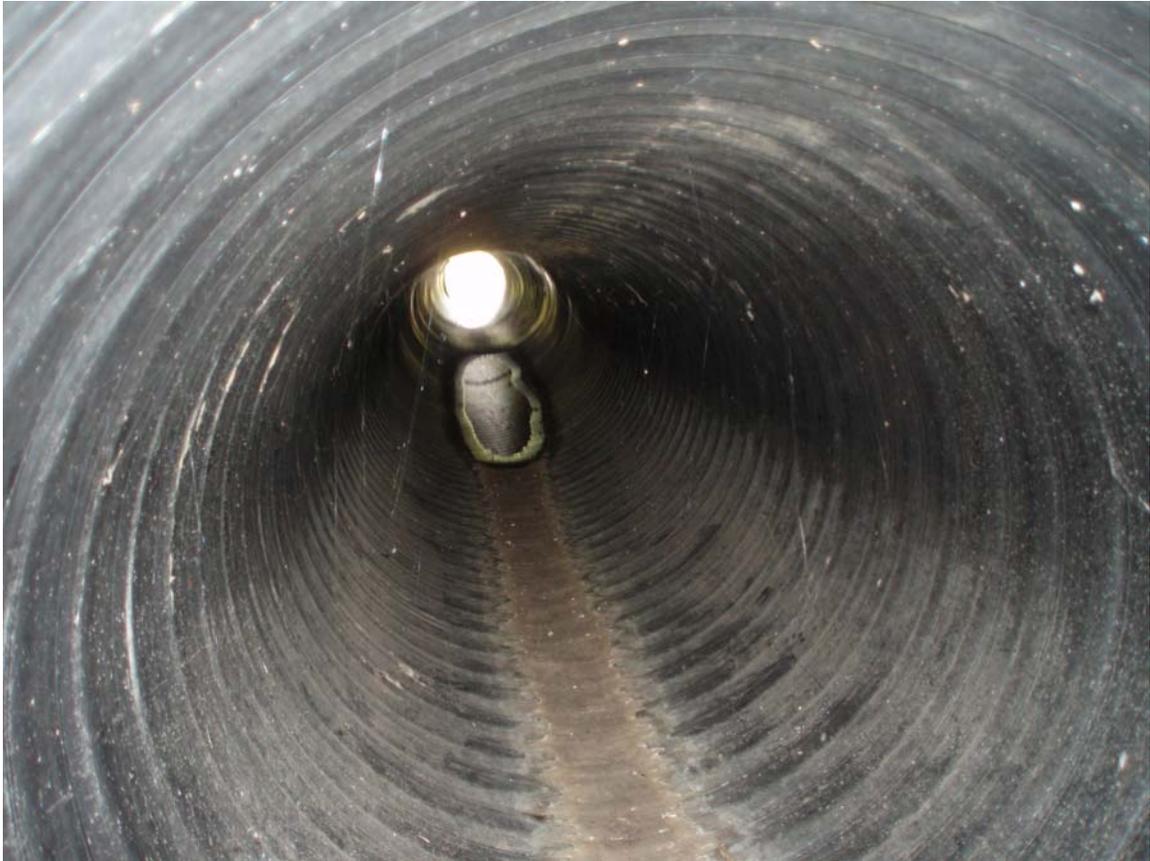
8-1-07, Rt. B 3.0 miles west of Rt. 13, 60" DWP (pipe measured 58.27" d. before installed)

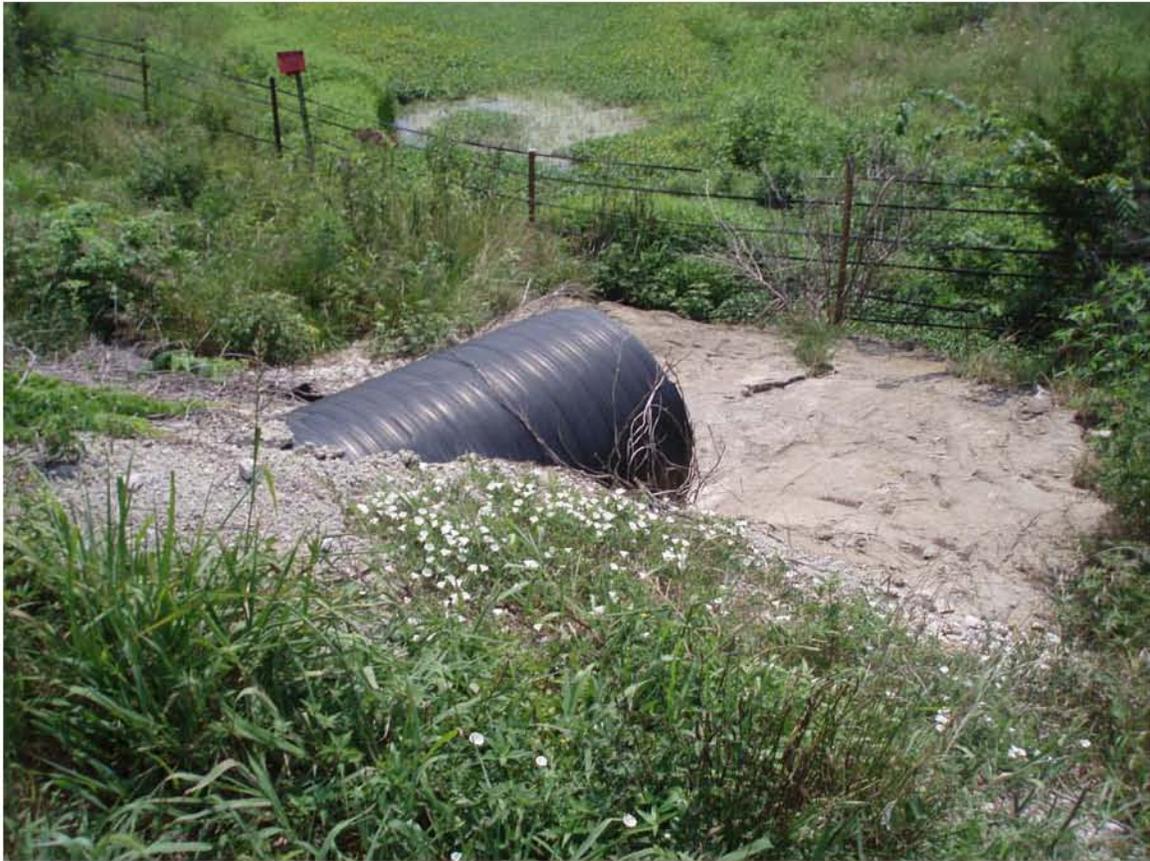
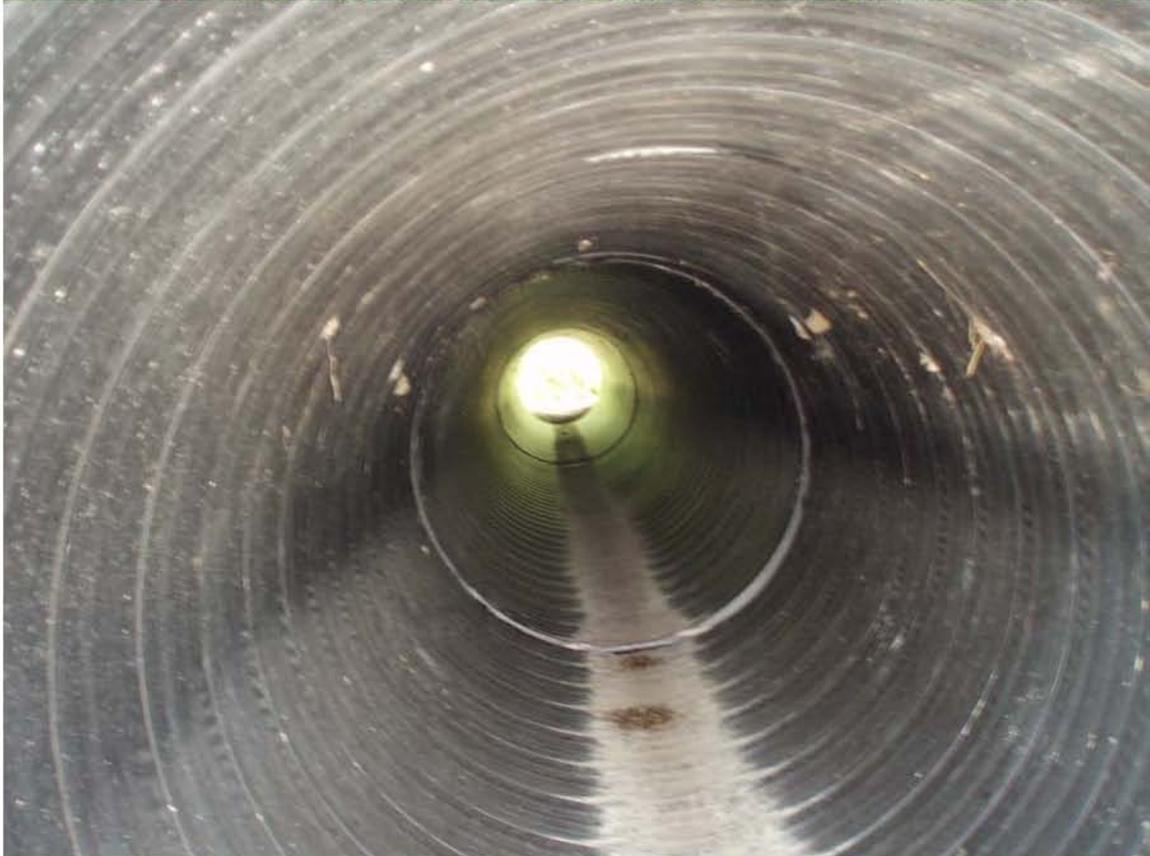
8-1-07, 1.5 m. E. of Rt. VV, 42", Pipe looks good. Couldn't get measurements.

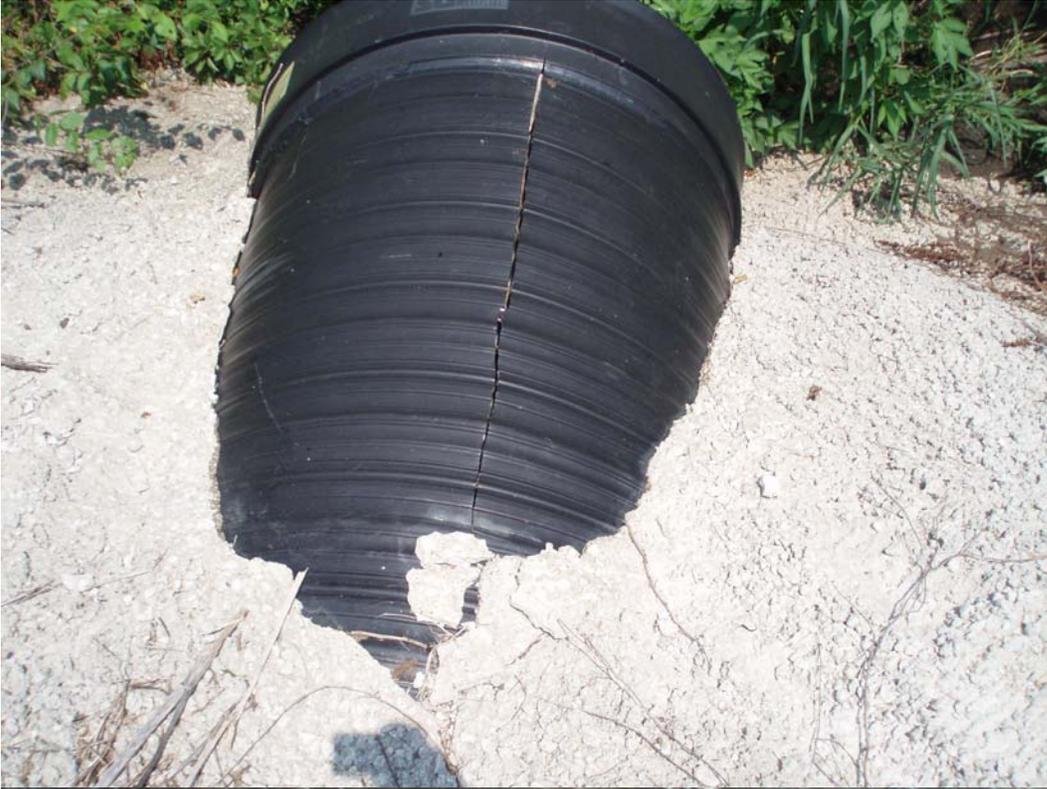
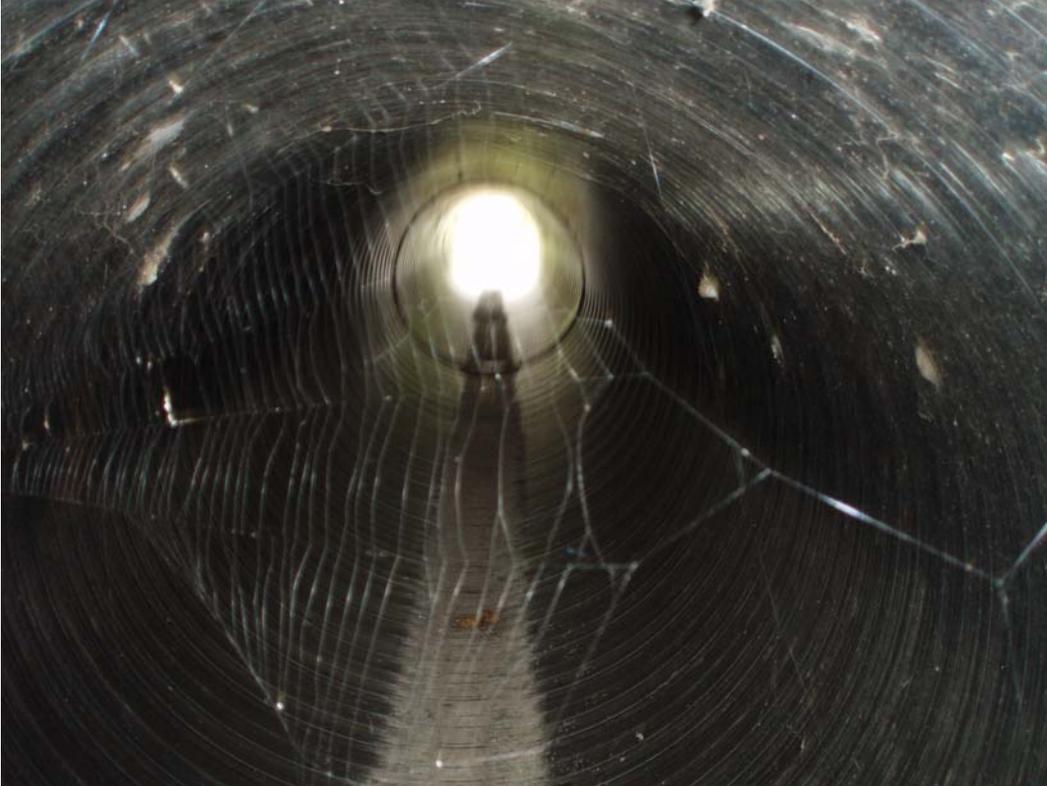
Rt. H 2.7 miles east of Rt. V V, 42" DWP, Pipe looks good. Couldn't get measurements. Pipe has split on the outside at the inlet

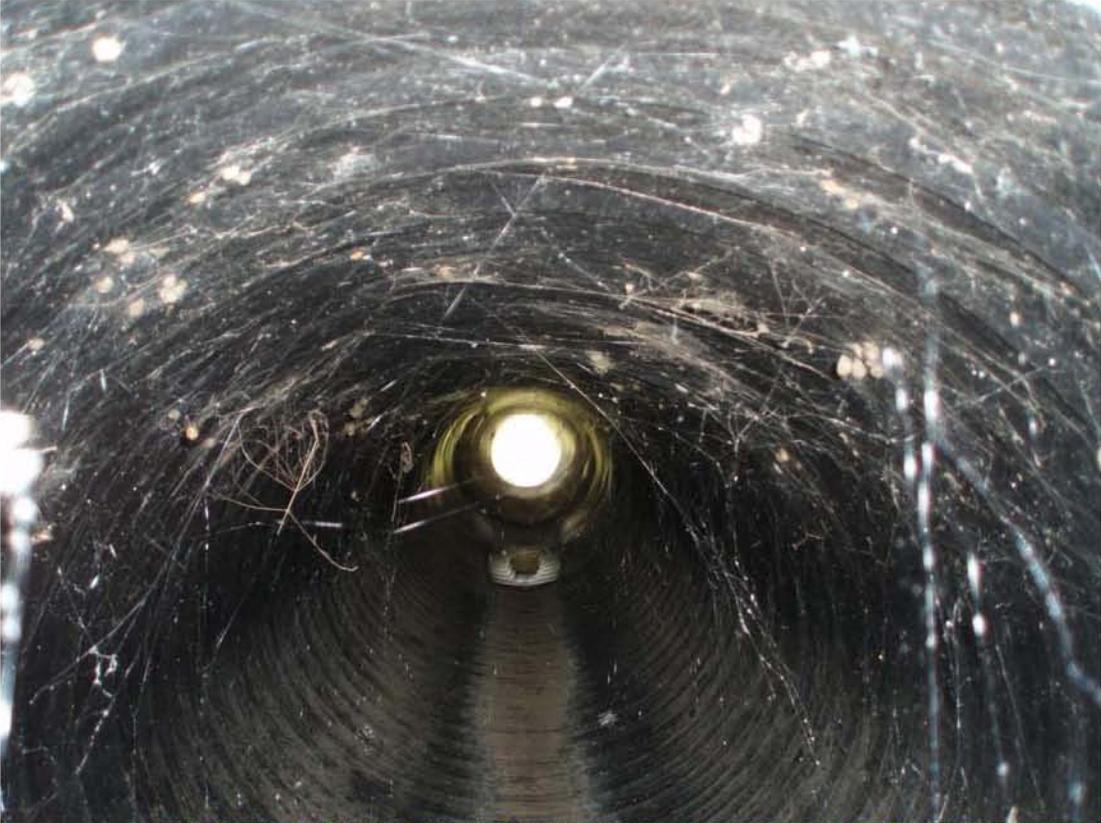
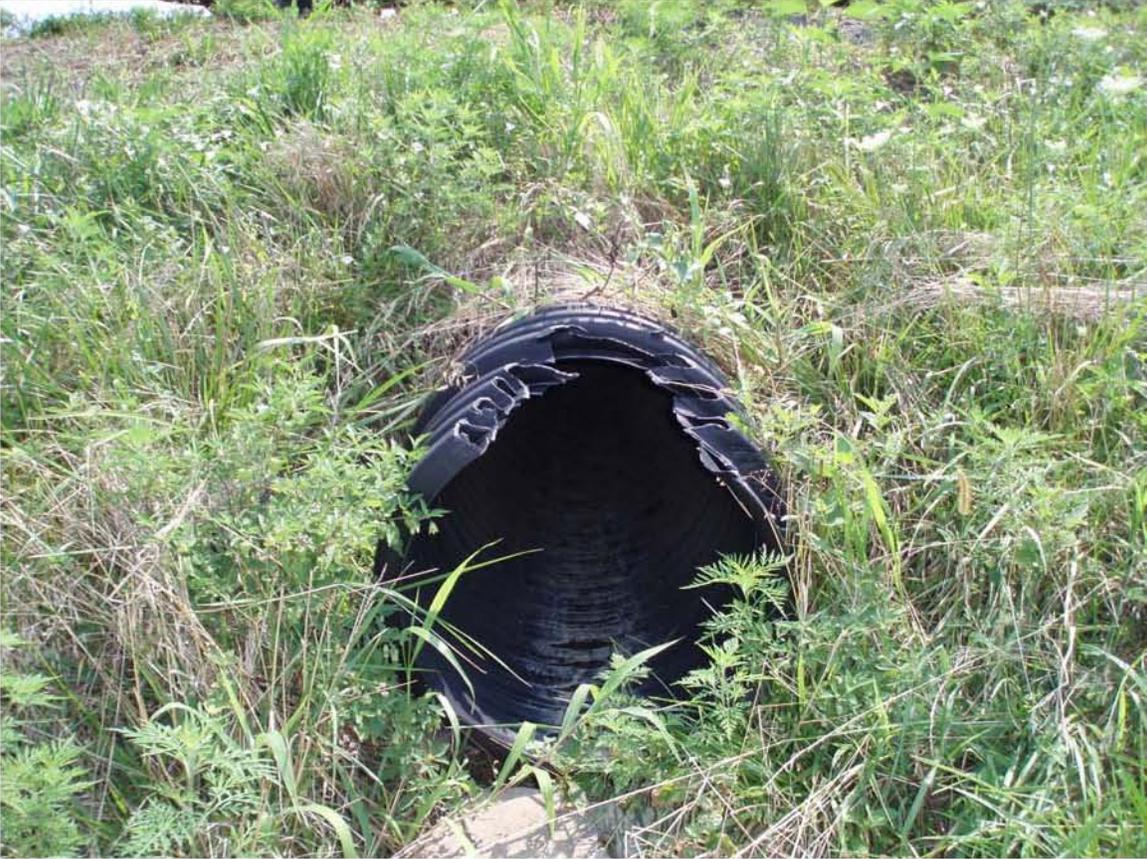
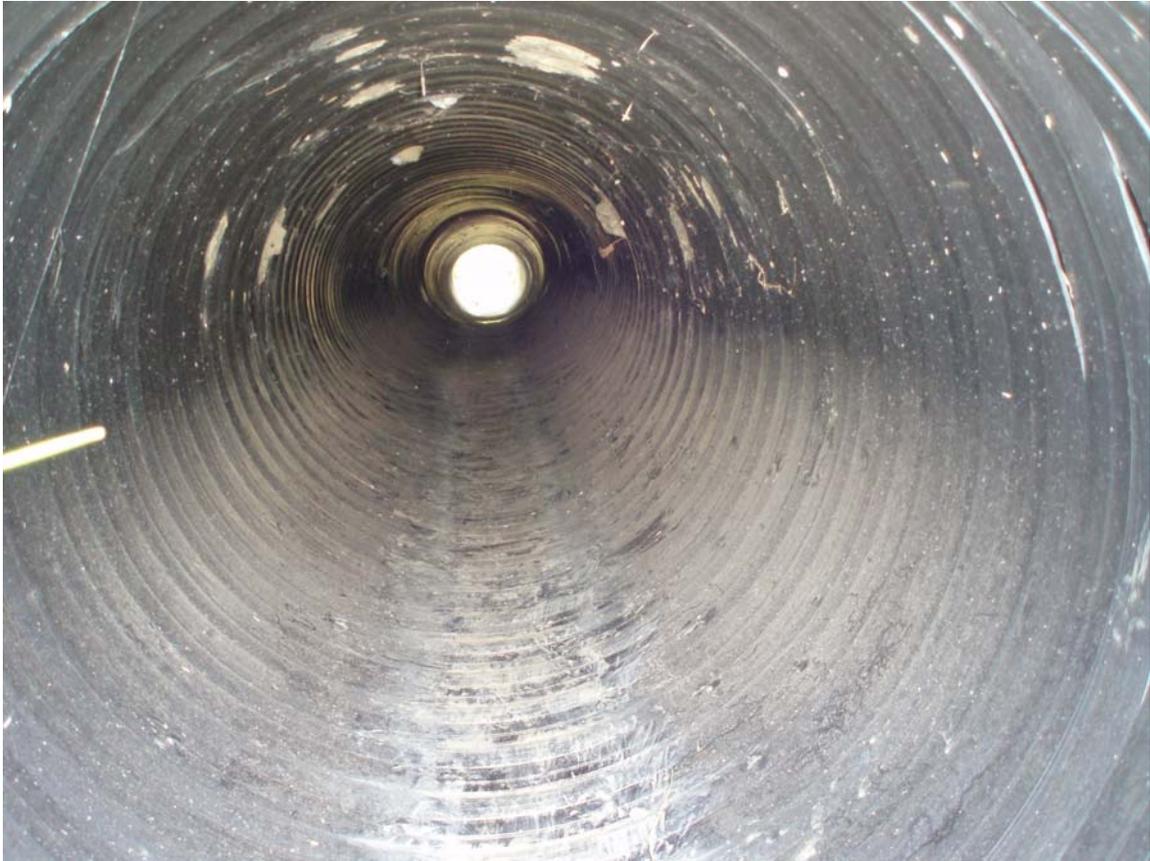
8-1-07, Rt. O 5.4 miles south of Rt. 52, 24" DWP, Couldn't get a good look inside the pipe, too much curvature.

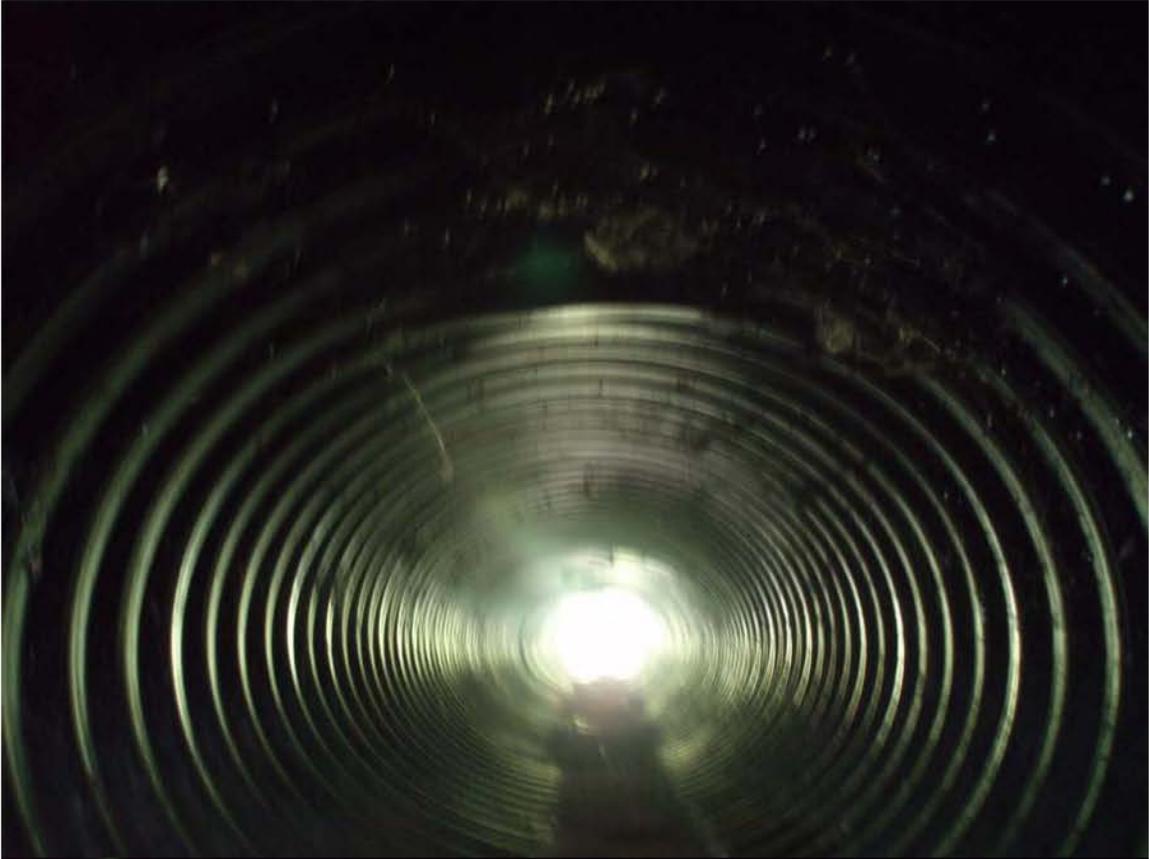
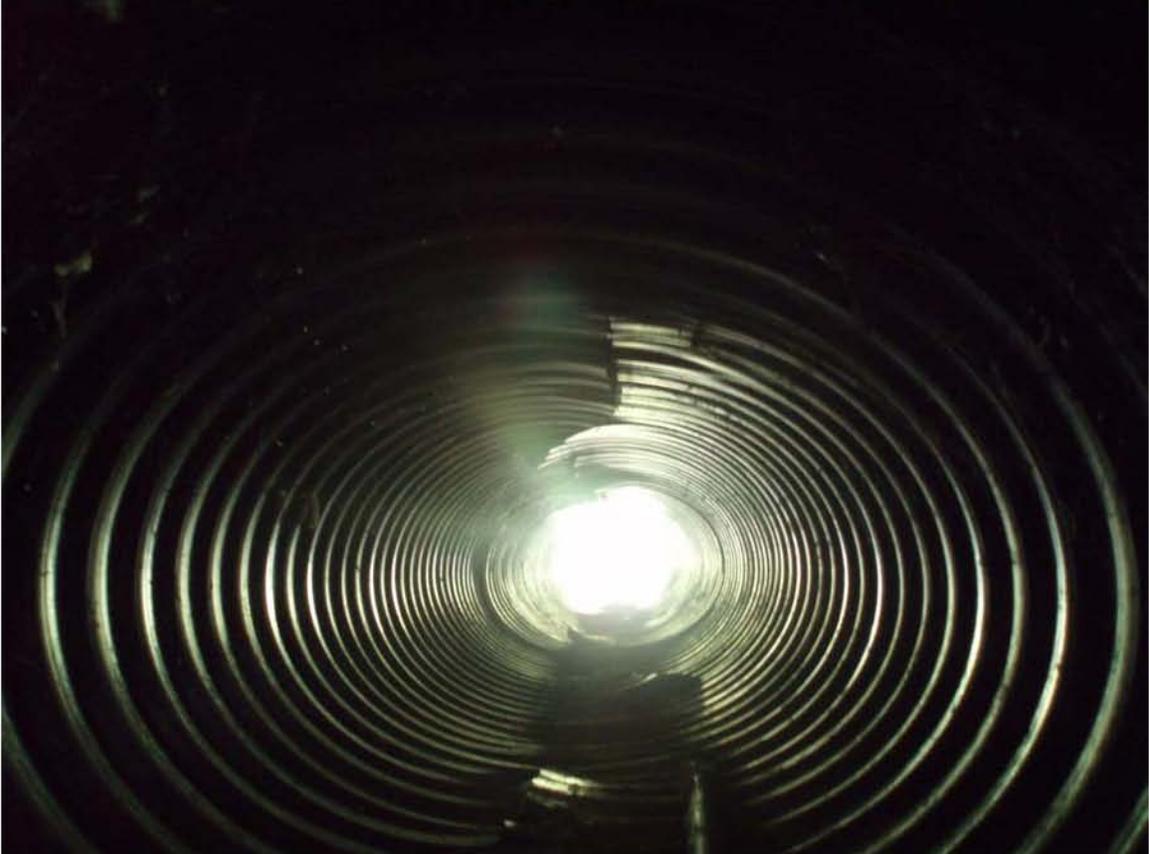
8-2-07, RT. AA, 1.0 m. w. of Rt. 63, 18", Installed 2000±, vert. Deflection, top and bottom longitudinal fractures, mower damage at outlet.

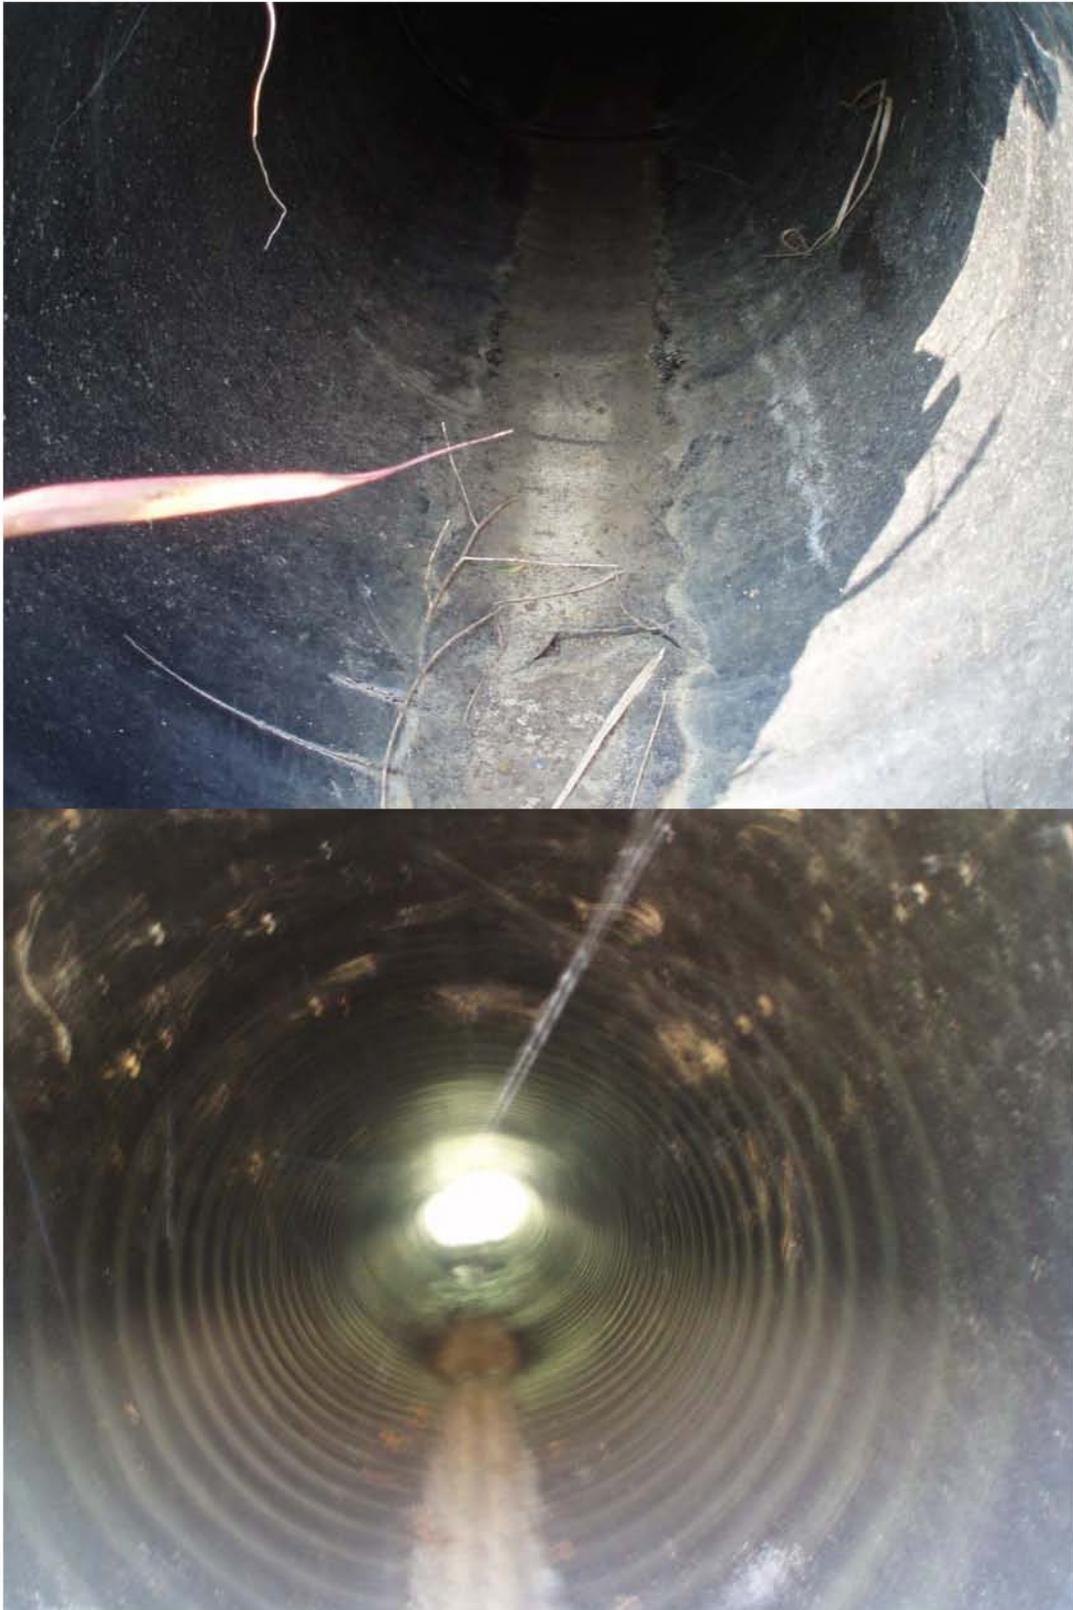
8-2-07, RT. AA, 1.0 m. w. of Rt. 63, steel pipe nearby, good condition.

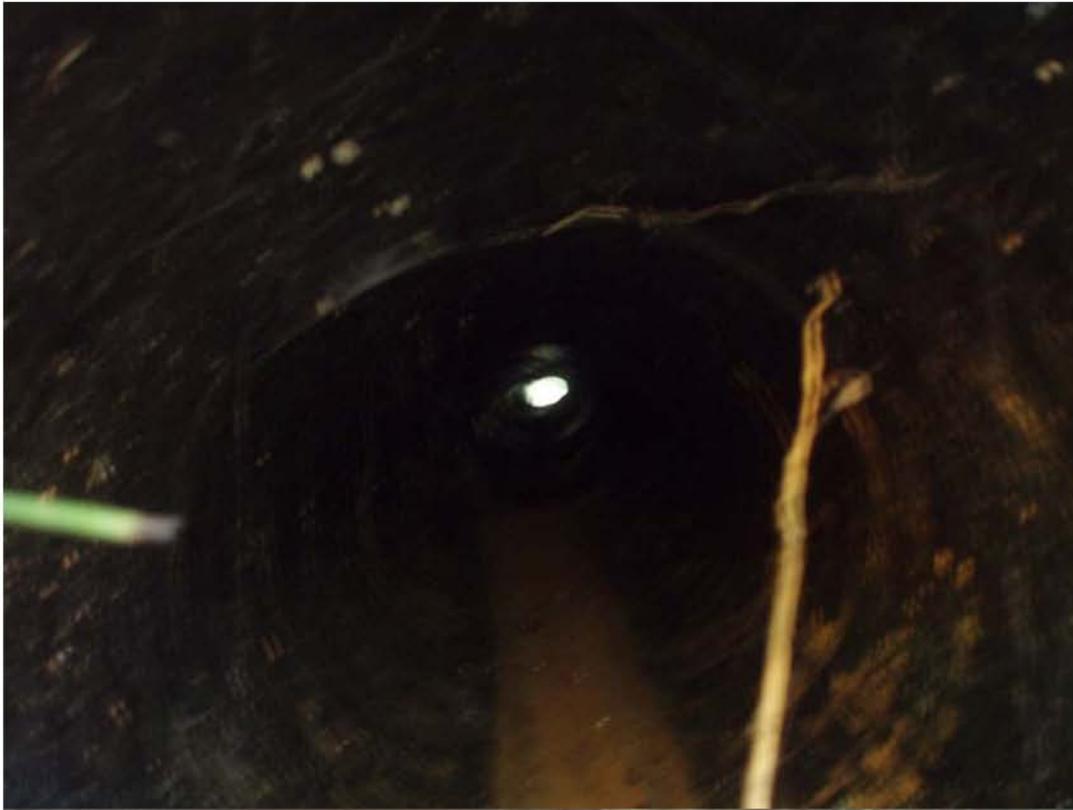
8-3-07, Rt. W., 2.55 m. W. of Rt. 63,15", view from Inlet and Outlet

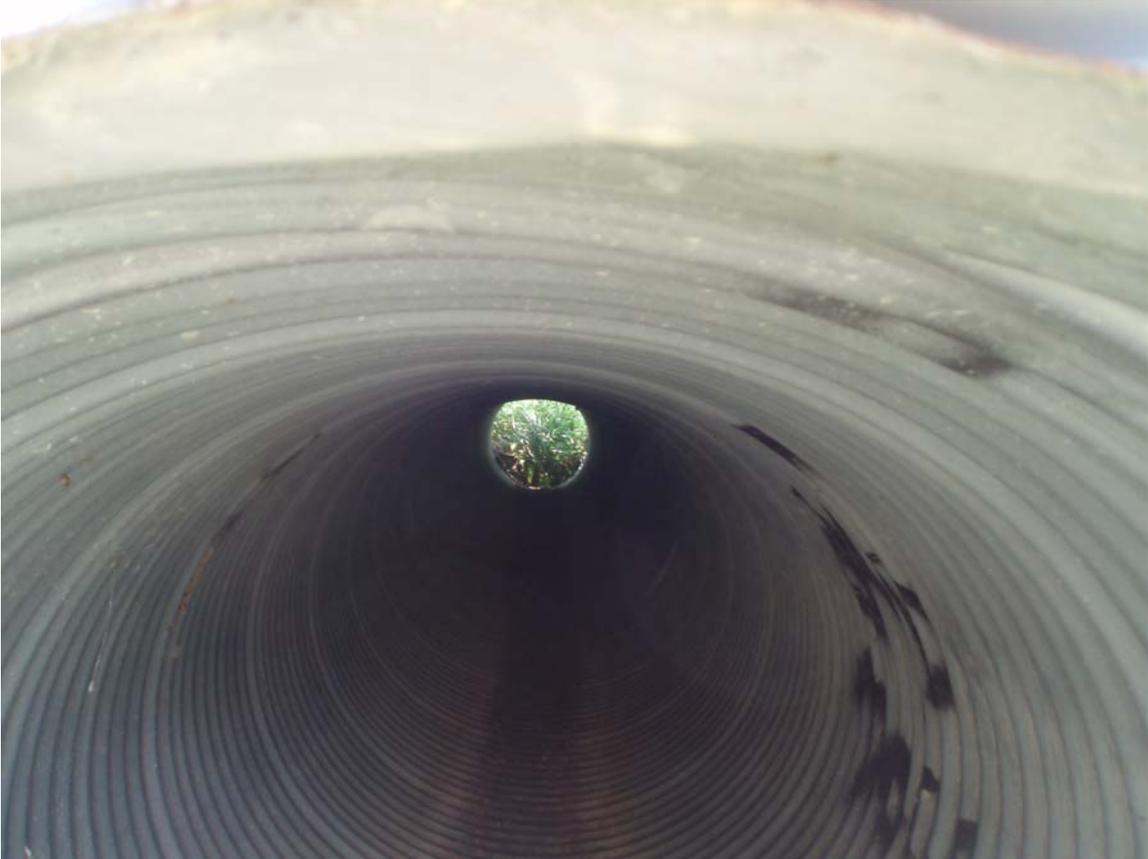
8-3-07, Rt. P - 0.6 m. W. of Rt. M, X-road 42" CMP installed in last 5-10 yrs., 40' long  $\pm$ , measured 38" under center line of roadway for deflection of 4" or 10.5%.

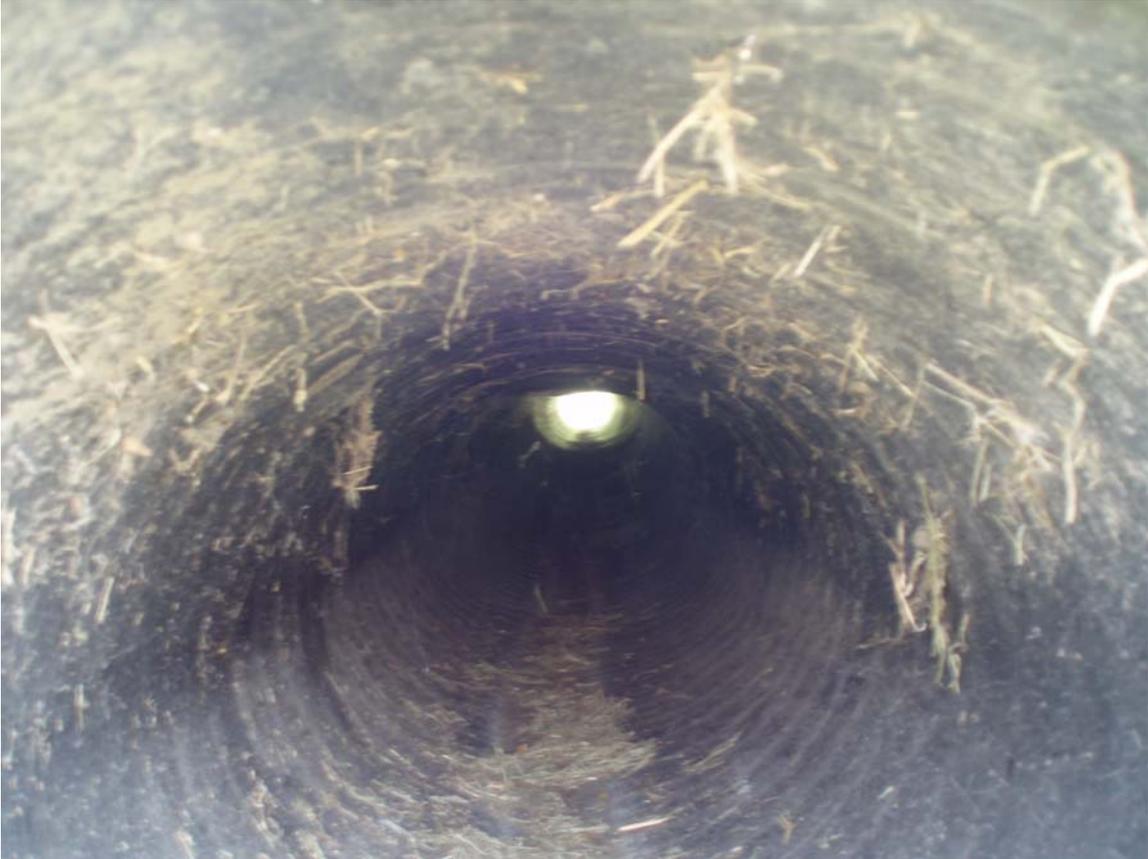
8-3-07, Rt. P, 1.4 W. of Rt. M, 24", view at inflow, possible 1"-2" (4%-8%) deflection @ CL of roadway, approximately 3' overfill.
