Macon and Adair County, Route 63, Job J2P0485

Route 63, Howell Co., project J9P0497, HDPE double wall storm sewer, W. Side Rt.63

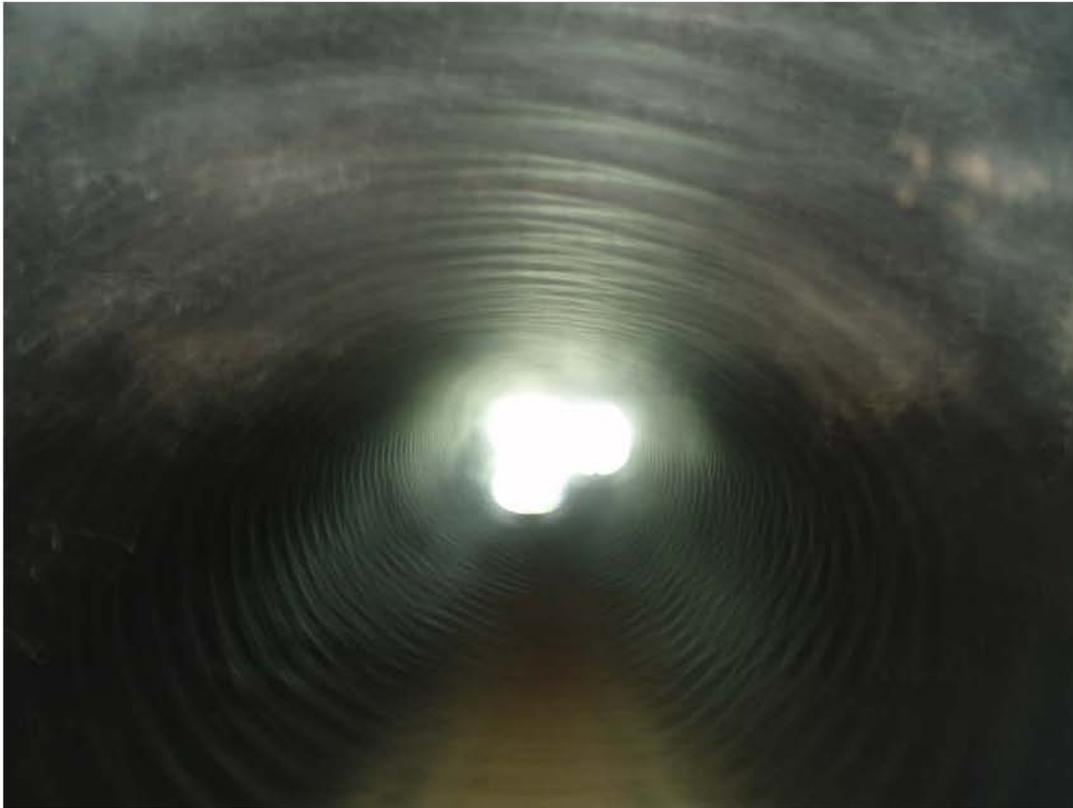
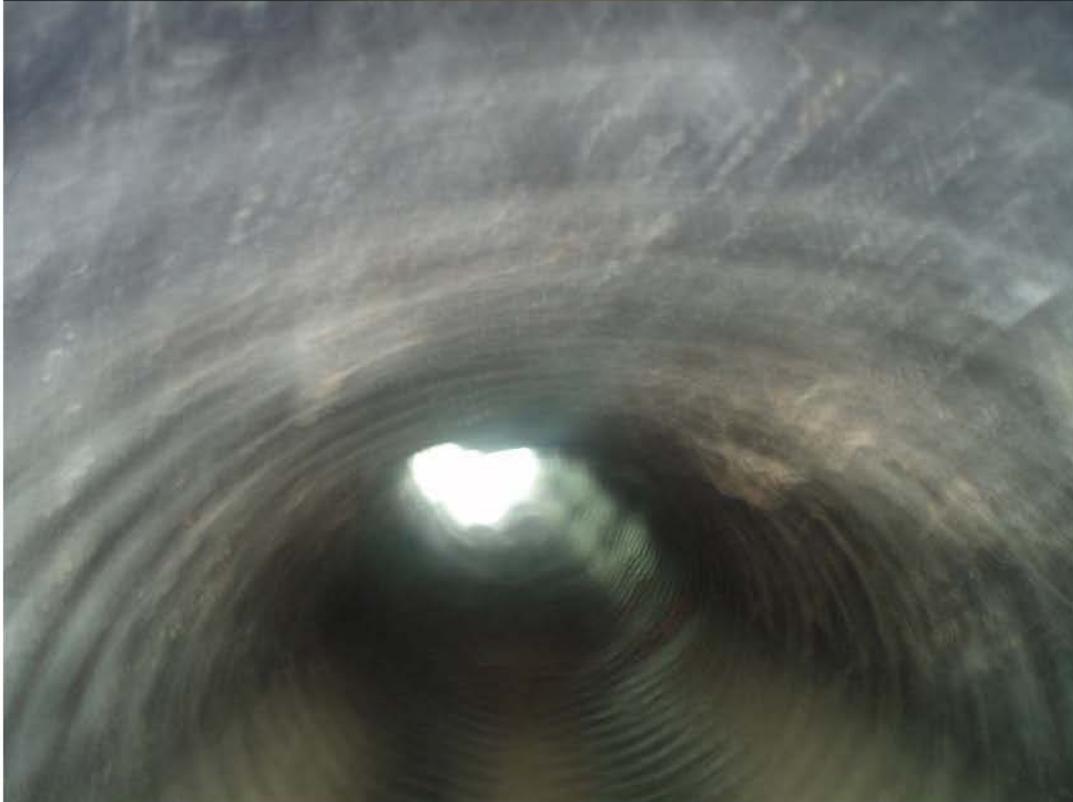
8-3-07, Rt. P, 1.5 m. W of Rt. M, 24", 2"+ deflection @ inflow, measured at other end 18.5"(5 1/2" d.) and 15.5" (9" defl.) under N. Shoulder.

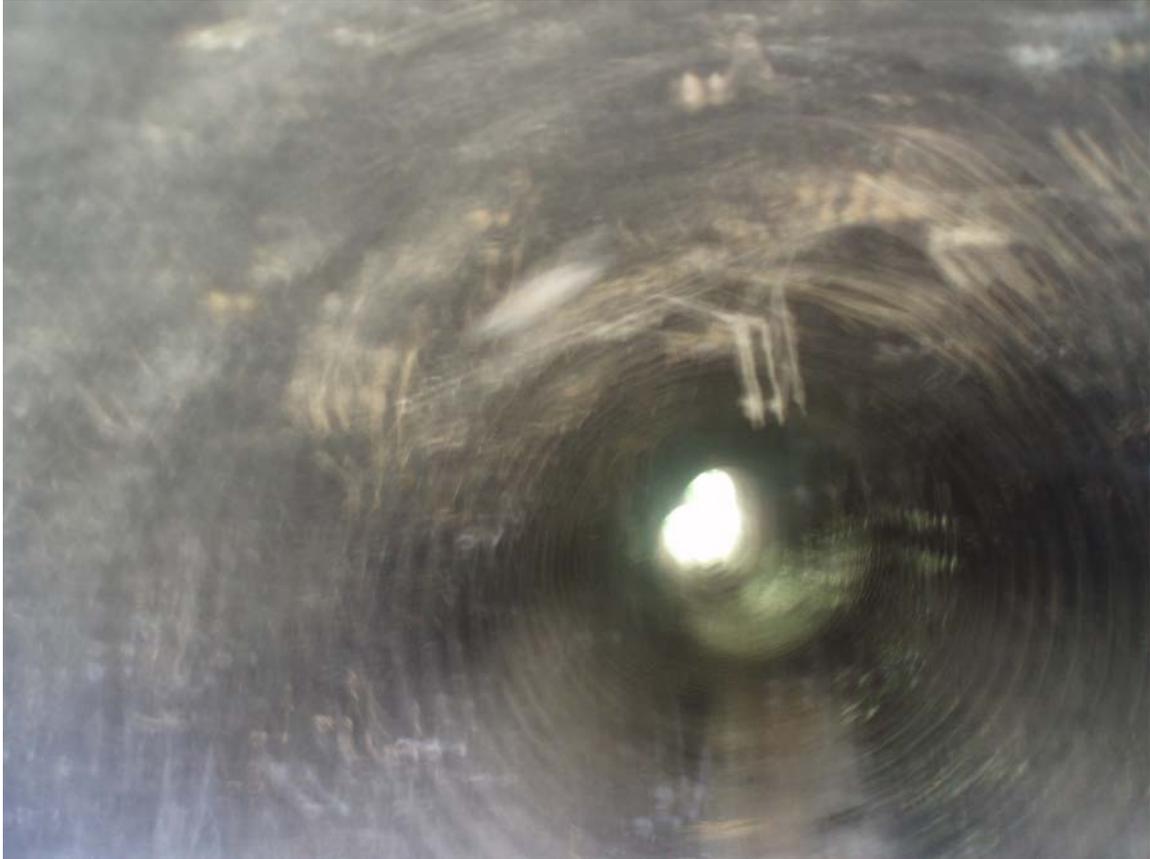
8-3-07, Rt. P, 3.5 m. W. of Rt. M, Inflow – small deflection ½ way in @ 11 o'clock, maybe a rock in backfill.

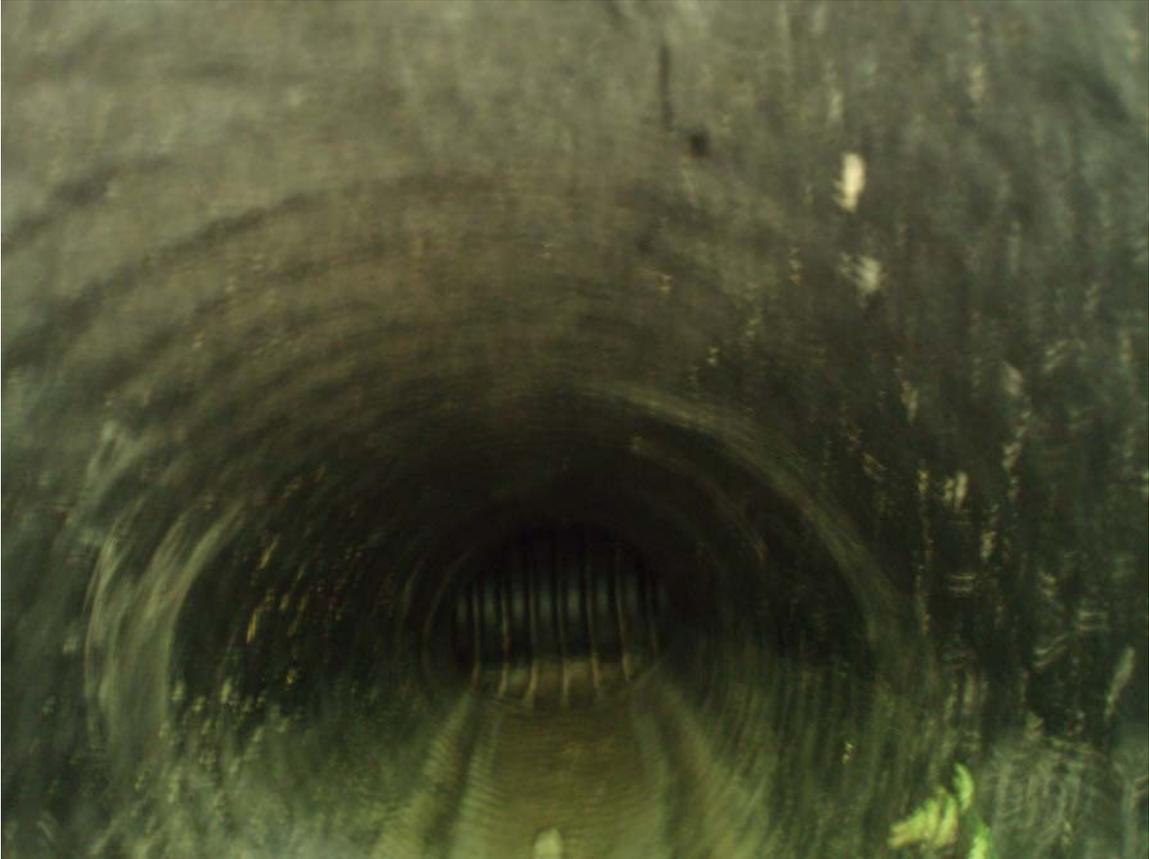
8-3-07, Rt. P, 0.2 m. E of Rt. 5, 15", looking from outflow, other end can not be seen because of horizontal curvature of pipe.

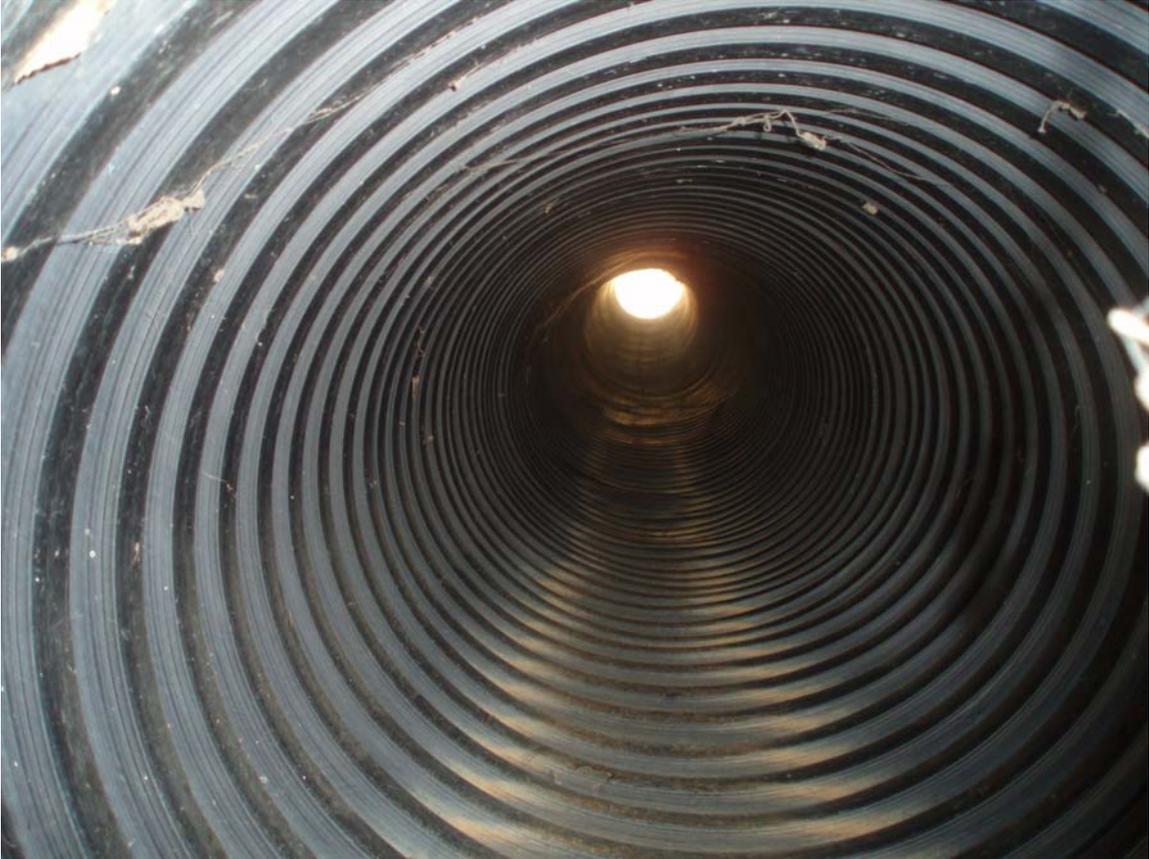
8-8-07, Rt. M Texas Co., 7.1 m. S. of Rt. YY, 18", no change since installed 1/13/02.

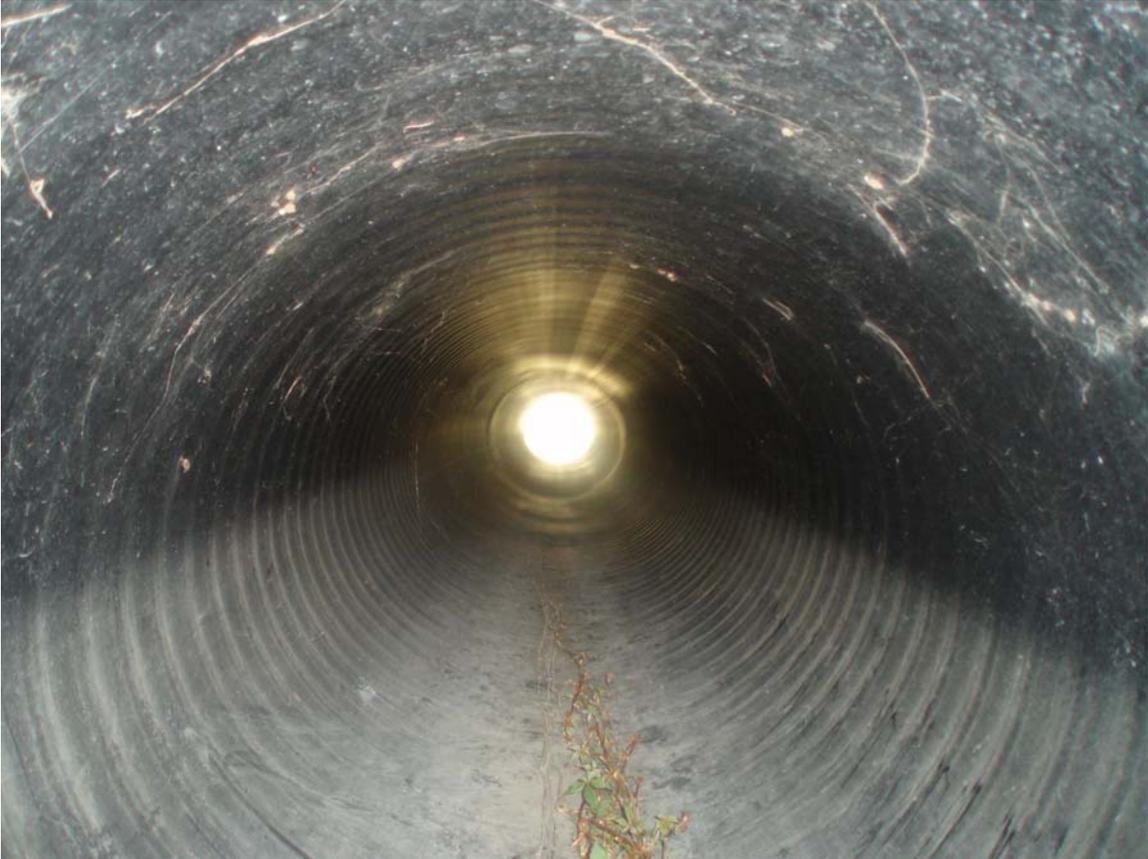
8-8-07, Rt. 38 teas Co., 0.225 m. N of Rt. M, 18", no change since installed 1-22-02.
